TOWN OF TILLSONBURG

2019 OSIM INSPECTIONS

NEEDS STUDY

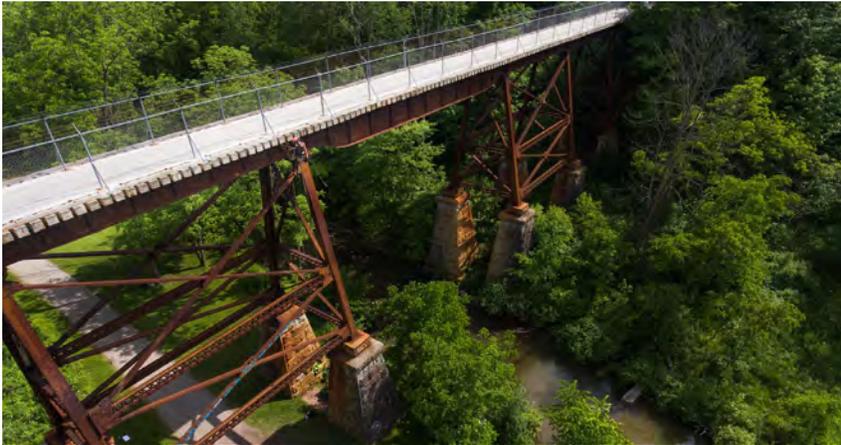
Enhanced OSIM Inspection completed with use of rope access technicians. All structure members inspected to determine severity of deterioration. Steel members showing light to severe corrosion and delamination. Delaminated steel sections are flaking. Steel strapping missing on North I pier cap (refer to Enhanced OSIM Drawing for element locations). The overall condition... Refer to OSIM for details.

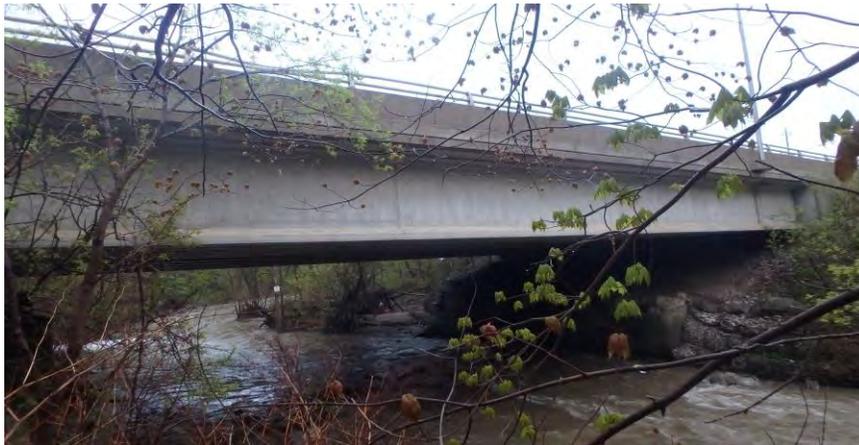
Superstructure and substructure are generally in good condition.

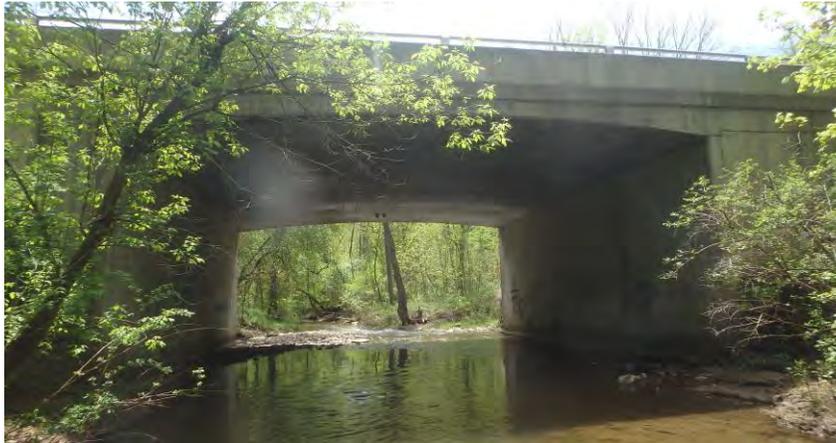
Localized cracking and delamination noted in soffit.

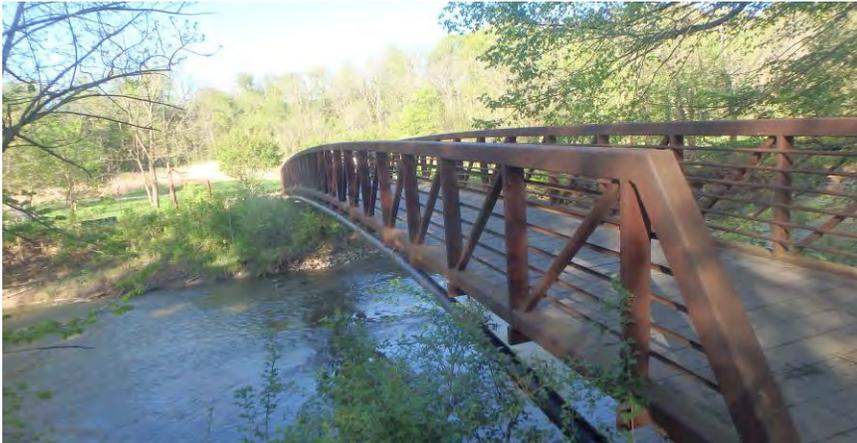
The structure is generally in good condition. Settlement of east concrete approach slab noted. Steel plate installed as temporary fix. Maintenance work required.

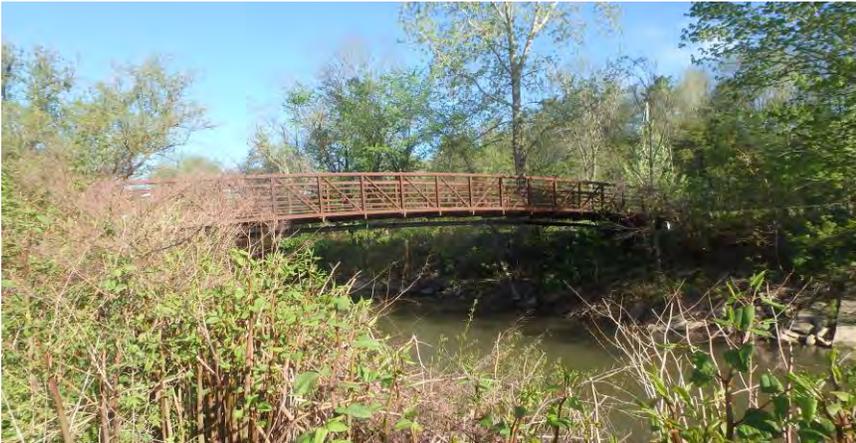
The structure is generally in good condition. Deterioration of approach ramps noted. South utility box open during time of inspection. Maintenance work required.

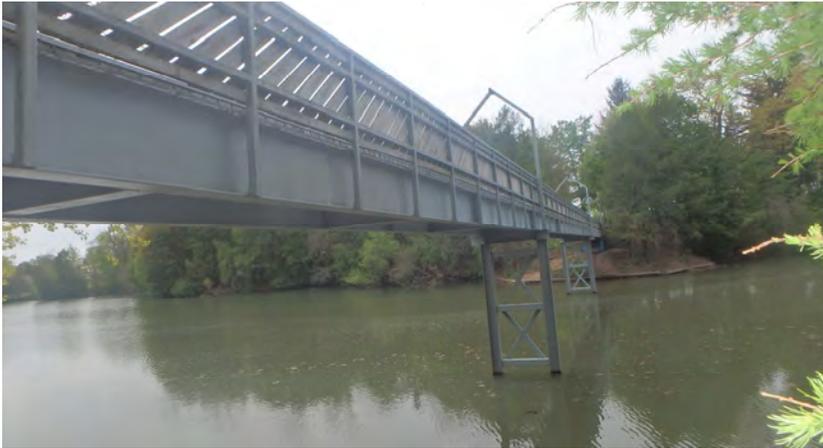
Minor rehabilitation work required. Severe undermining of retaining wall footing at southwest quadrant. Major rehabilitation recommended in 10 years including cleaning and coating of all structural steel.

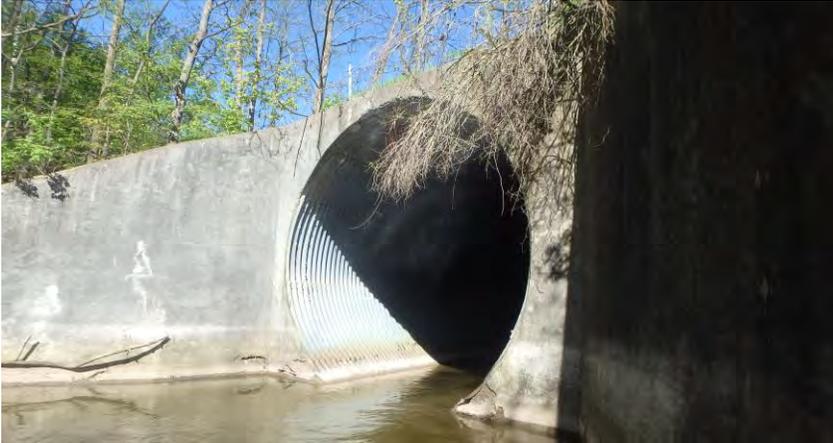
Structure is generally in fair to good condition. Localized spalls at inlet and outlet. Minor rehabilitation work required.

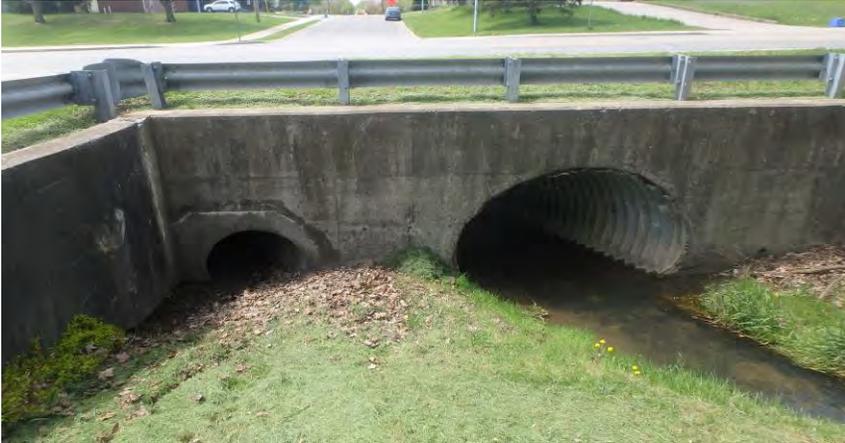
Structure is generally in fair condition with some poor elements. Deformations at crown are of concern. Recommend replacing culvert within 10 years.

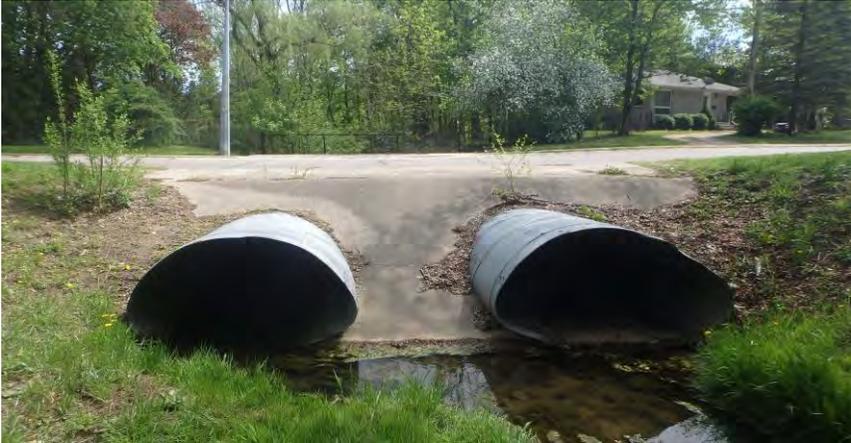
Structure is in overall fair to poor condition. Culvert replacement is recommended.

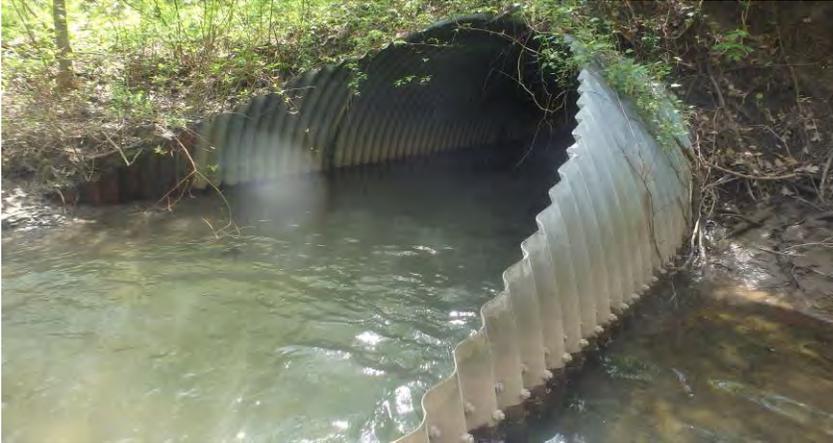
Previous OSIM describes significant amount of deterioration. Limited inspection in 2019 due to water levels. Recommend supplementary inspection at lower levels or underwater inspection to determine appropriate recommendation.

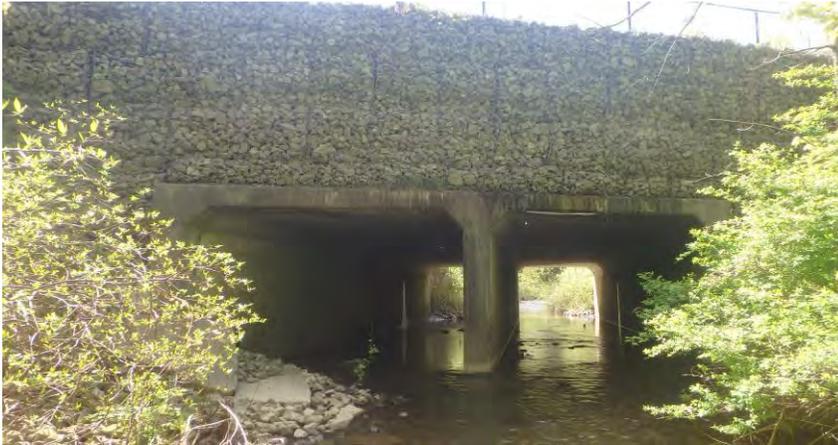
Severe rotation and sliding of retaining wall at southwest quadrant. Continue to monitor movement, settlement and rotation of gabion basket retaining wall on the west side until replacement. Replacement or stabilization of the southwest section should be done as soon as possible.

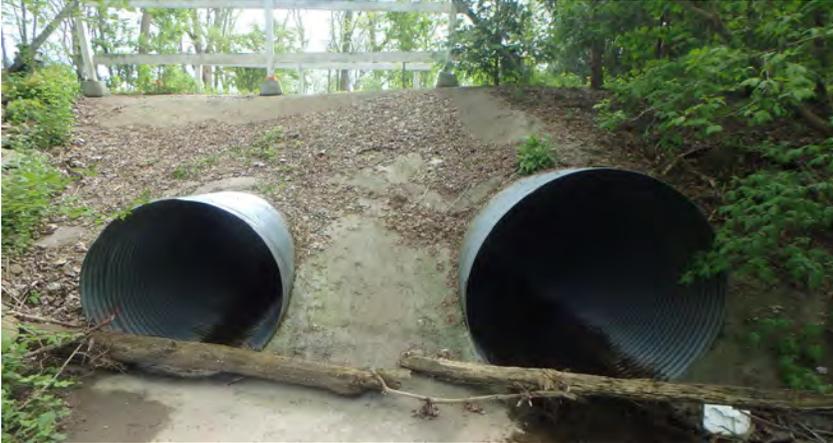
Structure is generally in good condition, however, barriers are not anchored.

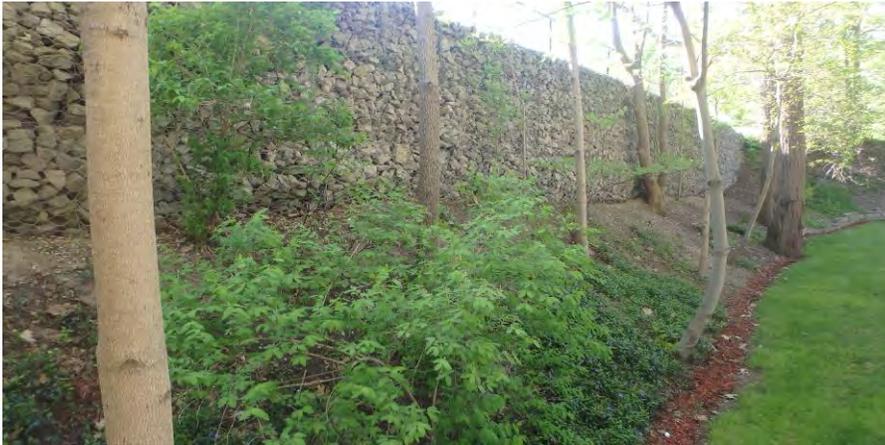
Replacement is recommended. Continue to monitor movement, settlement and rotation of retaining wall until replacement. If any immediate safety concerns are identified, immediate rehabilitation or replacement is required. Evaluate structures and new RSS option in-front of existing.

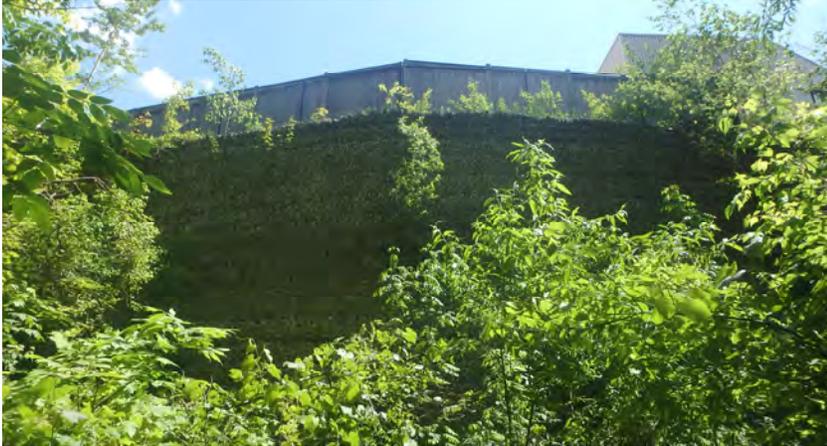
Structure is in generally good condition. Localized areas of bulging noted in wall.

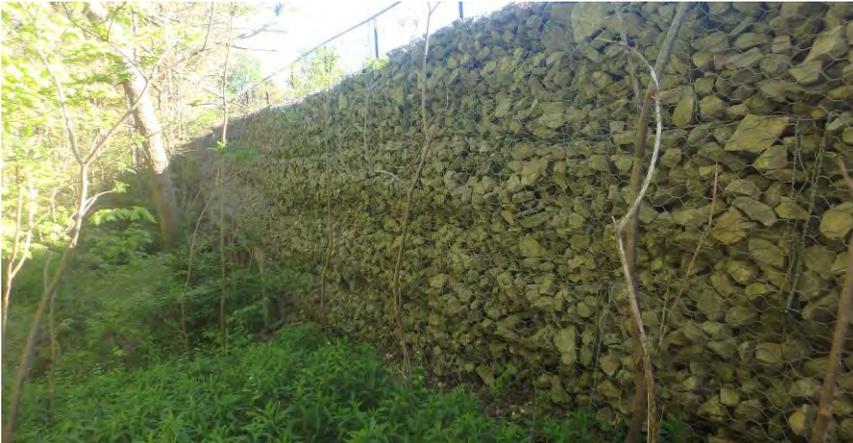
The structure is in fair to good condition. Settlement of wall is causing deformation to elements above.

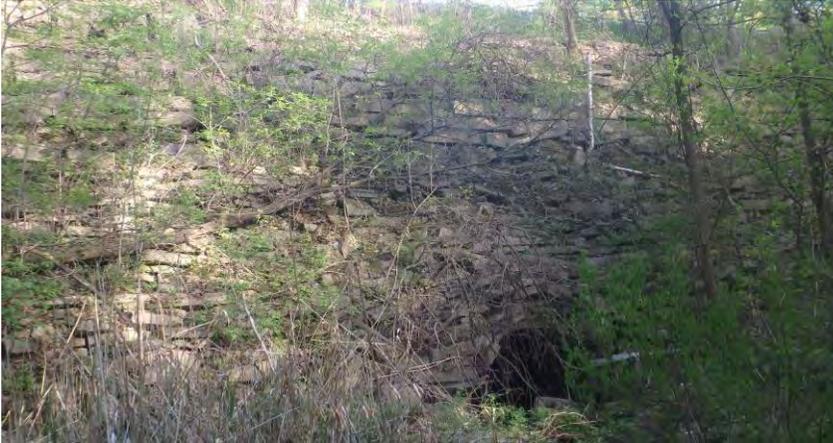
The structure is generally in fair to poor condition. It is recommended that the retaining wall be replaced.

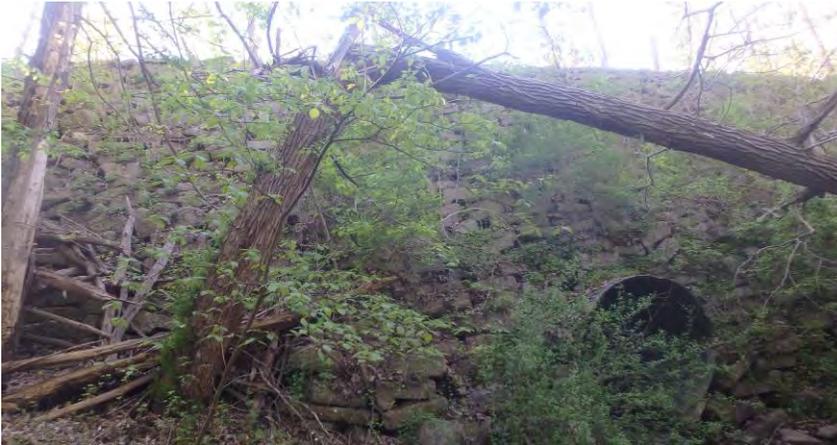
The structure is generally in fair to poor condition. It is recommended that the retaining wall be replaced.

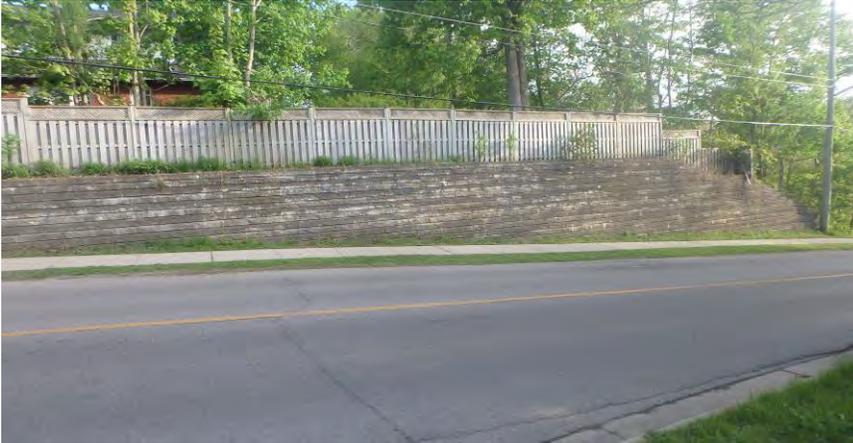
The structure is in overall fair to good condition. Broken fence post at west end of wall.

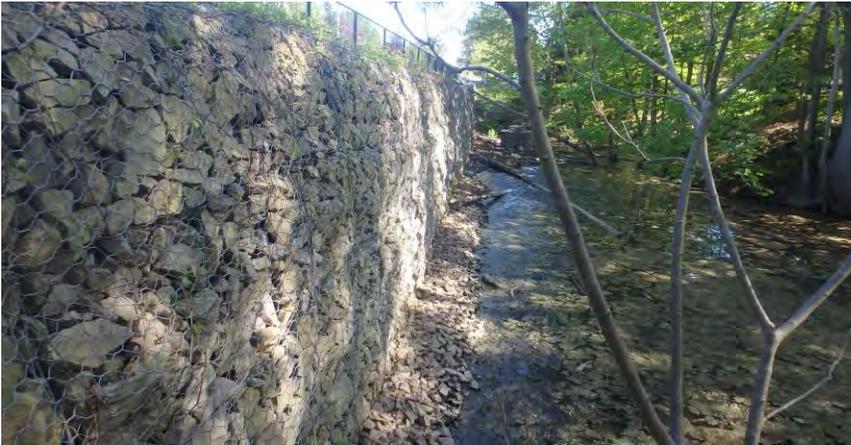
Settlement of gabion baskets noted. Settlement and rotation of structure causing sidewalk above wall to rotate.

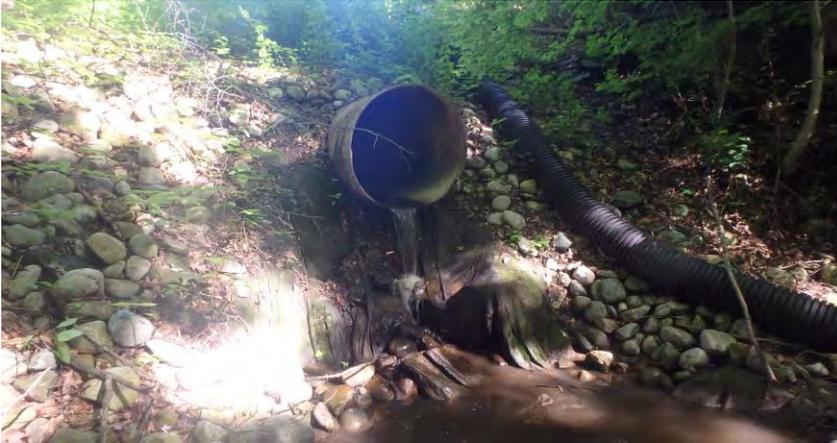
The structure is generally in fair to poor condition.

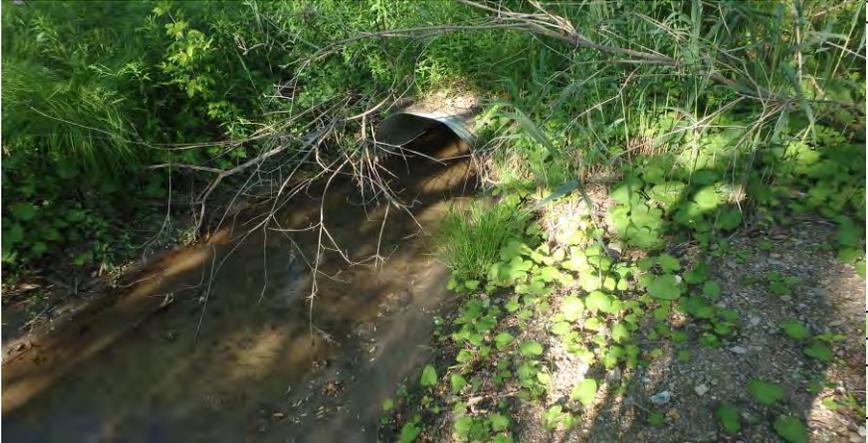
Limited inspection of structure due to limited access and size of structure. Structure is generally in good condition. Build-up of debris at inlet. Maintenance work required.

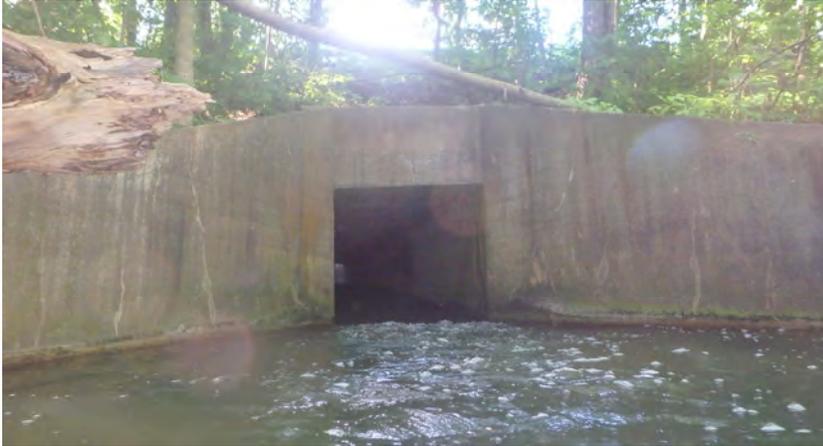
Limited inspection of barrel due to limited access. Enhanced OSIM recommended. Severe undermining of footing at outlet. Rehabilitation recommended.
