January 22, 2026

Reference: 25-05-0084

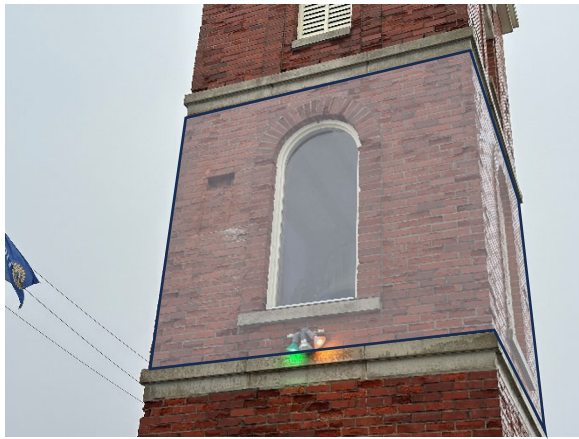
Partial West Elevation
Deteriorated brick units

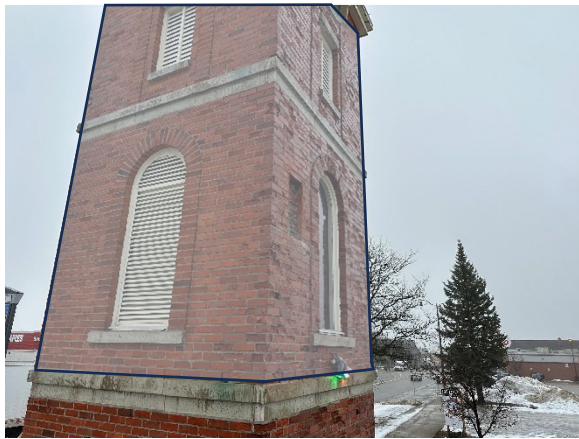
North (left) West (right) Elevation Masonry
Deterioration

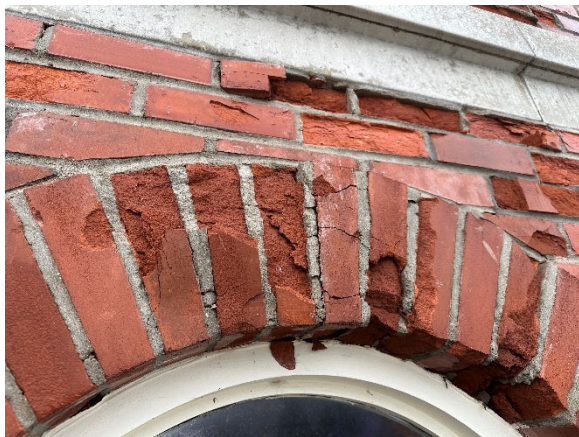
Window Header Brick Deterioration

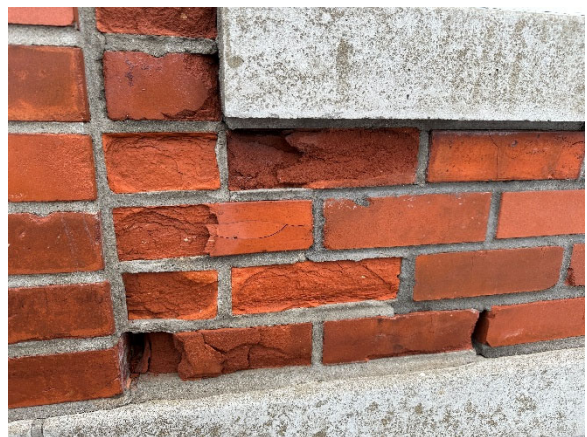
Brick Spalling @ Window Sill

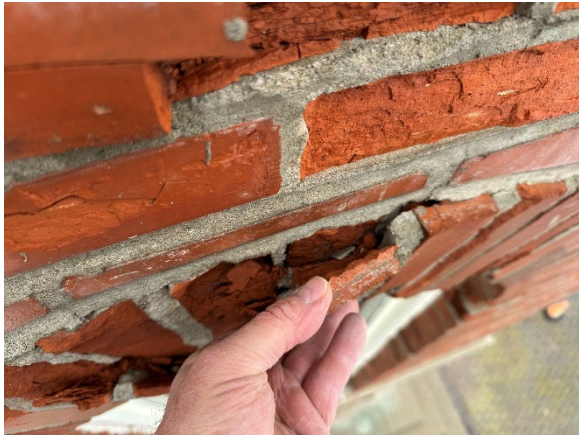
Brick Spalling @ Window Arch

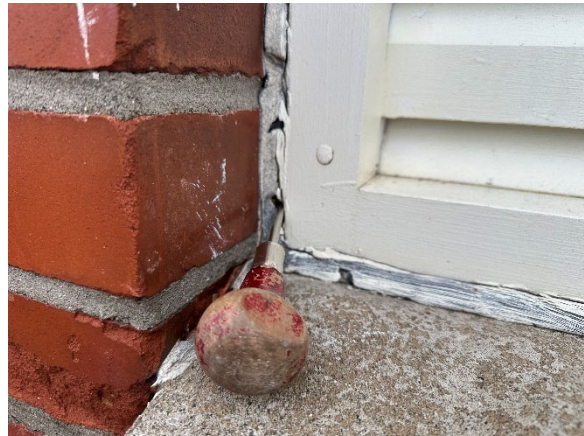
Deteriorated Sealant @ Louvre

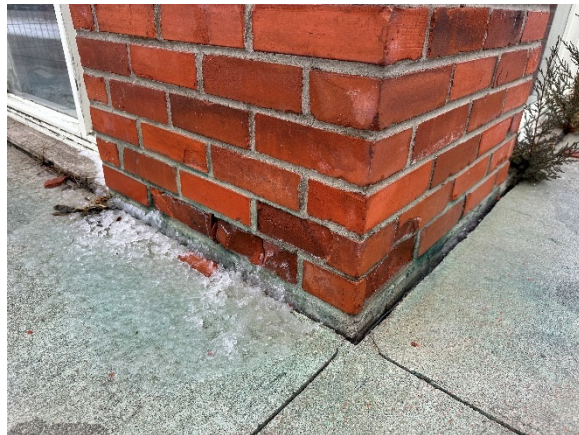
Brick Deterioration at Grade

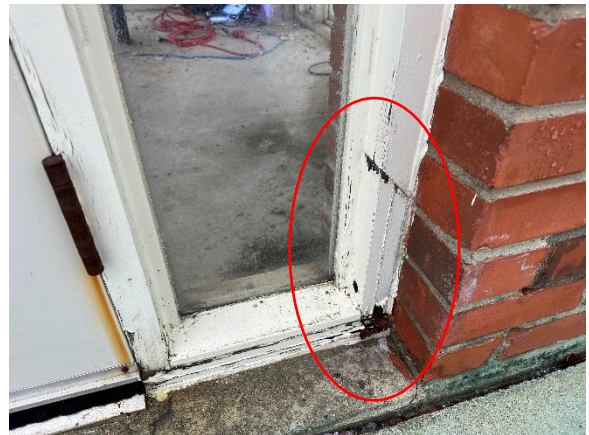
Wood Entrance Screen Deterioration
Wood dutchman repair

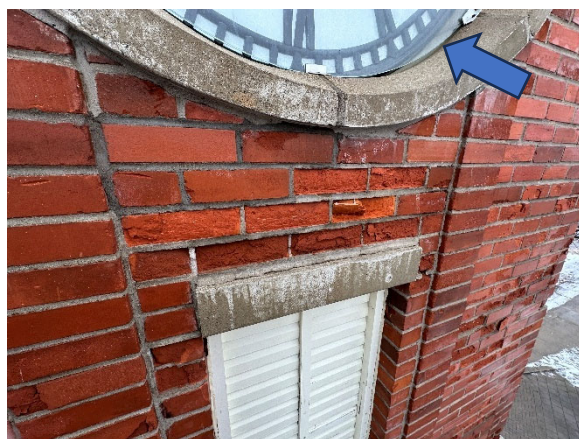
Brick Deterioration
Vented space between storm glass and surround

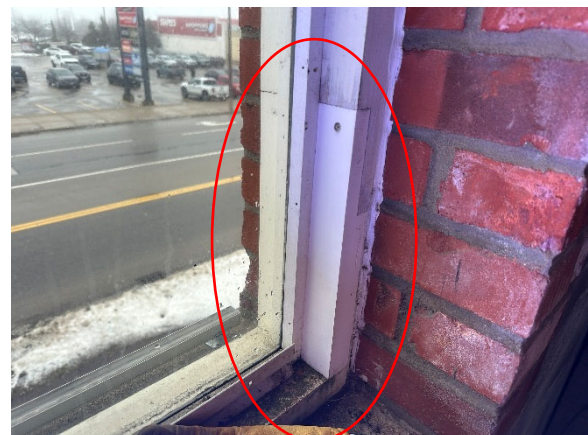
Window Frame Dutchman Repair

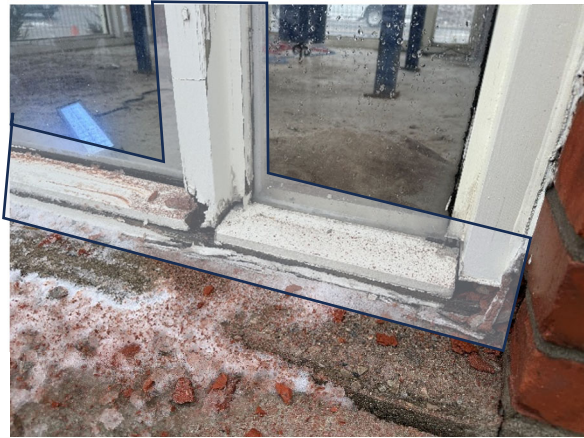
Wood Screen at Grade Deterioration

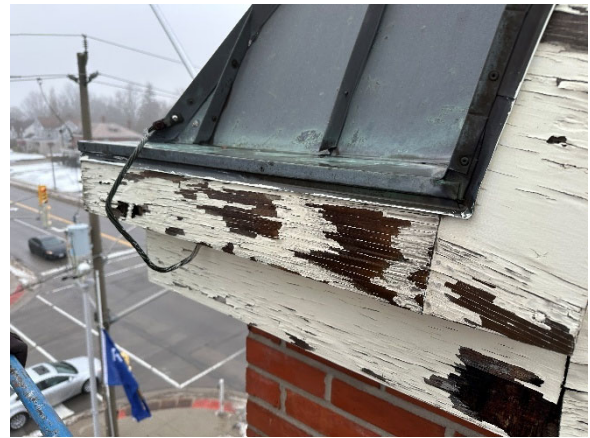
Wood Fascia and Trims Deterioration

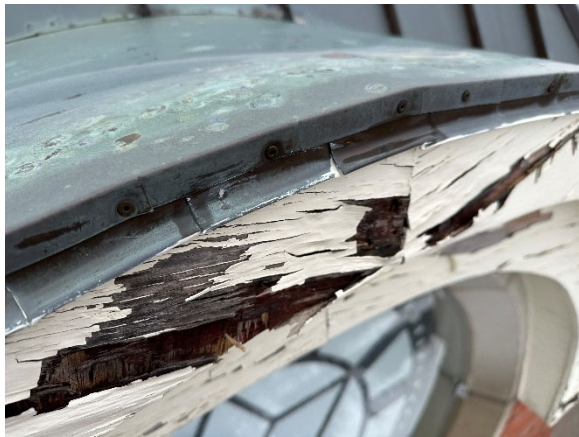
Wood Fascia Deterioration

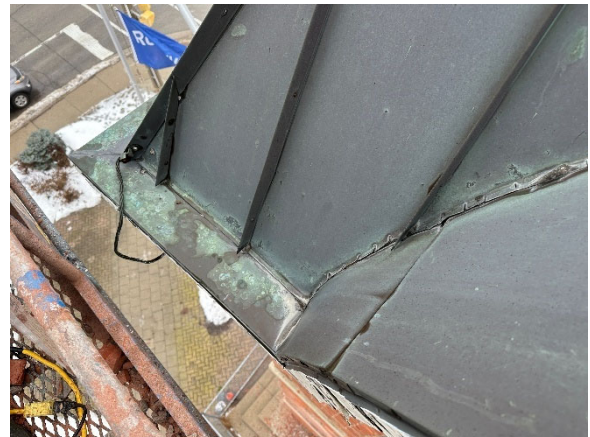
Copper Roofing at Eave and Barrel

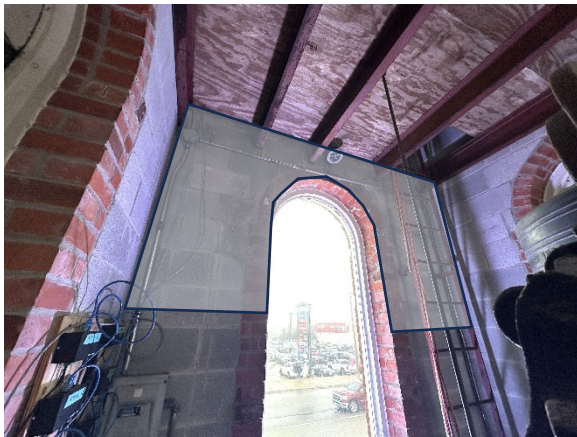
Wet and Spalling Interior Block

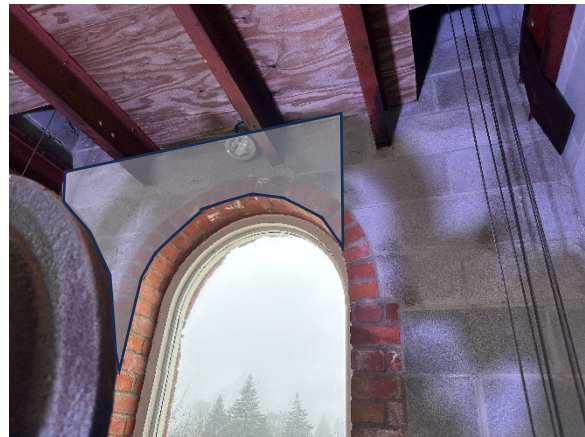
Wet and Spalling Interior Block

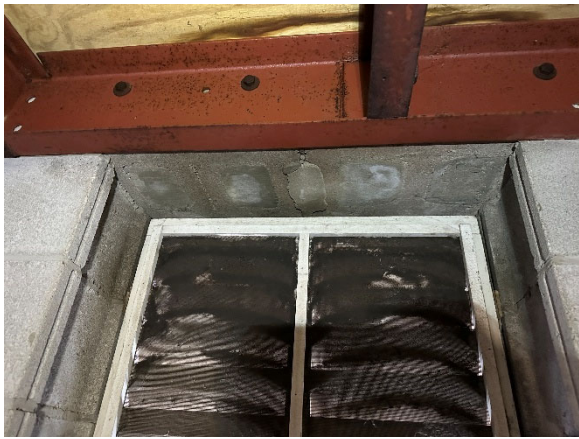
Wet Interior Block at Louvre Opening
Block is saturated with moisture

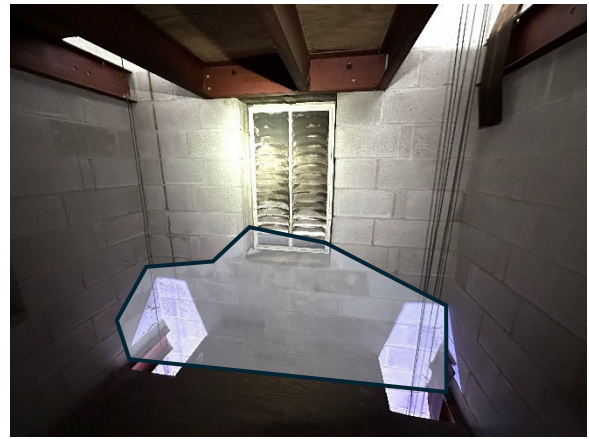
Water Staining and Spalling Below Louvre

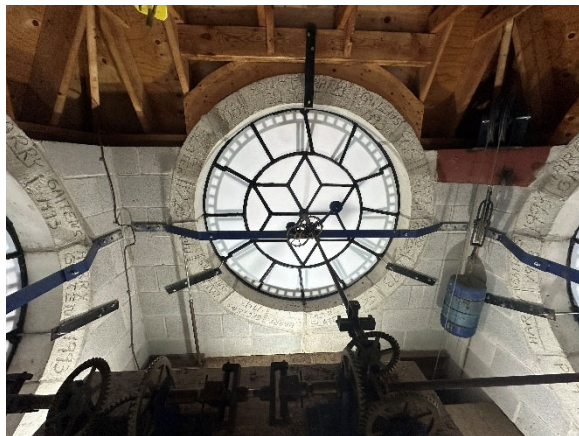
The standing seam metal roofing is grounded via a copper stranded cable running into the interior of the structure.

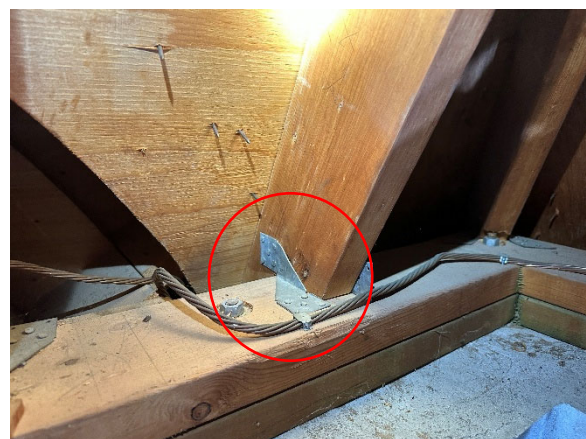
Improper Tie Down Anchors
Grounding cable
