# **BUILDING CONDITION ASSESSMENT AND CAPITAL PLANNING STUDY 8 ROSS STREET, TILLSONBURG, ON**

OCTOBER 12, 2017

**LAKE LISGAR WATER PARK  
AND SUMMER PLACE  
8 ROSS STREET  
TILLSONBURG, ON**

**TOWN OF TILLSONBURG**

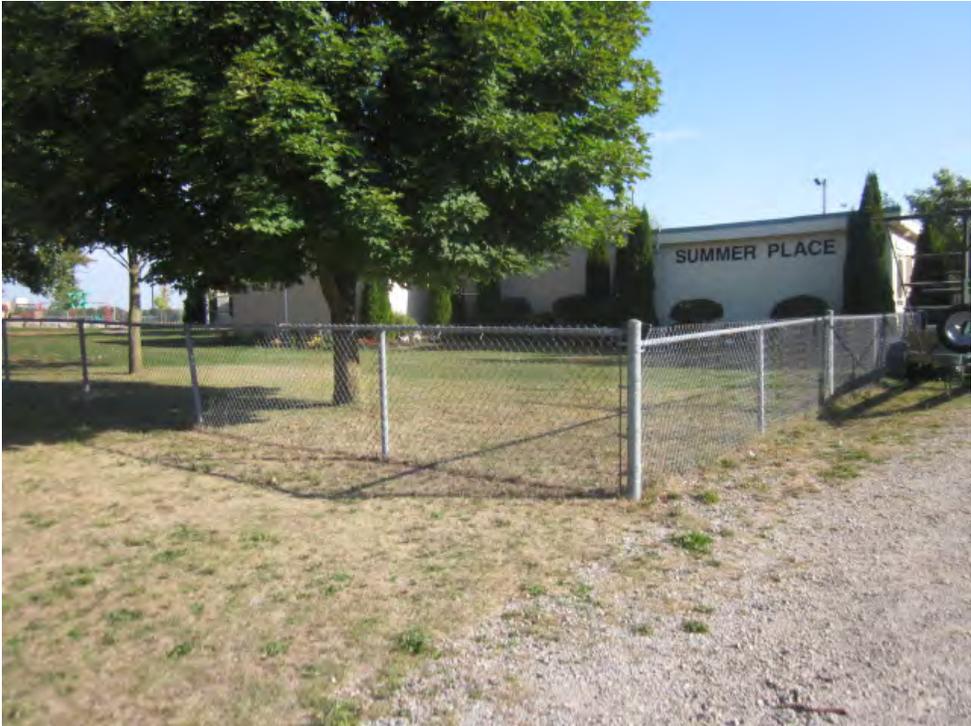
Photograph 1. Chain link fence at Summer Place

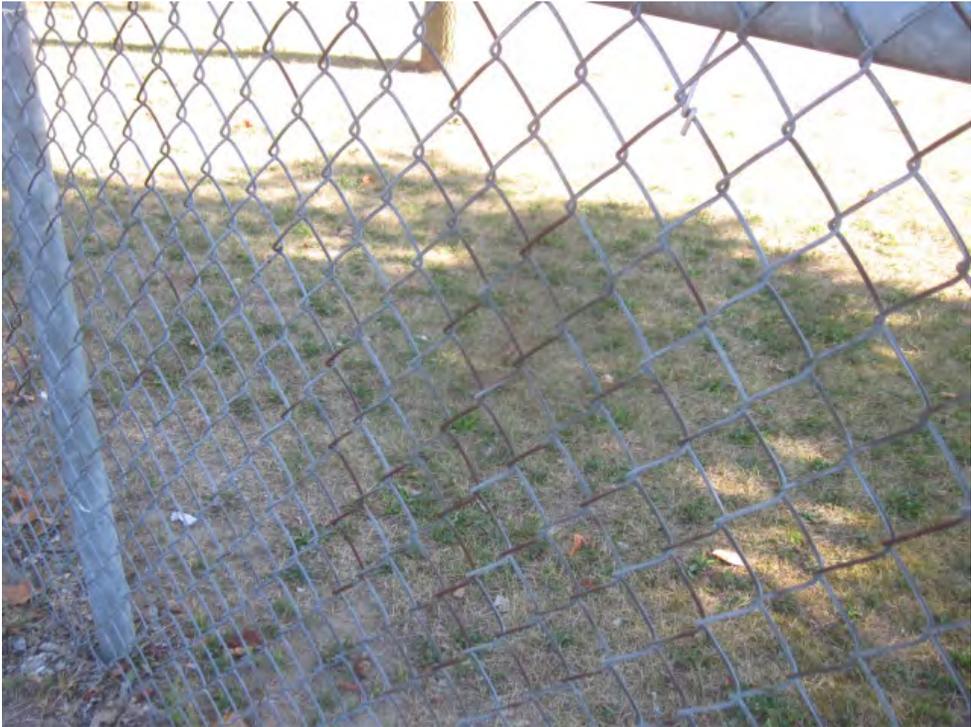
A 1.2 metre high metal chain link fence is provided along the perimeter of the site at the west side of the building. The chain link fencing is generally in good condition with local areas of rust noted.

Photograph 2. Local rust on chain link fence at Summer Place

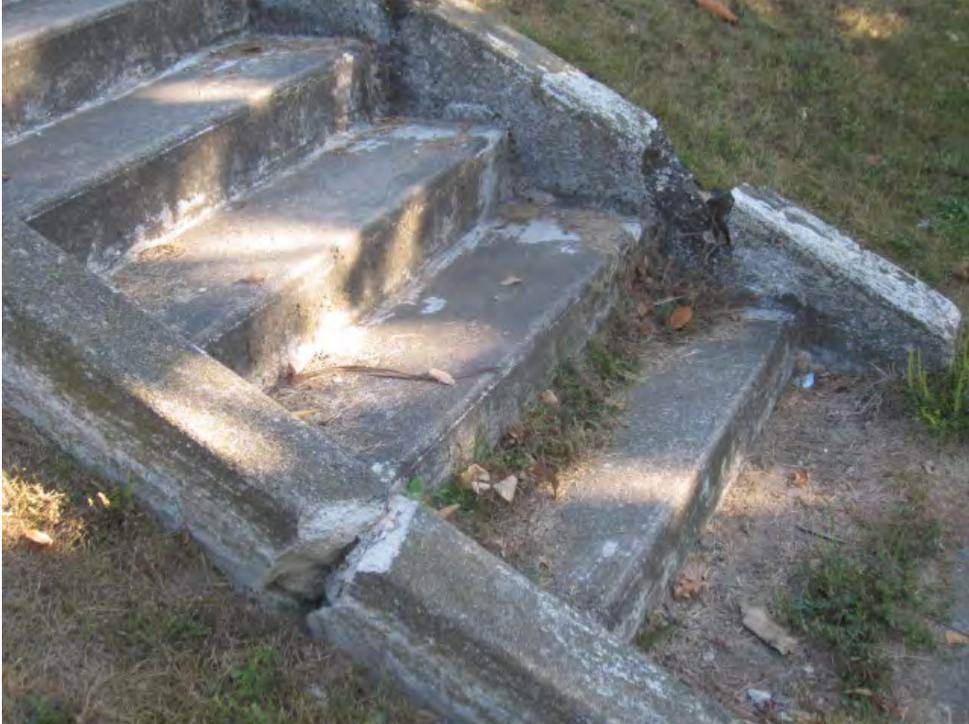
A cast-in-place concrete stair which provide access to the adjacent parkette is located at the south side of the site. This stair is in serviceable condition with areas of deterioration noted on the sidewalls. These deteriorated areas should be repaired as part on ongoing maintenance.

Photograph 3. Cracked and spalled concrete on concrete stair at south side of Summer Place

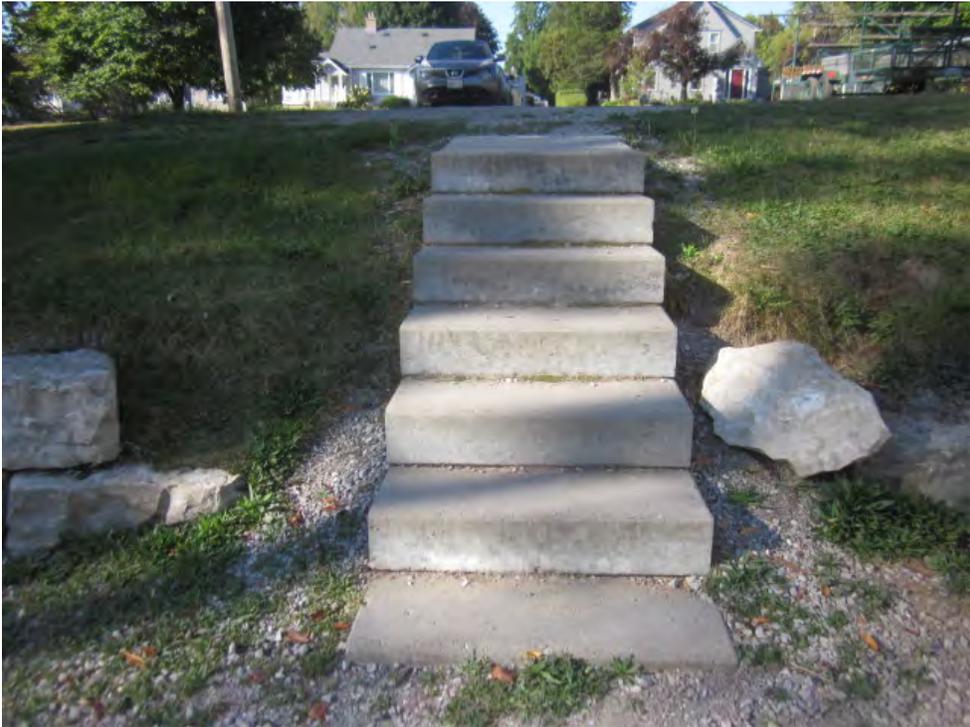
There is a precast stone stair leading from the gravel paved parking area down to the access driveway to the Tillsonburg Rowing Club. This stair is in good condition. While a guard is not required on this stair, it is suggested that a handrail be installed to assist pedestrians using the stair.

Photograph 4. Precast stair at Summer Place

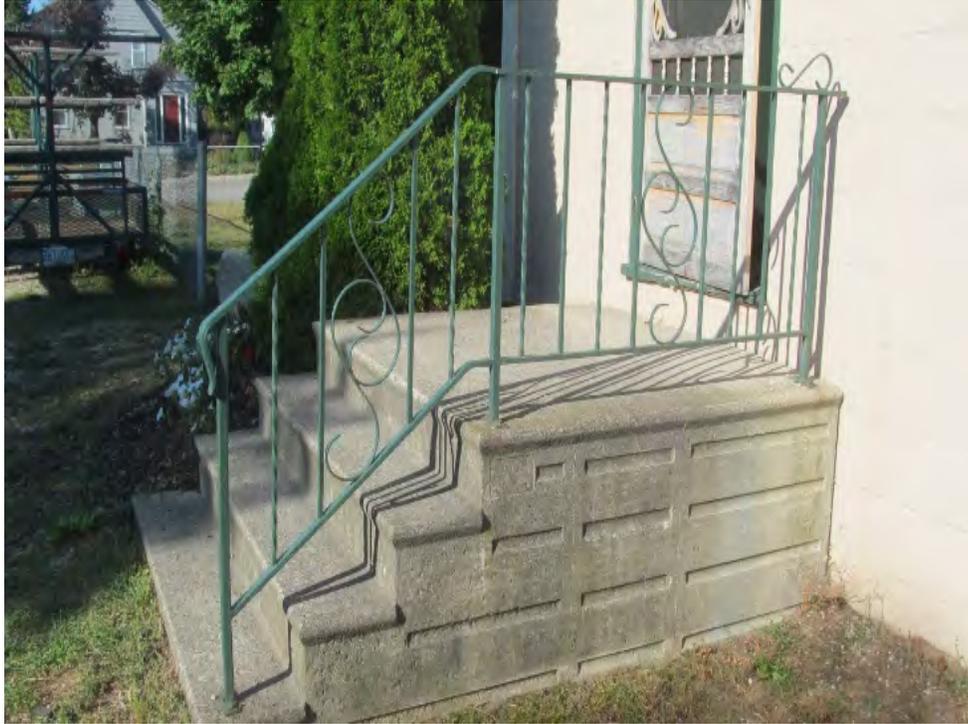
Photograph 5. Missing railing at south entrance to Summer Place

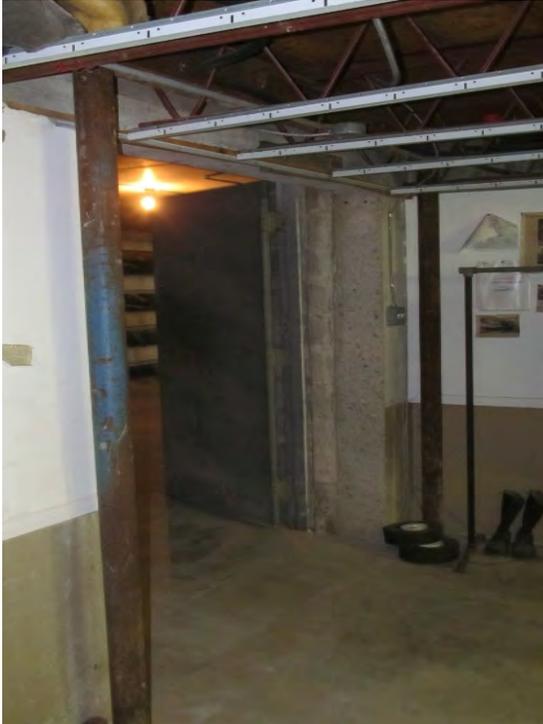
Photograph 9. Additional structural framing at foundation wall opening in basement of Summer Place

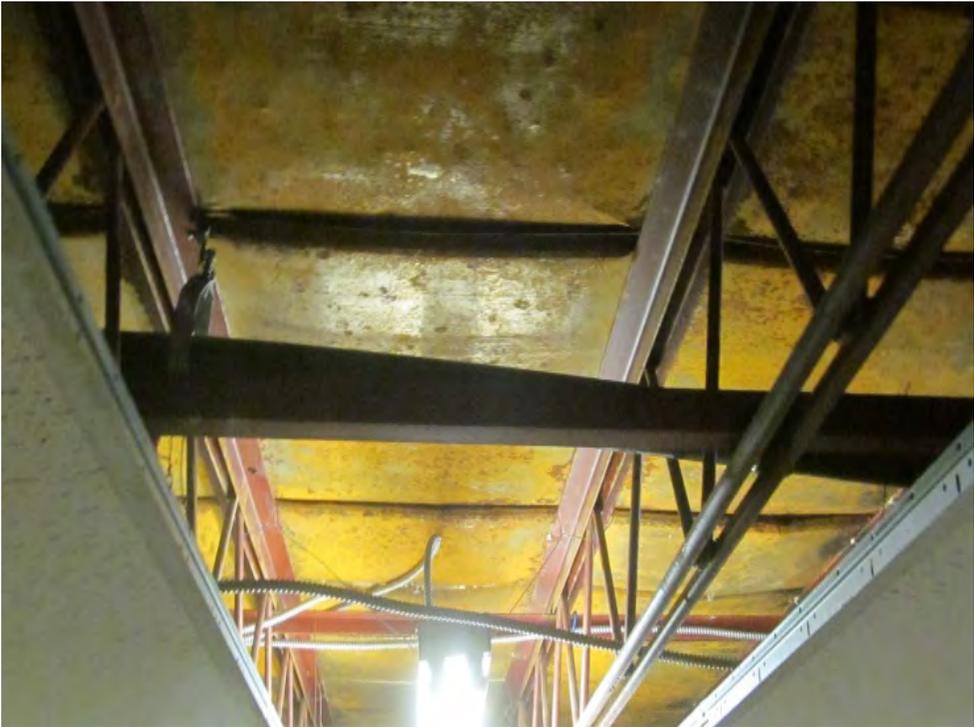
Photograph 10. Typical open web steel joist and metal deck framing for ground floor at Summer Place

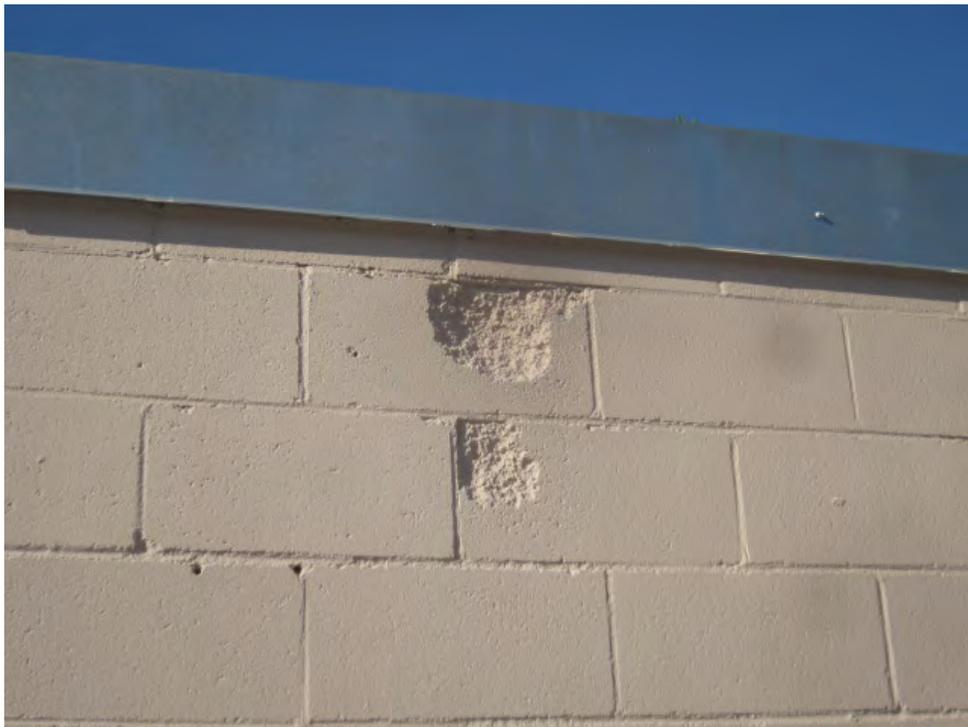
The masonry block walls are generally in good condition. There are local areas of spalled blocks and minor deterioration of the mortar joints on the east elevation of the building.

Photograph 16. Local spalling of block masonry on east elevation of Summer Place

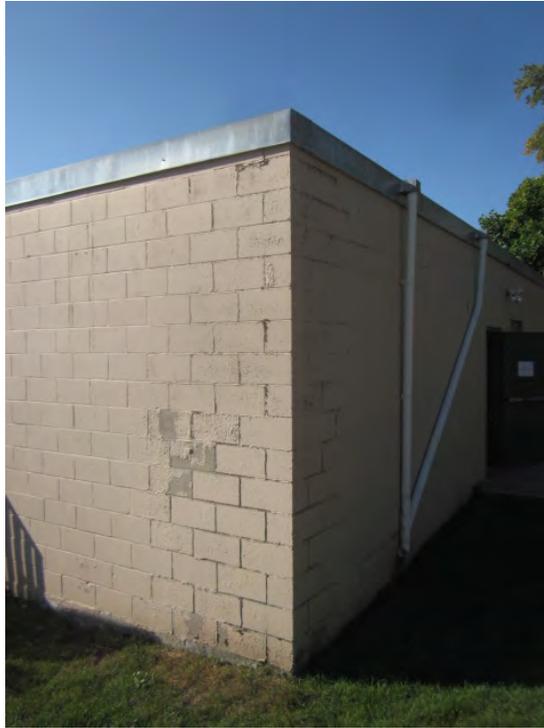
The paint finish on the walls at the north east corner of the building as well as at the west elevation is deteriorated in local areas. The deterioration noted at the north east corner may be due to a leak through the roof membrane at this location.

Photograph 17. Deteriorated paint on exterior wall at north east corner of Summer Place

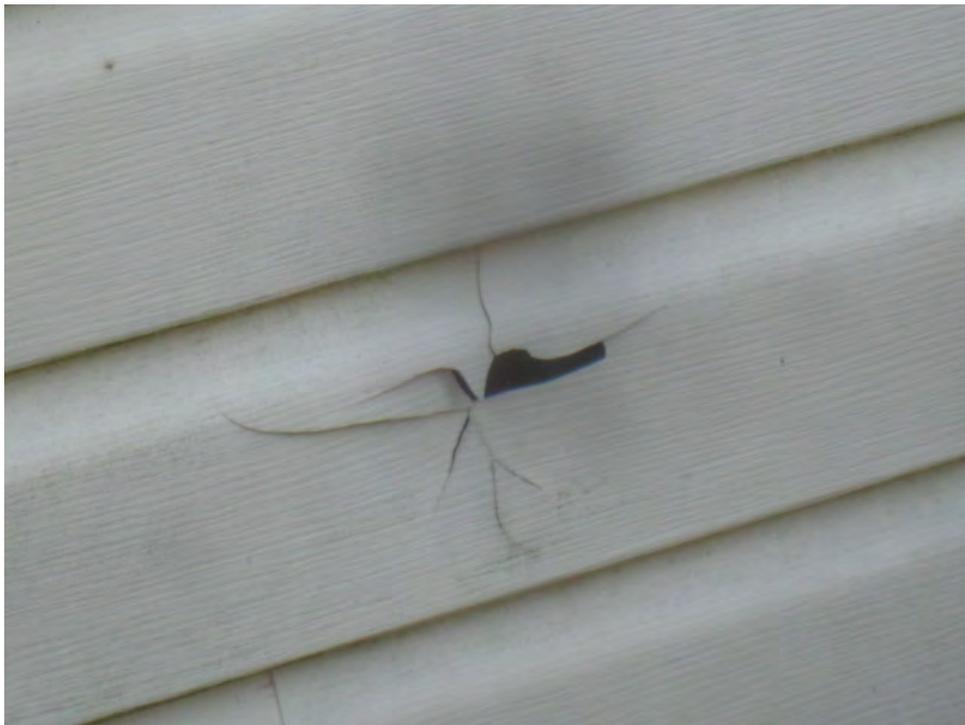
The horizontal vinyl siding on the south section of the building is generally in good condition. There is one area of impact damage on the east elevation. The cost of this repair is below the threshold value and should therefore be repaired as part of regular building maintenance. No test openings were made to confirm the wall composition or levels of insulation, if any

Photograph 18. Damaged vinyl siding at west elevation of Summer Place

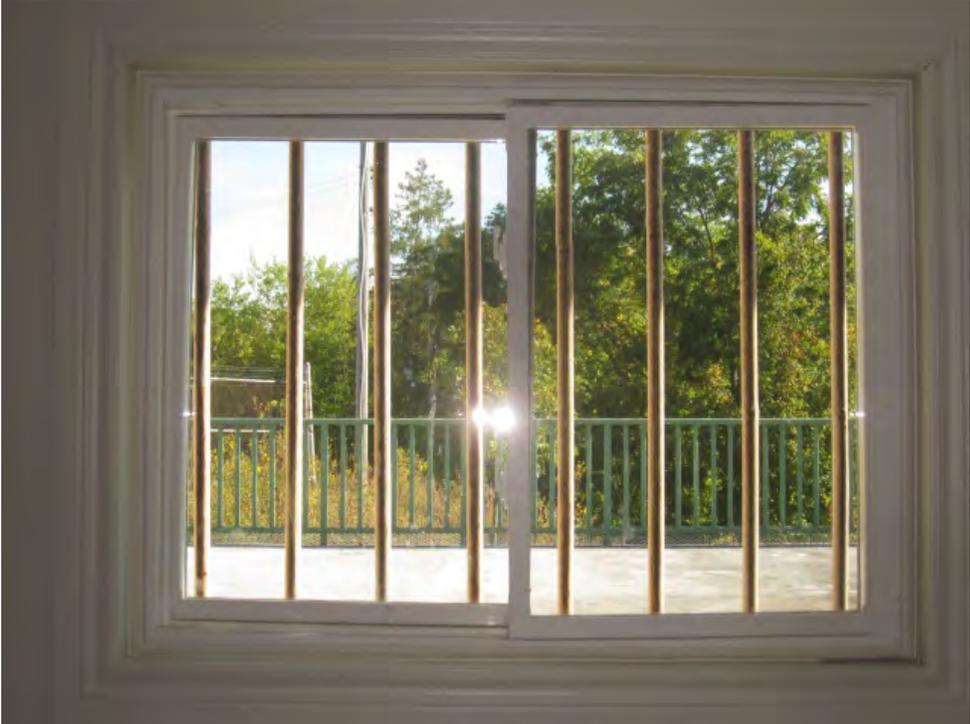
Windows are provided on the east and south elevations of the building. The windows consist of double glazed operable units in vinyl frames. The vinyl window frames have been retrofitted into the original framing and are in serviceable condition although they are generally not plumb within the frames. This may be due to insufficient support beneath the frames which has caused the frames to sag. Replacement of the windows has been allowed for in the Capital Plan.

Photograph 19. Windows not plumb at Summer Place

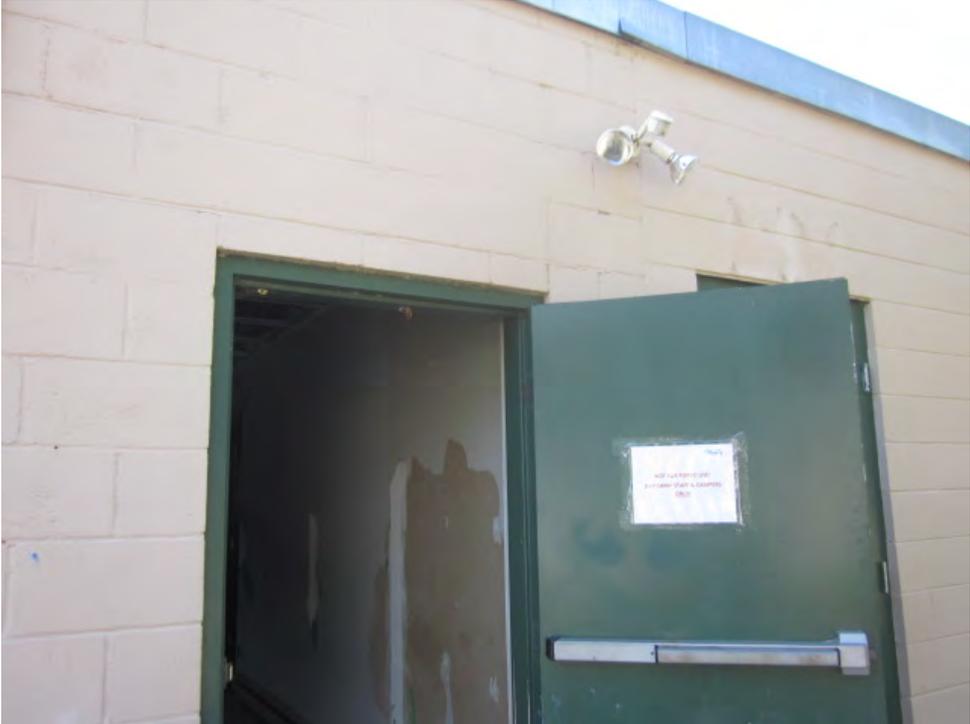
Photograph 22. Missing closer on east door at north elevation of Summer Place

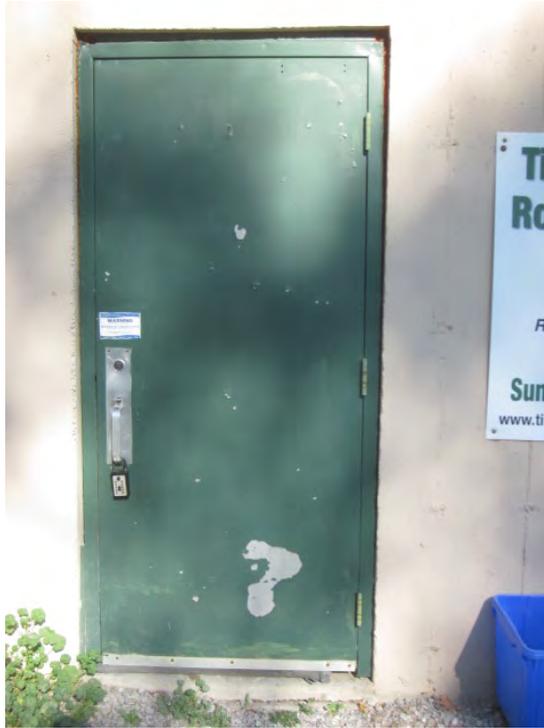
Photograph 23. Deteriorated paint finish on door to Tillsonburg Rowing Club

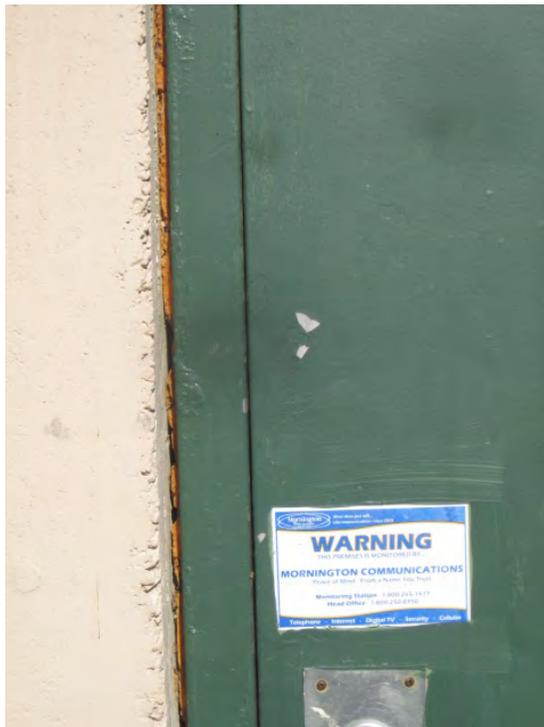
Photograph 24. Missing perimeter caulking around door to Tillsonburg Rowing Club

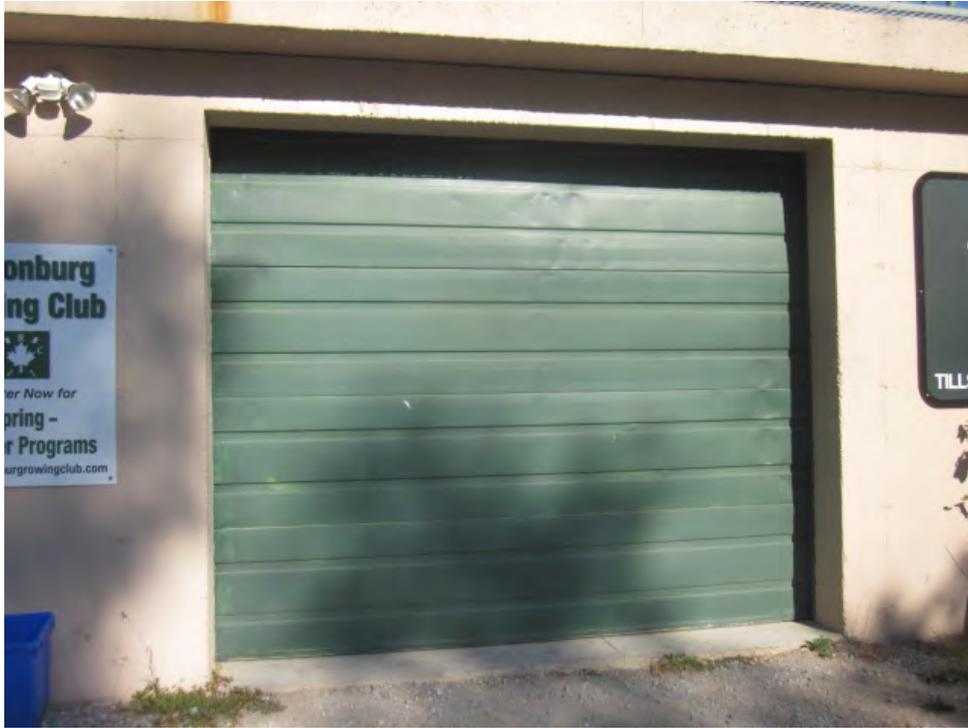
Photograph 25. Minor dents on overhead door at Tillsonburg Rowing Club

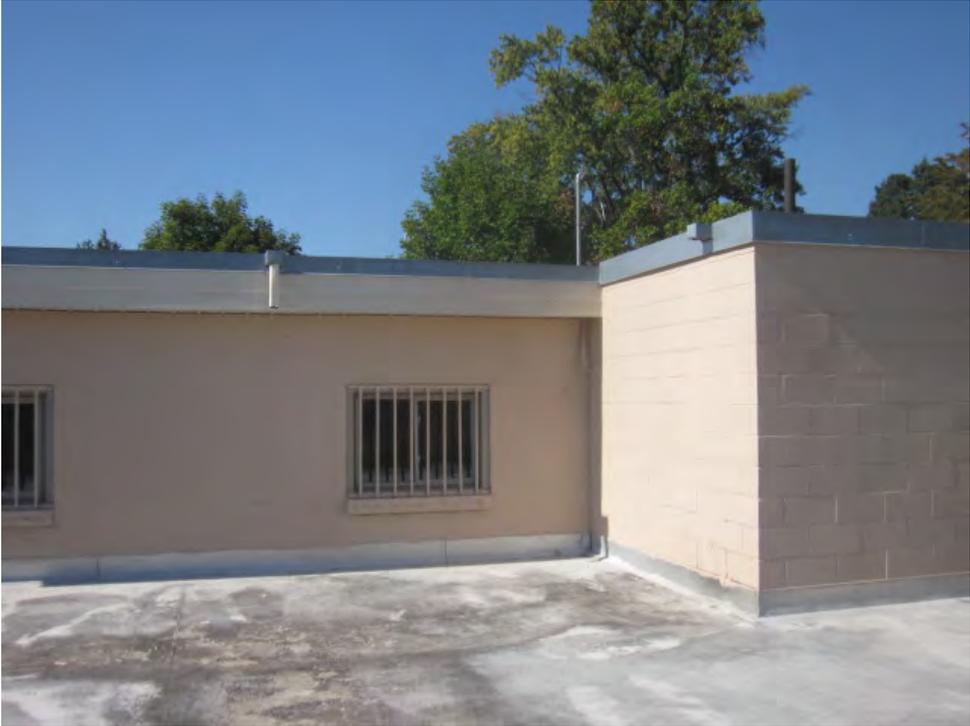
Photograph 30. Missing downspouts at scupper drains on east side of Summer Place

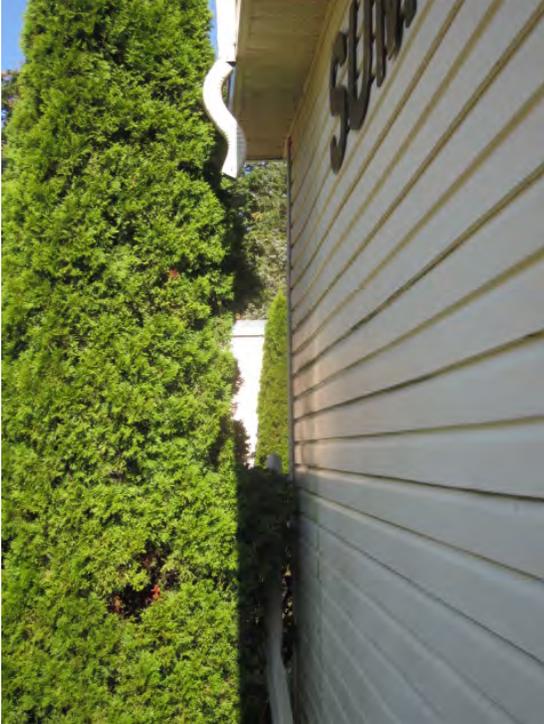
Photograph 31. Missing downspout at scupper drains on west side of Summer Place

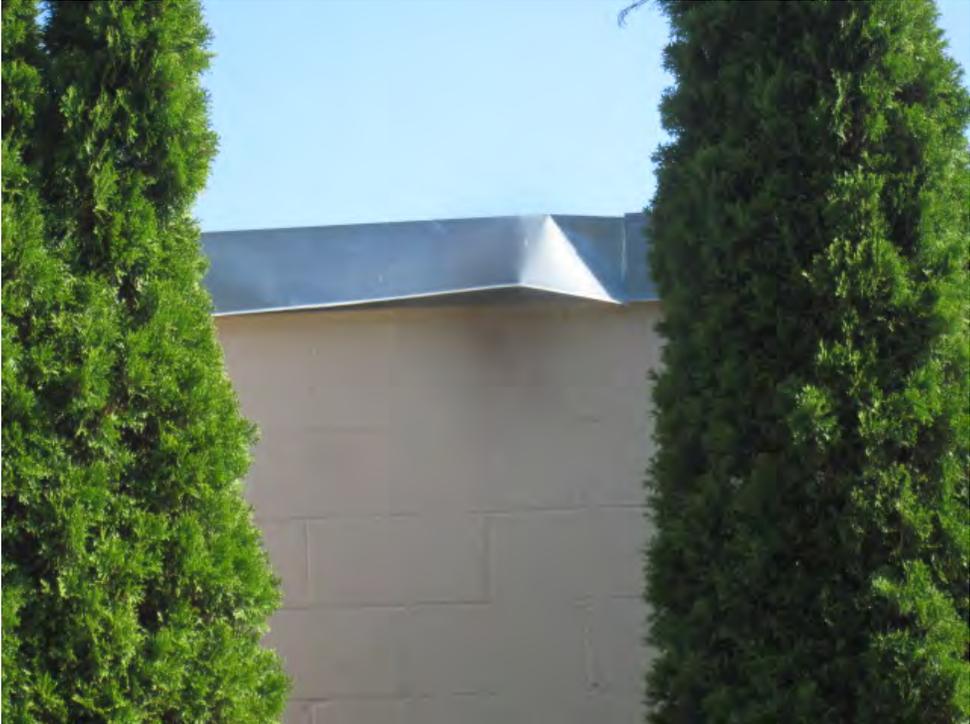
Photograph 32. Dented flashing on west elevation of Summer Place

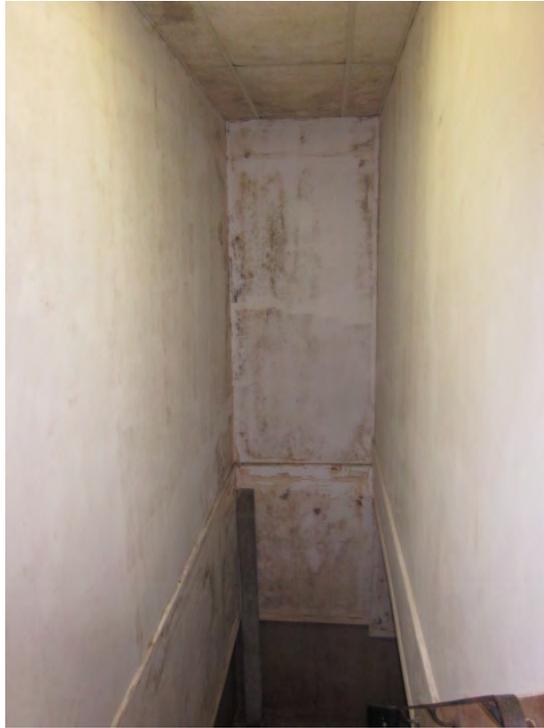
There is suspected mould growth and water damage on the wall and ceiling finishes in the basement stairwell as well as deterioration of the paint finish on the exterior walls at this location. These conditions are the result of suspected roof leaks.

Photograph 33. Suspected mould growth and water damage in basement stairwell at Summer Place

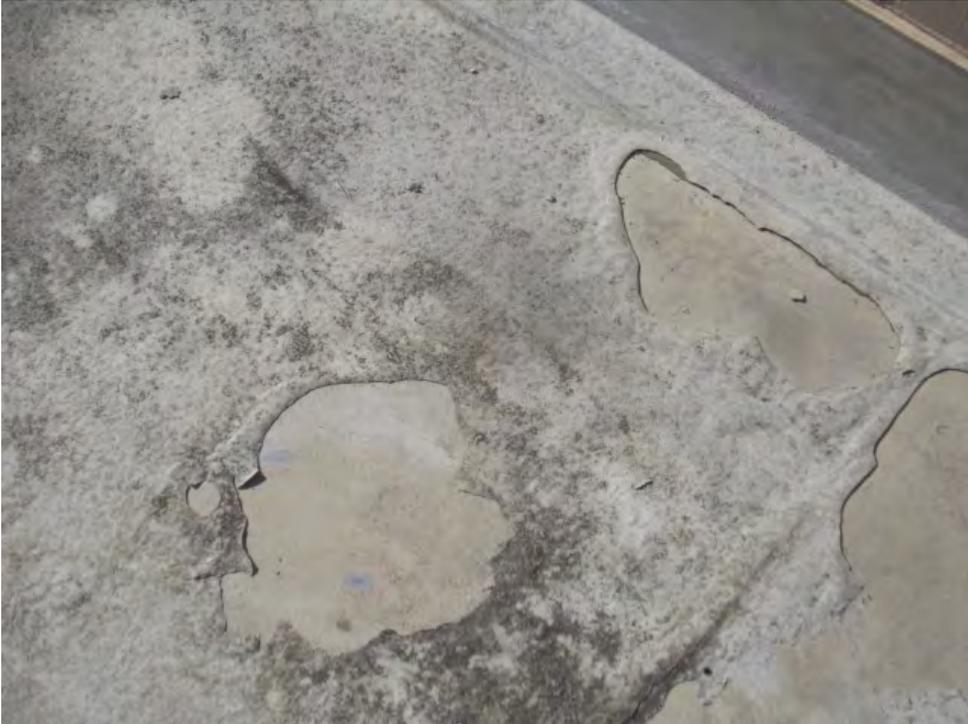
Photograph 36. Damaged waterproofing membrane on roof over Tillsonburg Rowing Club

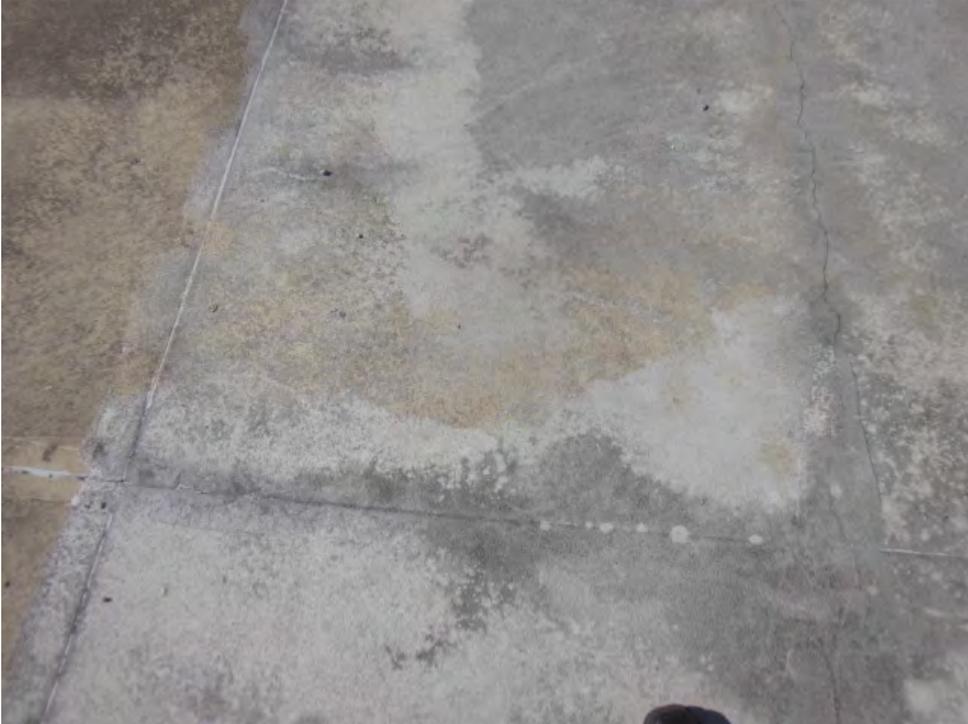
Photograph 37. Worn waterproofing membrane on roof over Tillsonburg Rowing Club

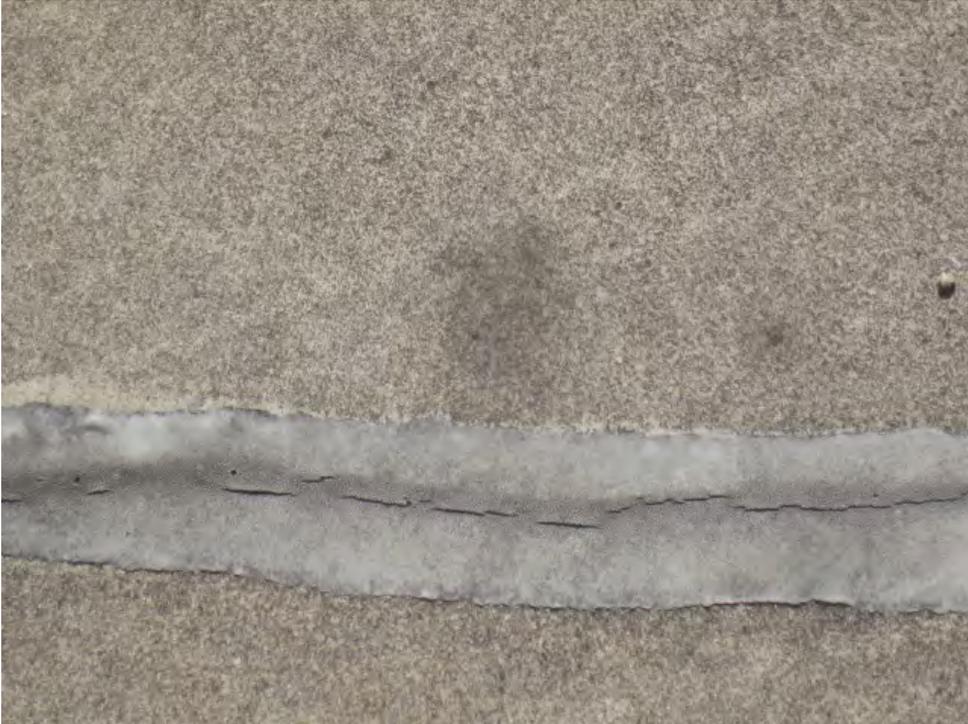
Photograph 38. Split sealant in crack on roof over Tillsonburg Rowing Club

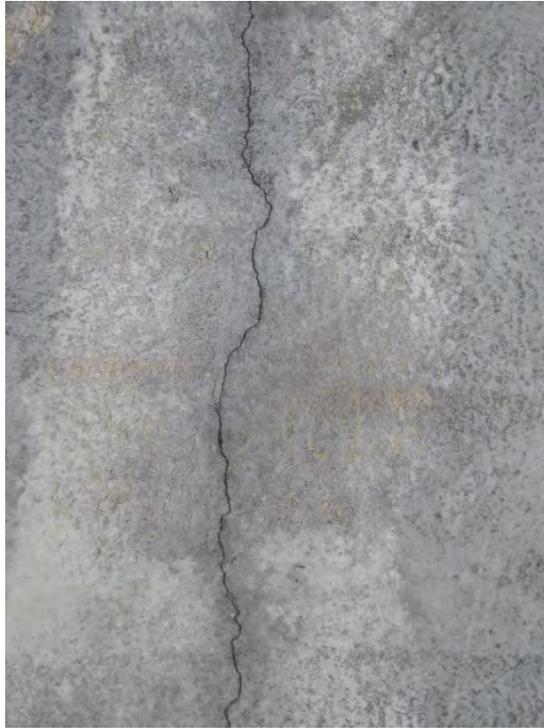
- At a few locations, concrete parging on the side of the roof slab showed cracking and spalling. This occurs mostly at the joints between the concrete topping and the precast slab due to their different material properties and shrinkage rates. We suggest that the concrete parging be removed and reapplied in these areas with new parging. There are also long cracks along the joints between the precast concrete planks. These cracks had been repaired and the planks are in reasonable service condition.

Photograph 39. Unsealed crack in concrete topping on roof over Tillsonburg Rowing Club

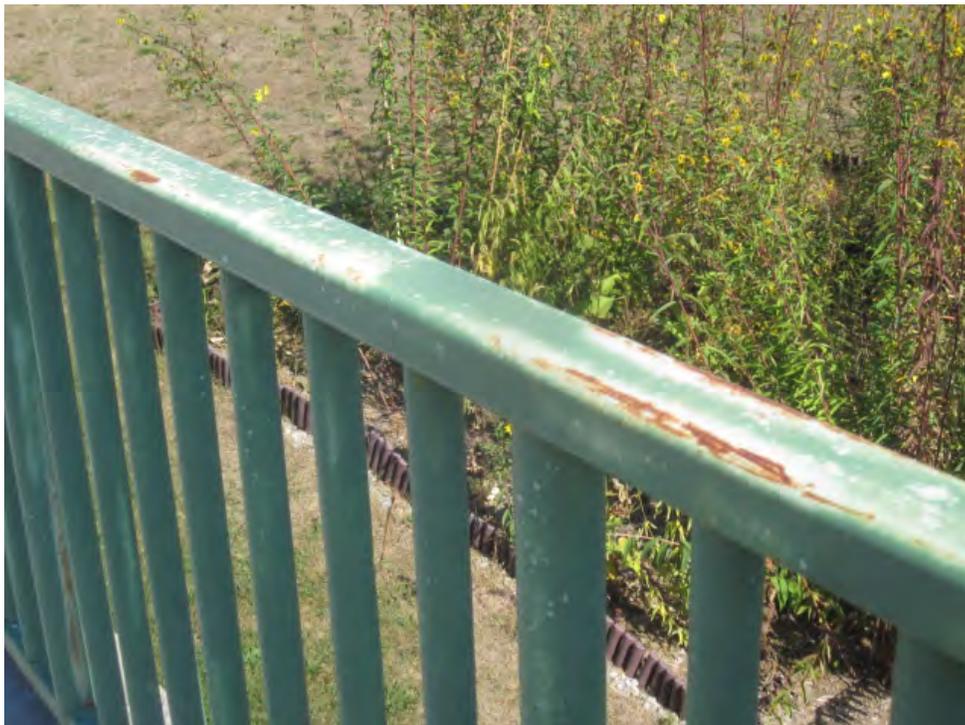
Photograph 40. Typical rust on railings at perimeter of roof over Tillsonburg Rowing Club

- The metal railings around the roof slab are showing peeling paint, and rusts at some locations. We suggest that the railing be cleaned with a wire brush down to bare steel and repainted with zinc-rich paint and a top coat.

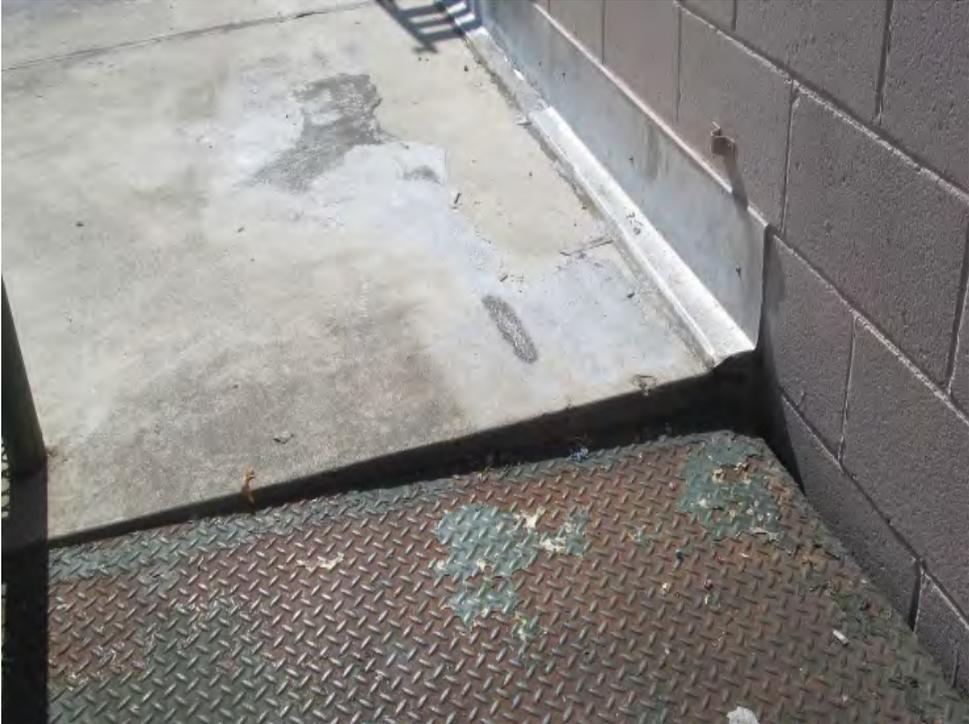
- The steel stair that leads to the roof is showing extensive paint peeling and rust. The top landing of the stair is tilted due to the lack of one supporting leg. This has resulted in a step of almost 50 mm (2") to the top surface of the roof, which presents a tripping hazard for anyone who is accessing the rowing club roof. We suggest that a new stair that is supported by steel posts on concrete caisson foundations be installed at this location.

Photograph 41. Misaligned access stair to roof over Tillsonburg Rowing Club

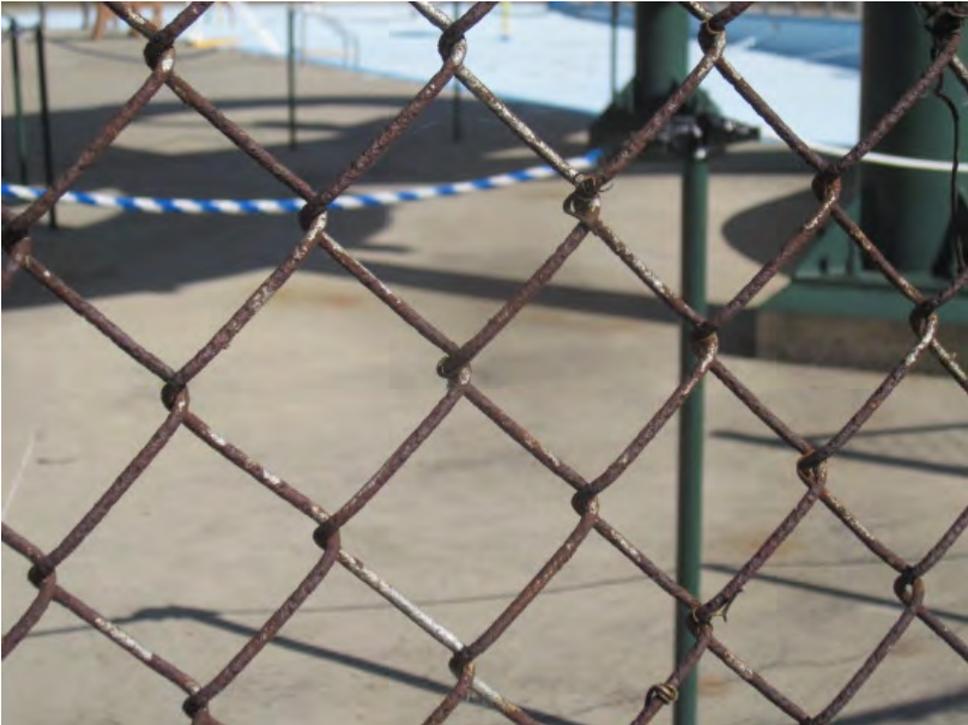
Photograph 54. Rusted chain link fence at Lake Lisgar Water Park

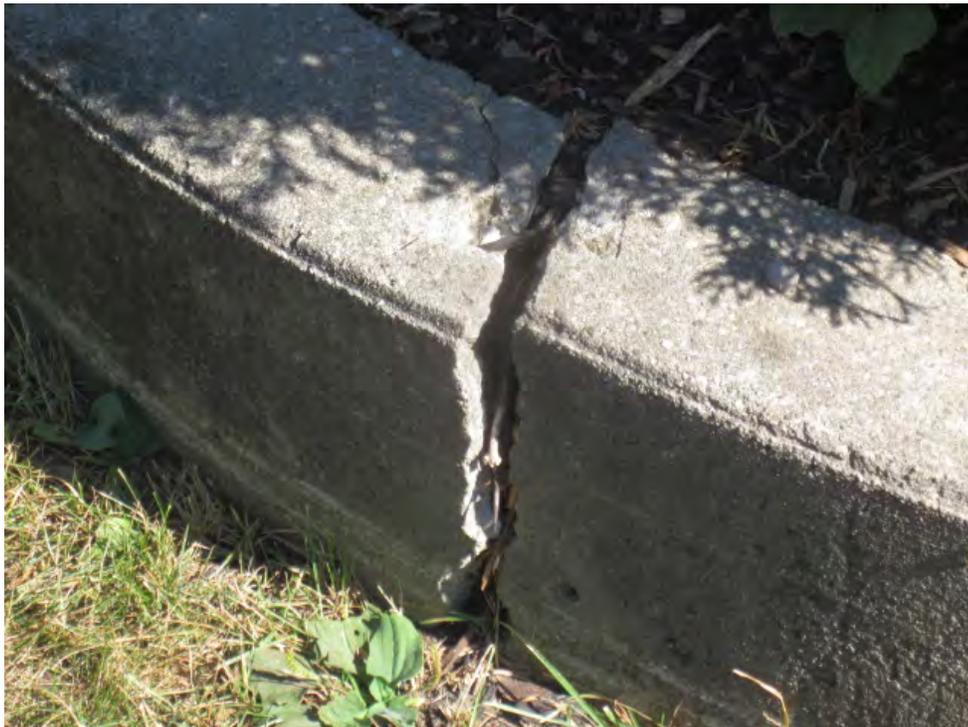
Photograph 56. Cracked planter curb at west side of Lake Lisgar Water Park building

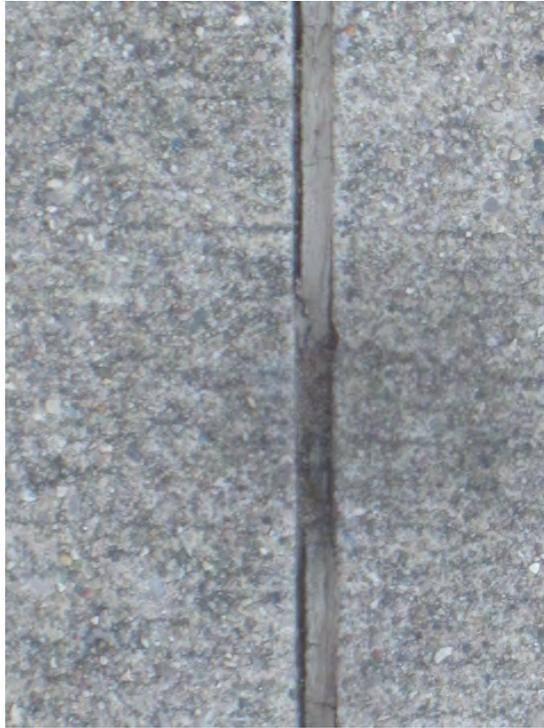
Photograph 57. Debonded sealant between joints in pool deck at of Lake Lisgar Water Park

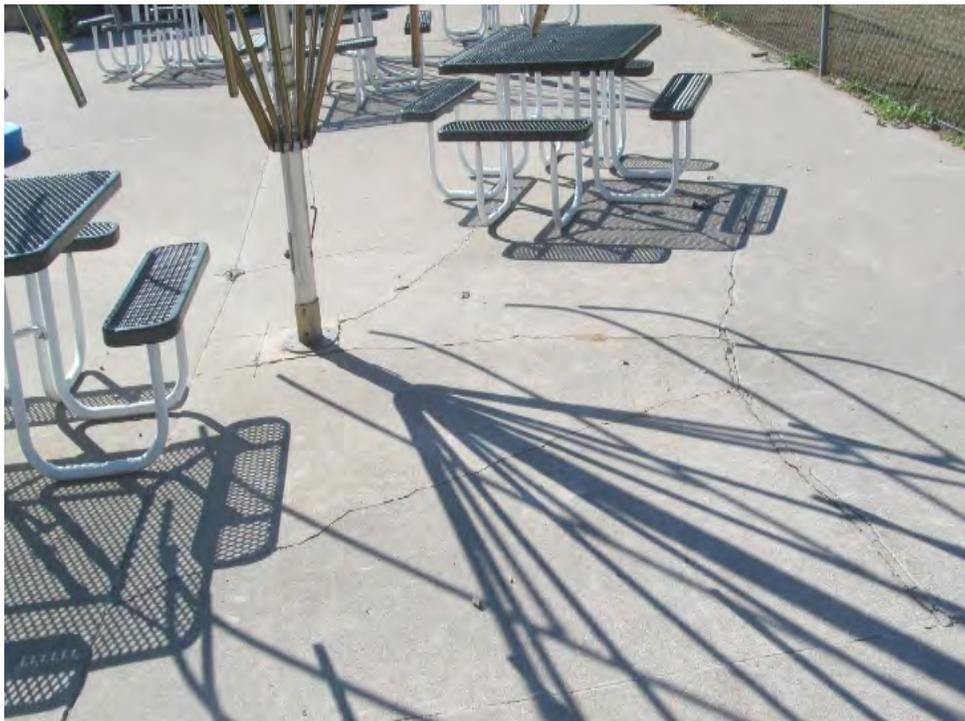
Photograph 58. Cracked concrete deck at sitting area at Lake Lisgar Water Park

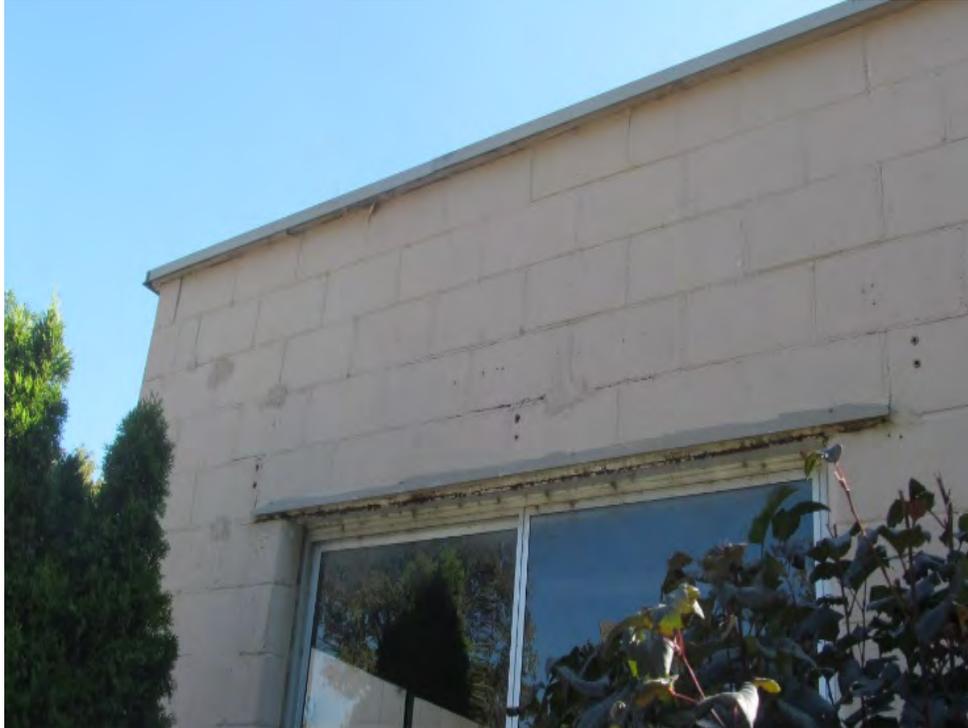
Photograph 59. Typical rusted steel lintels above windows at Lake Lisgar Water Park building

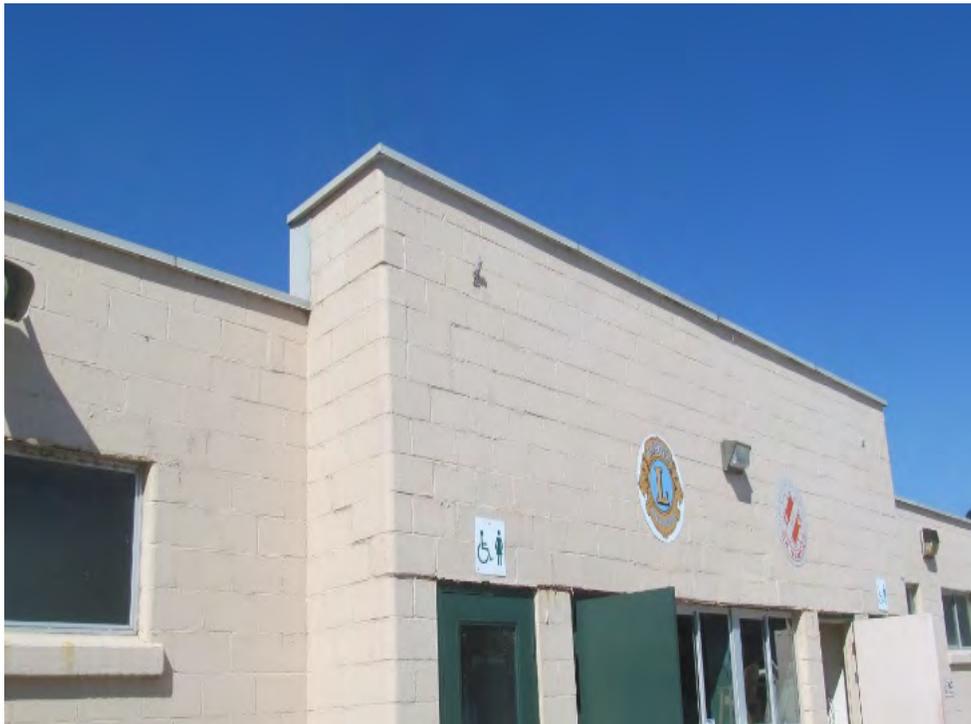
Photograph 60. Cracked mortar joints and displaced masonry on the east elevation of the Lake Lisgar Water Park building

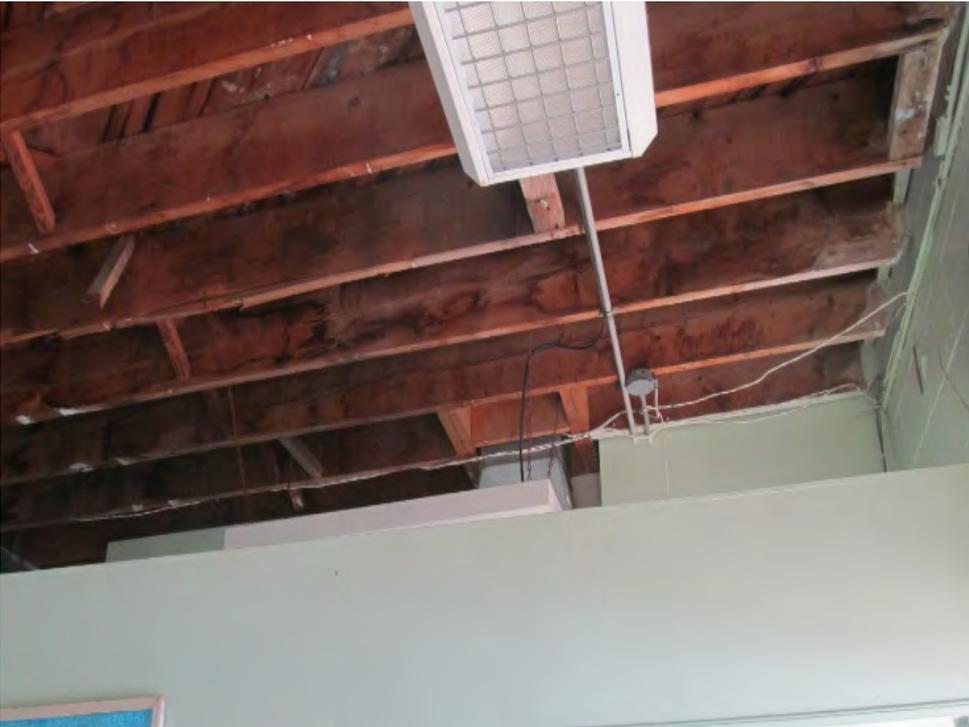
Photograph 62. Missing cross bracing between joists in the Lake Lisgar Water Park building

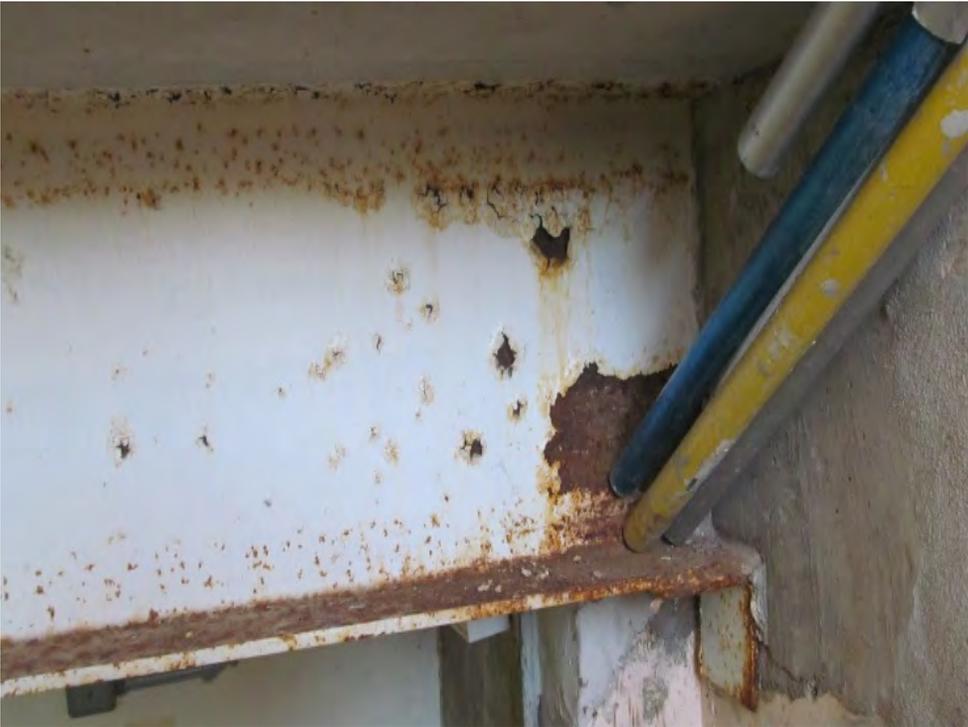
Photograph 64. Rusted steel beam in basement of the Lake Lisgar Water Park building

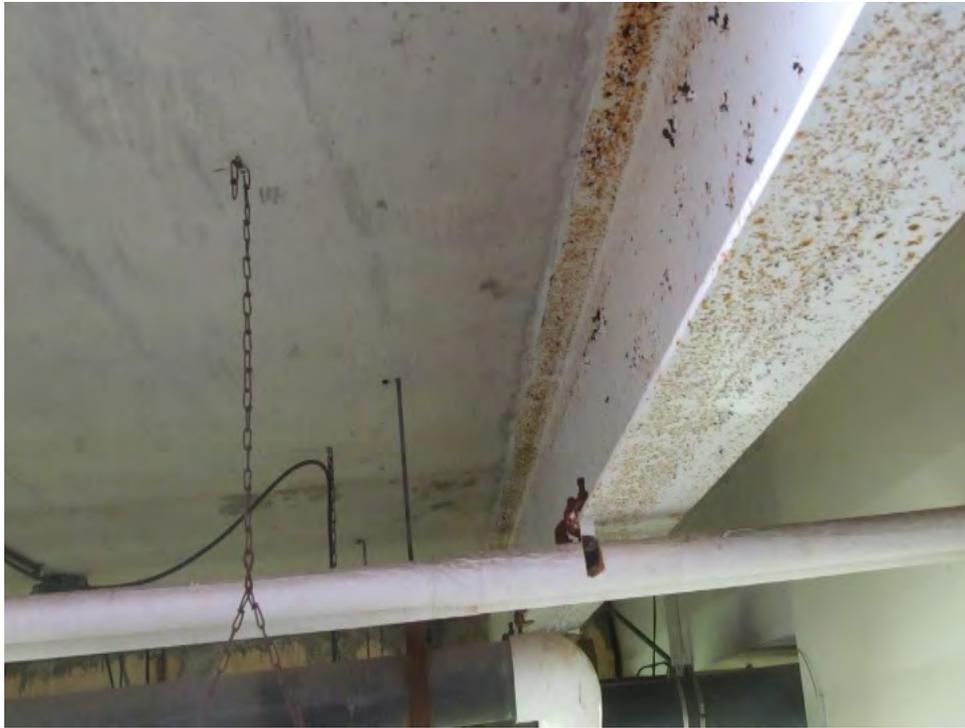
Photograph 65. Rusted steel beam in basement of the Lake Lisgar Water Park building
