# **BUILDING CONDITION ASSESSMENT AND CAPITAL PLANNING STUDY 8 ROSS STREET, TILLSONBURG, ON**

OCTOBER 12, 2017

**LAKE LISGAR WATER PARK  
AND SUMMER PLACE  
8 ROSS STREET  
TILLSONBURG, ON**

**TOWN OF TILLSONBURG**

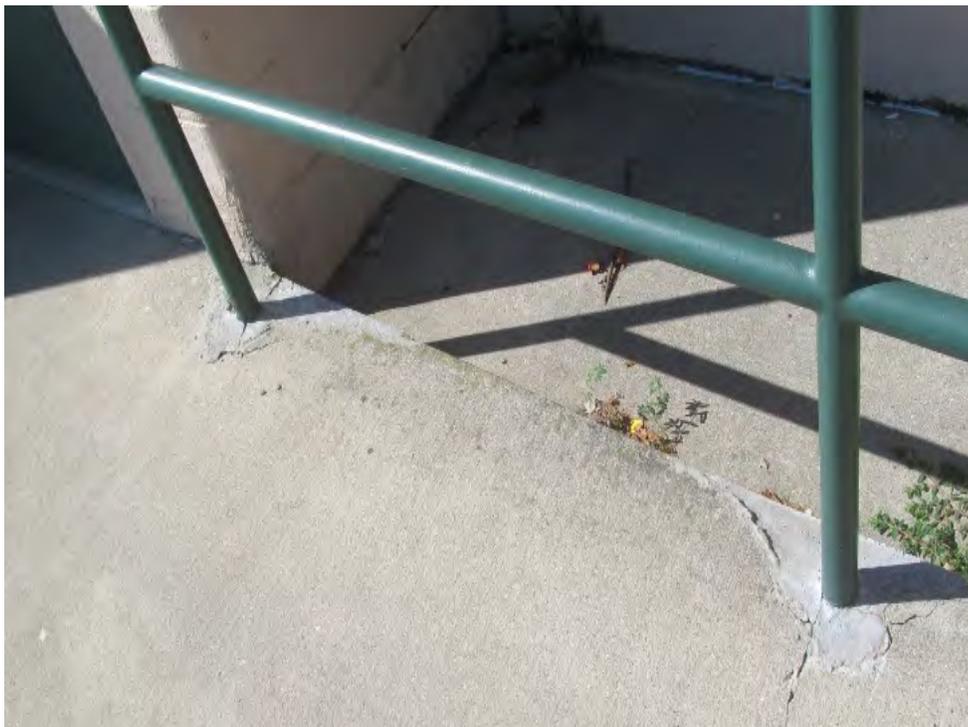
Photograph 66. Cracked and delaminated concrete around railing support posts at Lake Lisgar Water Park building

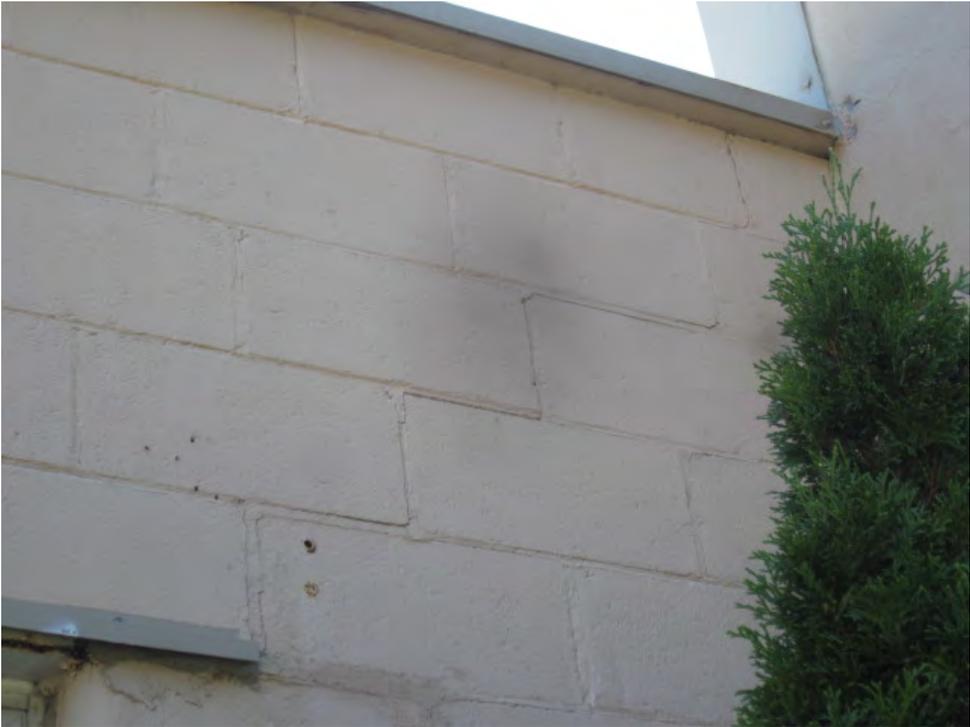
Photograph 72. Step cracks in masonry on east elevation of Lake Lisgar Water Park building

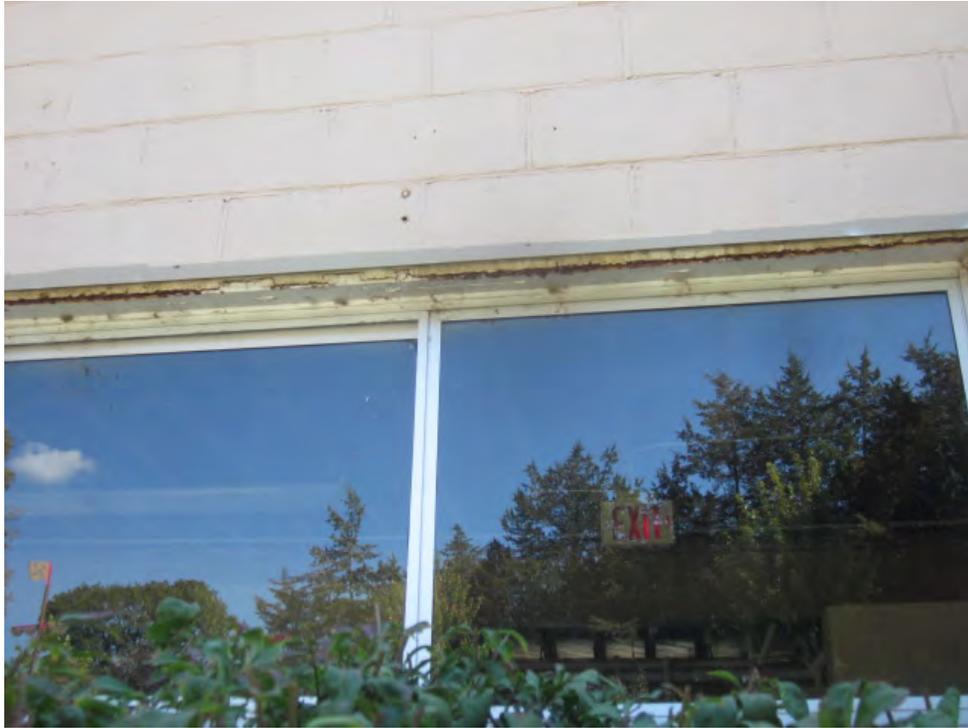
Photograph 73. Typical rusted steel lintel above windows at Lake Lisgar Water Park building

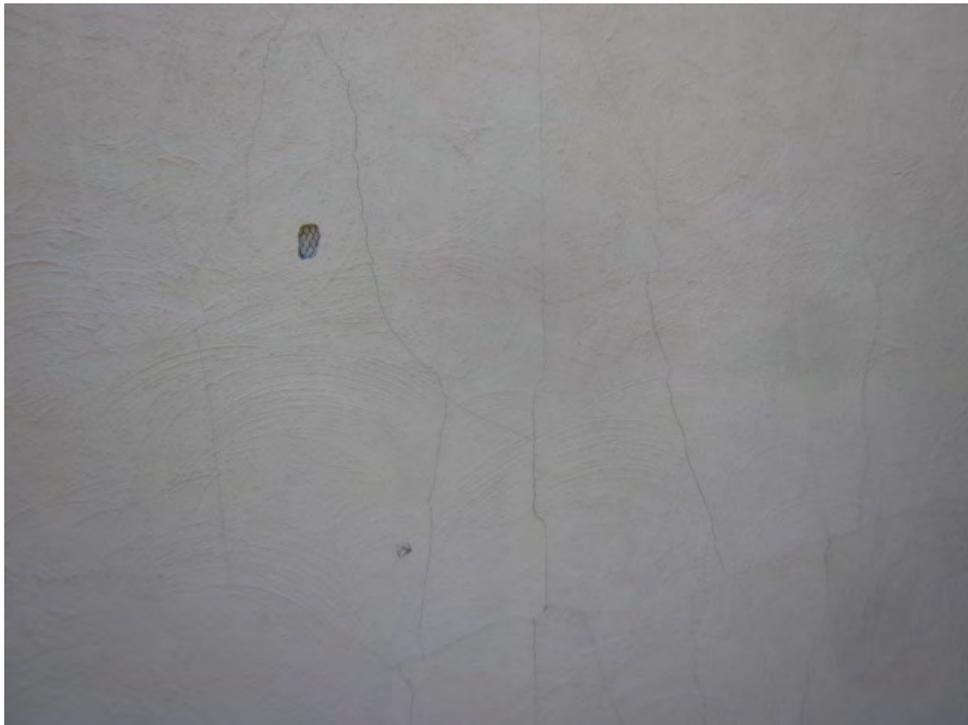
Photograph 74. Cracked and delaminated cementitious material on west elevation of Lake Lisgar Water Park building

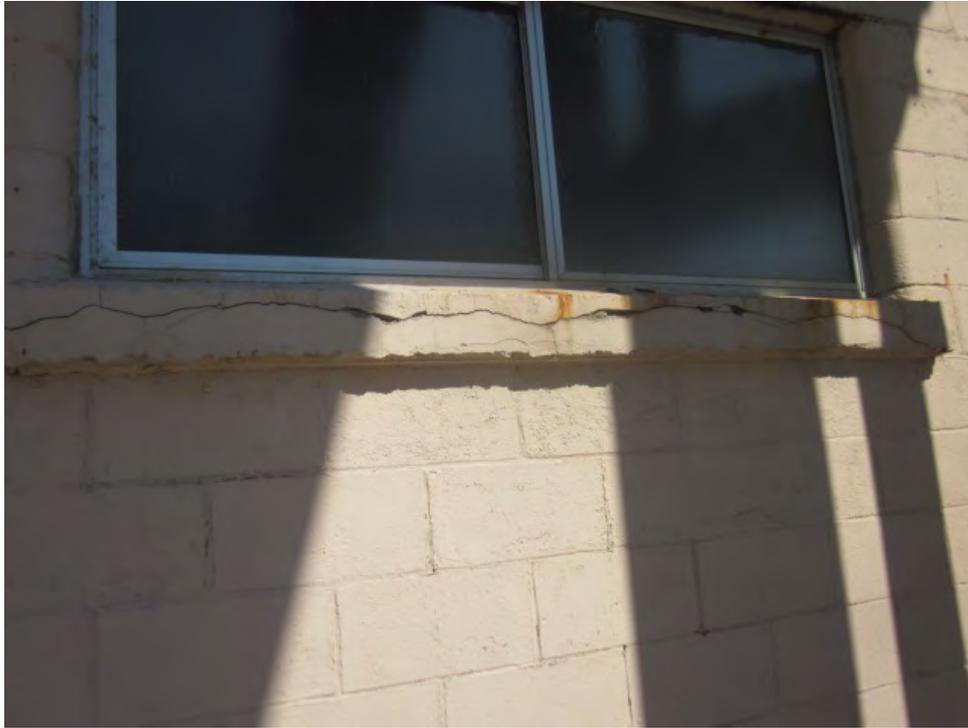
Photograph 75. Typical cracked and delaminated concrete sill at Lake Lisgar Water Park building

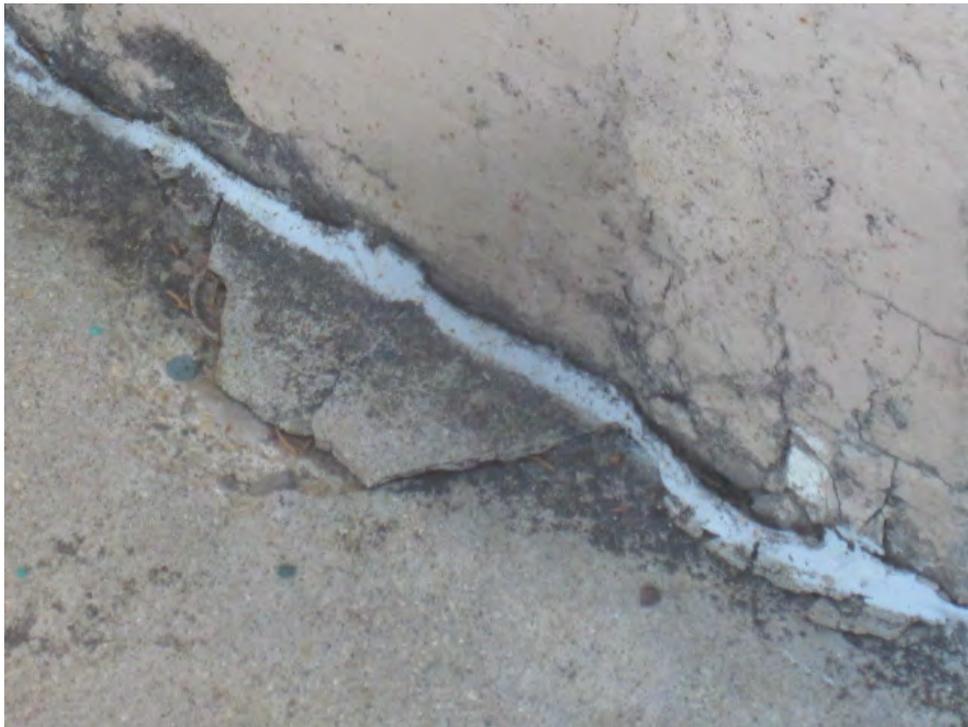
Photograph 76. Deteriorated sealant at base of wall at Lake Lisgar Water Park building

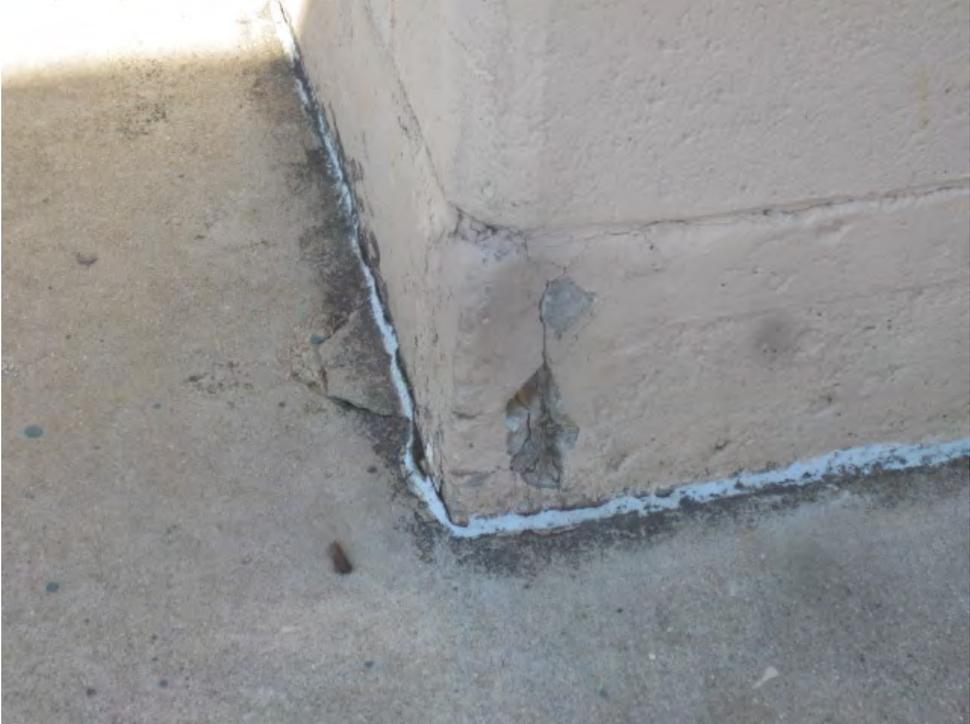
Photograph 77. Cracked and delaminated concrete at Lake Lisgar Water Park building

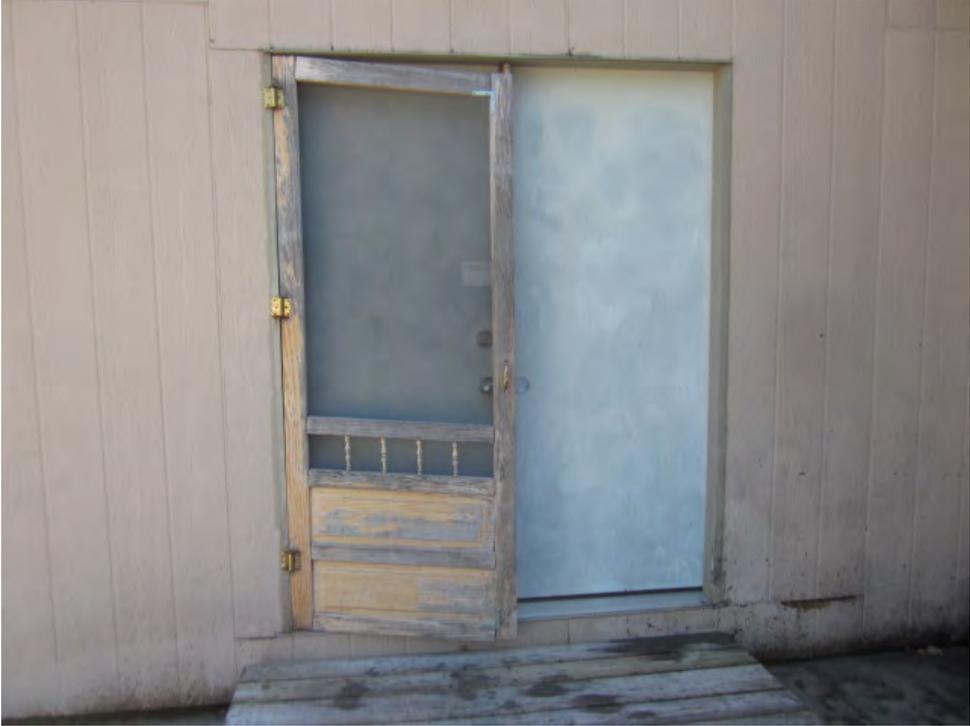
Photograph 79. Deteriorated wood screen door at canteen at Lake Lisgar Water Park building

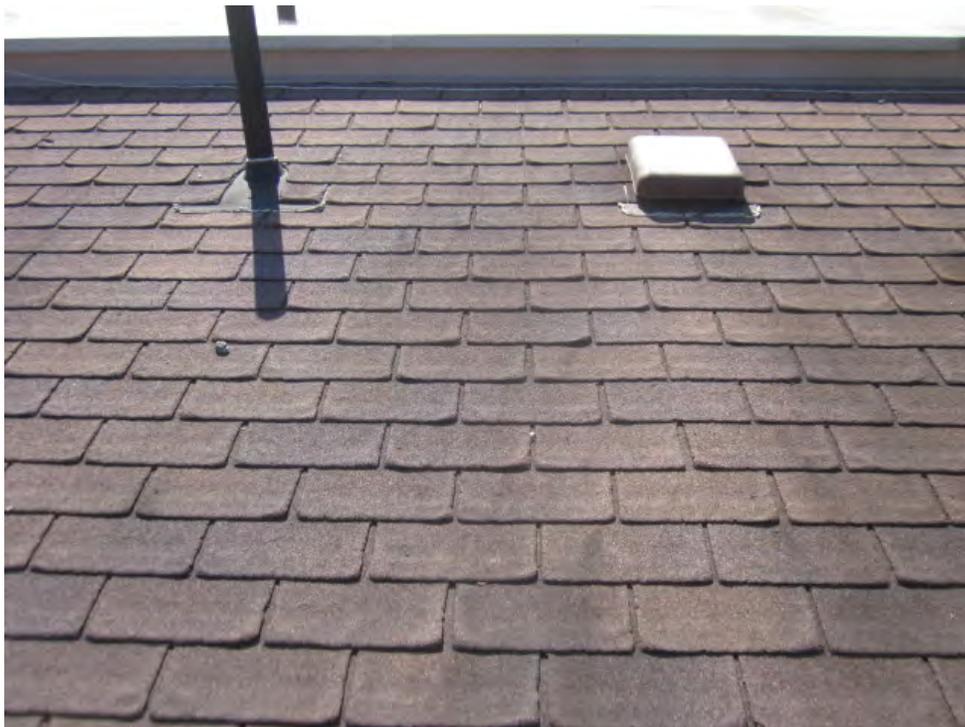
Photograph 84. Deteriorated asphalt shingles on canteen roof at Lake Lisgar Water Park building

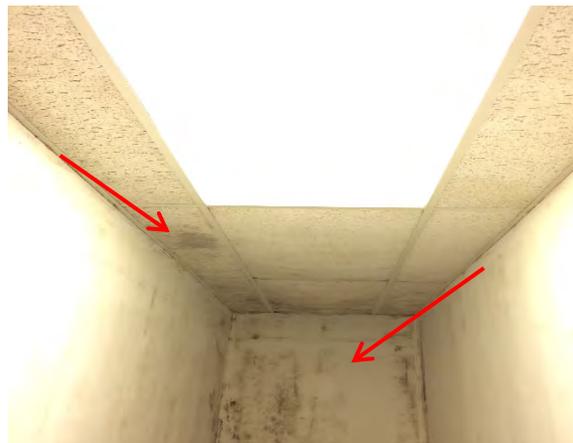
Photo #22: Mould and water damaged drywall and ceiling tiles observed within the stairwell to the basement.

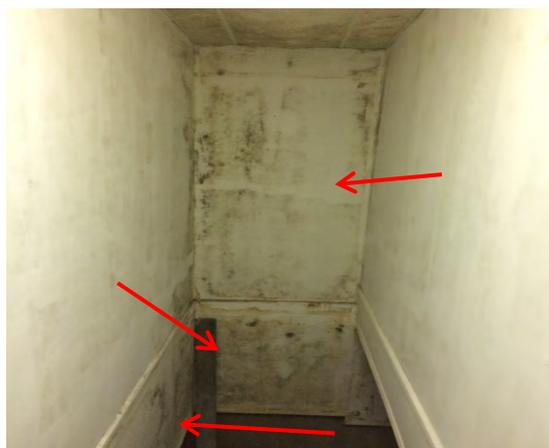
Photo #23: Mould and water damaged drywall and ceiling tiles observed within the stairwell to the basement.
