Station Arts Centre Building Condition Assessment Report

The Corporation of the
Town of Tillsonburg
Station Arts Centre
41 Bridge Street, West
Tillsonburg, Ont.
N4G 5P2

a+LiNK Architecture Inc.
126 Wellington Road
London, Ont.
N6C 4M8

20 November, 2018

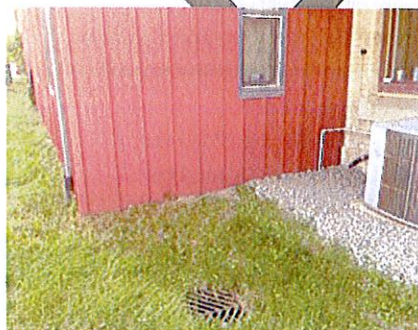
Figure 2, Current grading south side.

3.2 Grading south side: The grading on the south side is above the top of foundation and the wood siding is buried into the dirt at some locations.

- a) Recommend – Cut and regrade to below the top of foundation and slope away from building.

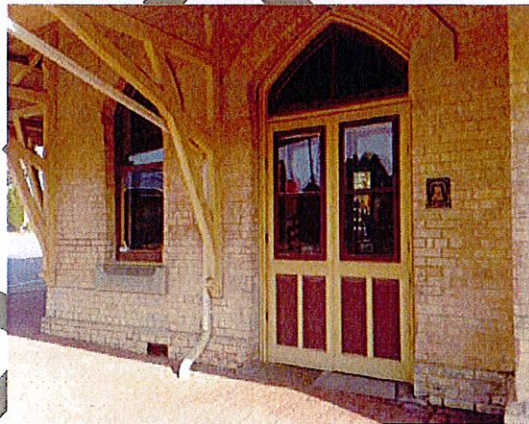
Figure 4, Current grading north side.

3.1 Grading north side: although rather shallow, the grading on the north side appears to slope away from the building. However, the grading is above the top of foundation and the crawlspace vents at the GWR station are buried below grade.

- a) Recommend – provide a detailed topographical survey of the entire property including underground services and utility locates.
- b) Recommend – provide destructive investigation below grade to ascertain the condition of the foundation walls. See section 4.8 Foundation walls.

- c) Recommend – provide areaways with grating covers for the crawlspace vents.
- d) Recommend – lower grade inside basement window wells to a minimum of 6" below window sill.

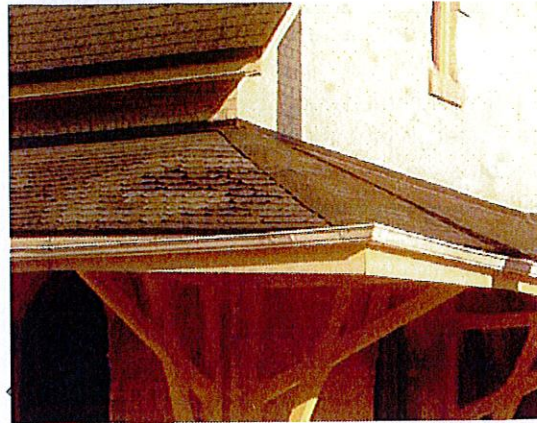
Figure 5, Sagging canopy roof and deteriorate shingles.

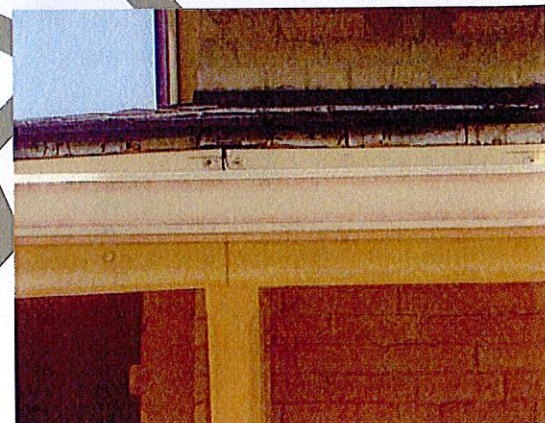
Figure 6, Exposed deck boards no drip flashings.

- d) Recommend – Provide new drip edge flashings.
- e) Recommend – Provide dutchman repair for rotted fascia boards.
- 4.1.2 Roof Framing & Gable ends:
 - a) Recommend – Remove and replace rotted wood framing and repair deficiencies. See section 5.0 Structural Condition below.
 - b) Recommend – Repair open holes in gable ends of TLEPR.
- 4.1.3 Roof ventilation: The heritage roofs do not have adequate air ventilation in the attics.
 - a) Recommend – design and install new attic ventilation strategy.

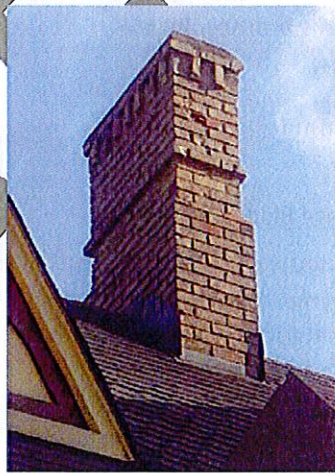
- 4.2.1 Chimneys appear to be in fair condition. Masonry deficiencies: some brick spalling was observed.

Figure 7, Heritage Chimney

- a) Owner to confirm the silicone material applied to the chimneys.
- b) Recommend – remove and replace all damaged bricks, assume 24 bricks for each chimney.
- c) Recommend – repoint all deteriorated mortar joints, quantity is unknown.

- 4.2.2 Chimney Caps: it is recommended to install new metal rain chimney caps to protect from water infiltration. The caps should be vented at the flues.

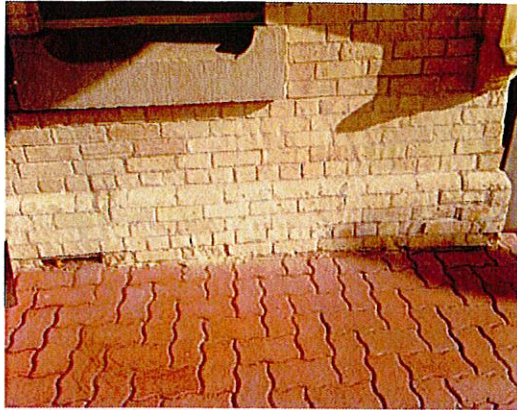
- a) The brick at the base of the building is unusually smooth and appear to have been ground or sandblasted. It was reported that the base of the building was previously painted and it has been confirmed that the previous paint was removed using sandblasting. The natural fired hardened surface of the bricks have been removed which compromises the original weathering characteristics of the brick against water absorption and consequent spalling. It is recommended that all sandblasted bricks be removed and replaced with new colour matched salvaged bricks.

- b) There is evidence of brick spalling and damage at grade level possibly aggravated by the use of de-icing salts along the sidewalk.
- c) The previous repointing repairs are inconsistent and some are not to heritage preservation standards.

Figure 9, Deteriorated bricks at base of building.

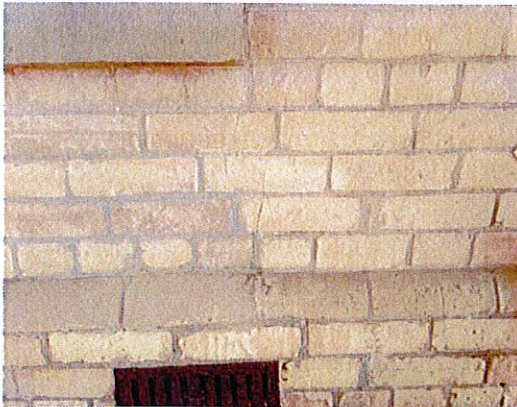
- d) Diagonal cracking and displaced brick may be an indication of a water infiltration or possible foundation problem, further investigation is recommended.

Figure 10, Diagonal cracking, inconsistent mortar repairs and brick mortar patch.

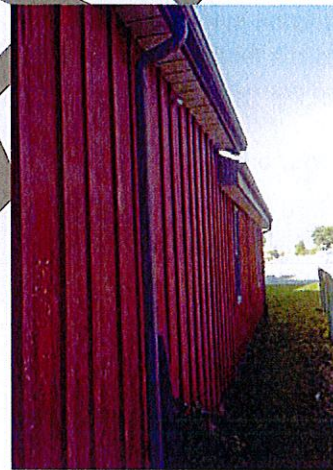
Exterior walls of the addition are wood framed stud walls with board and batten siding. There are a few random cracks in the board siding and evidence of previous repair patches. It appears that an opaque penetrating stain was used on the siding. The interior face of the exterior walls are clad with gypsum wall board.

Figure 12, Previous patches on siding (1995 Addition).

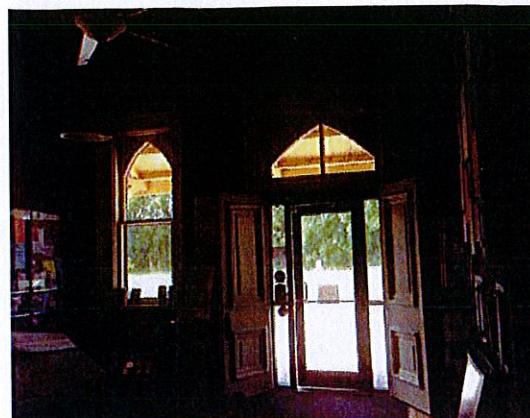
The west door has a new fully glazed aluminum door, swing out, with a glazed side light on each side. This door and frame is installed on the exterior side of the heritage wood doors and has a functional barrier-free operator. It is recommended that the heritage doors be fixed in the open position for display purposes only.

Figure 13, West heritage doors.

- a) Recommend – Heritage doors to be fixed open.

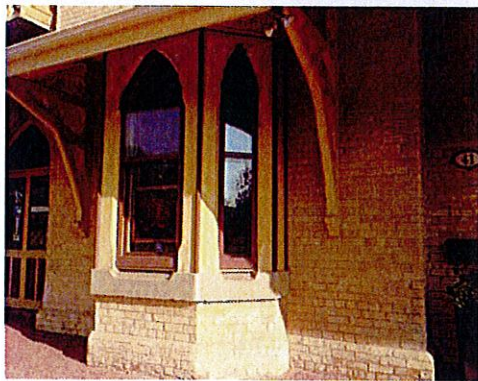
The window units are non-functional and have been painted shut. It was reported that the storm units are removed seasonally for window maintenance and cleaning.

Figure 15, Typical window units.

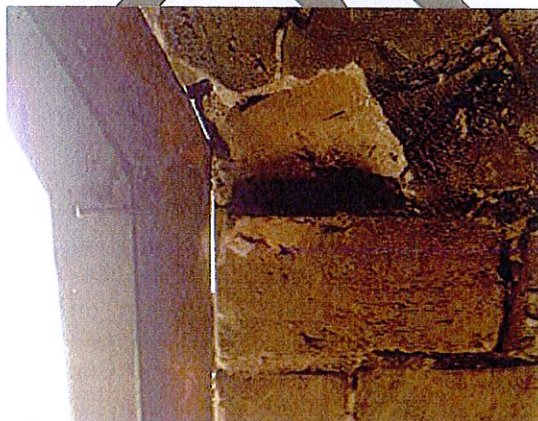
There are glazed wood sash window units in the gable ends of the attic set in masonry openings. These windows appear to have been modified from the original. There are numerous holes and gaps around the frame perimeter and in the fixed sashes. The sashes are secured to the wood frame with bent ardox nails. A more suitable anchoring device is recommended.

Figure 16, Attic windows (GWR).

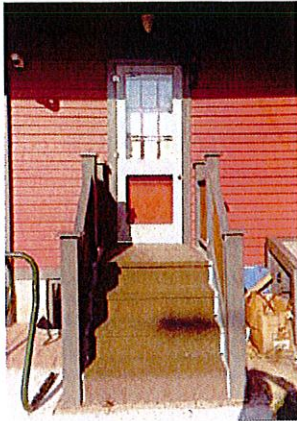
Figure 17, West exit door and stairs (TLEPR).

4.5.7 West Exit Door: Recommend - Review the exiting strategy for this door.

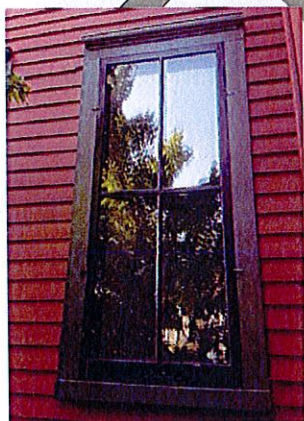
The window units are non-functional and have been painted shut. Lifting hardware has been removed or disabled. It was reported that the storm units are removed seasonally for window maintenance and cleaning.

Figure 18, Typical window (TLEPR).

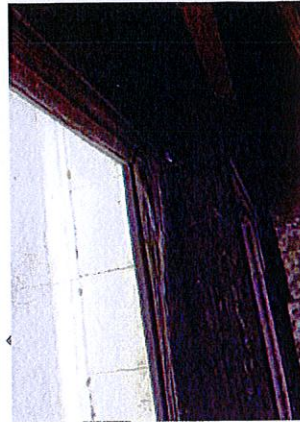
The attic windows are a wood sash hung type unit but appear to be fixed in place. The windows are single pane glass without storm windows. The attic windows are in fair condition with some minor wood rot developing at the glazing seat particularly at the meeting rails and sills.

Figure 19, Meeting rail of attic window.

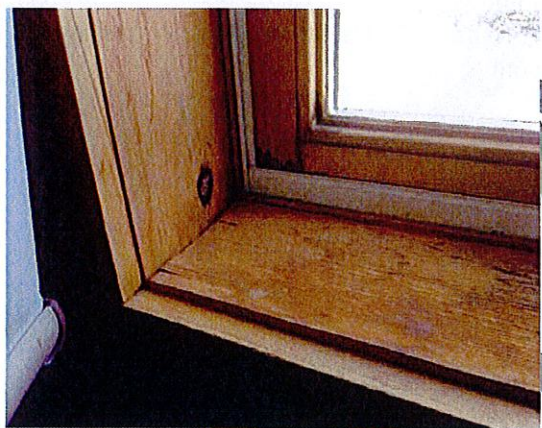
Figure 20, Water staining and sill deformation.

- a) Recommend - provide routine maintenance and painting.

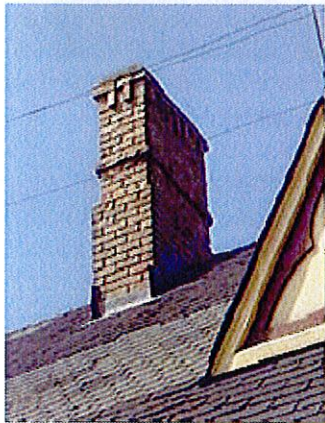
Figure 22, West chimney GWR station.

5.2.1.2 Masonry repairs and/or replacement should be provided to deter moisture migration and further spalling. To ensure structural stability, the use of booms or lifts should be undertaken to thoroughly examine the chimney condition up close.

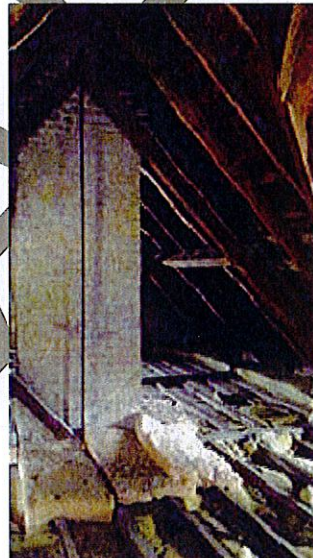
Figure 23, GWR station attic missing truss web.

5.2.2.2 Missing truss web should be replaced immediately.

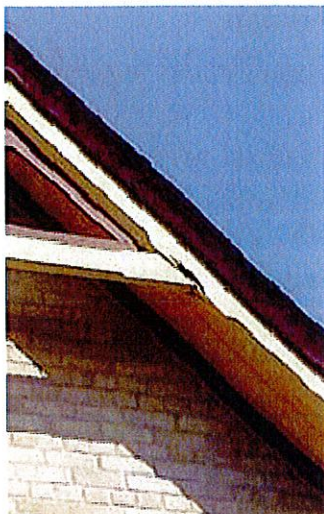
Figure 24, GWR station gable framing damage.

5.2.3.2 The decorative gable framing and fascia board connection should be replaced in the near future.

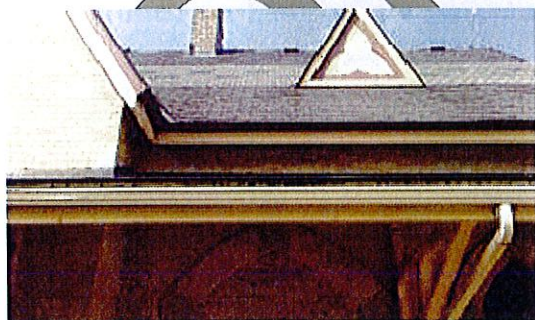
5.2.4.1 The large lower roof overhangs are constructed of wood roof planking on 2"x6" wood joists spanning between large timber soffit braces anchored to the multi-wythe masonry wall. Anchorage of the braces was not evident. Water damage was observed in several locations throughout the overhang and quite evident on the exposed ends at the fascia.

Figure 25, GWR station canopy.

In addition, the overhang was observed with a significant droop in the roof line (fascia's) on the northwest and northeast corners. A slight droop was observed on the southeast corner.

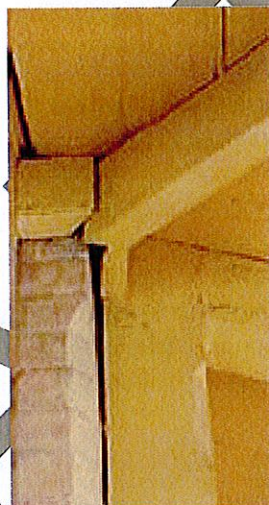
The hip rafters were observed with major separation from the masonry wall, caused by the dropping of the overhang framing. This in turn is causing additional stress on the timber soffit braces and showing signs of separation from the masonry wall.

Figure 26, Separation at hip rafter connection.

The cause of the droop is insufficient support of the roof and hip rafters in the outside corners. In theory, the rafters would be supported from cantilevered fascia boards supported from the timber soffit braces. The replaced fascia boards were provided with spliced joints at each of the braces, providing no cantilever action at the corners, except the southeast corner fascia which is the only fascia board with a cantilevered board and is why this corner has only slightly dropped.

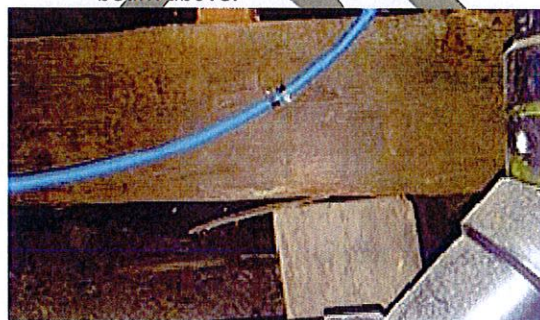
Figure 28, GWR station timber shims.

Also, hardwood shims appear to be utilized for the newer 2"x12" floor joists bearing on the

timber beams. These shims appeared to be not fully engaged.

- 5.2.5.3 Timber posts at the access point should be repaired and hardwood shims require adjustments to fully engage proper bearing.

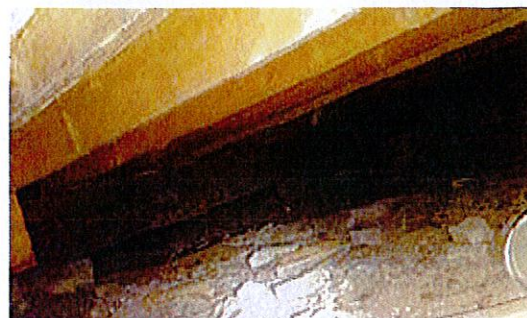
Visual observations from the access point, indicated the timber posts immediately adjacent the access point appeared to be rotating and not providing full bearing for the timber beam above.

Figure 29, GWR station timber beam and posts.

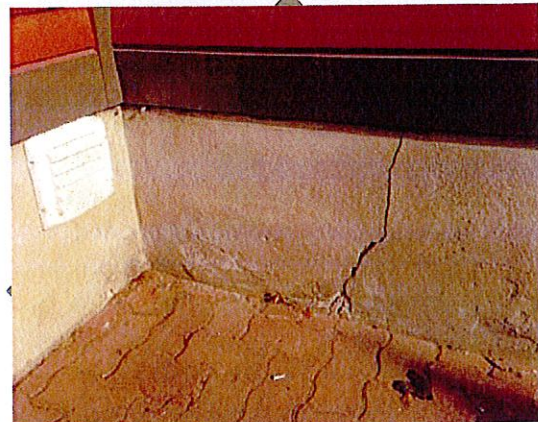
Figure 30, TLEPR station foundation crack.

5.4.1.4 Monitoring of the parging should be undertaken for maintenance purposes.

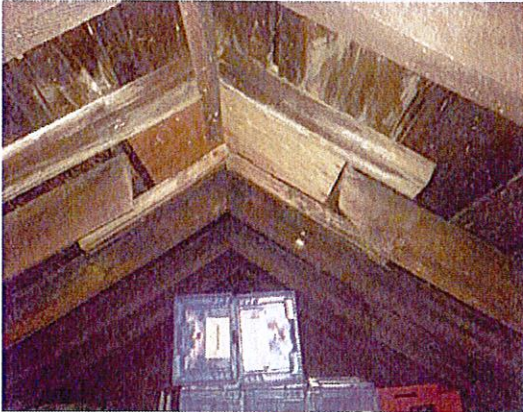
Figure 32, Cut rafters, ridge board, and rotted deck boards.

re-roofing project. The existing heritage deck boards should remain.

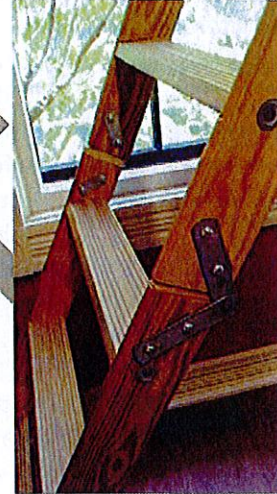
Figure 33, Modified ladder.

5.4.4.2 Based on the observations and modified condition of the ladder, contrary to the manufacturers recommendation, the access ladder should be replaced.

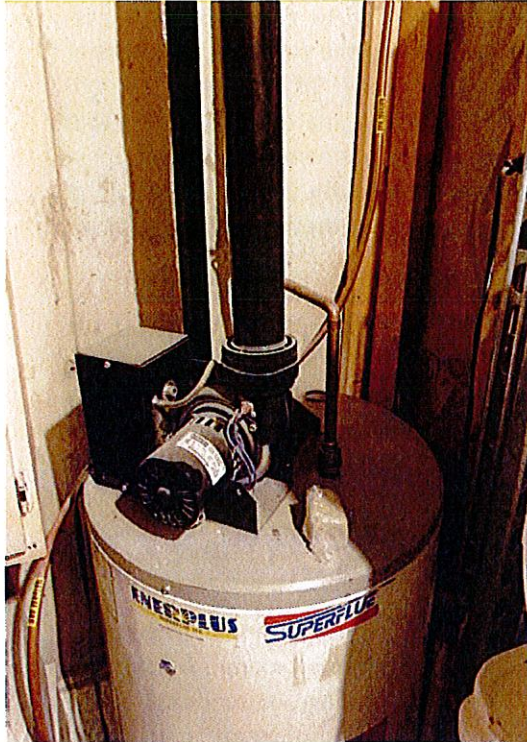
Hot water is provided to the TLEPR by a gas-fired water heater in the basement mechanical room, installed as part of the 1995 addition. The vent piping is ABS material, not acceptable by today's code requirements. The washroom in the GWR is provided with hot water by a point of use electric water heater located in the crawl space.

Figure 40, TLEPR Water Heater

- a) Has exceeded its life expectancy and should be scheduled for replacement.
- b) Replace vent piping when water heater is replaced.

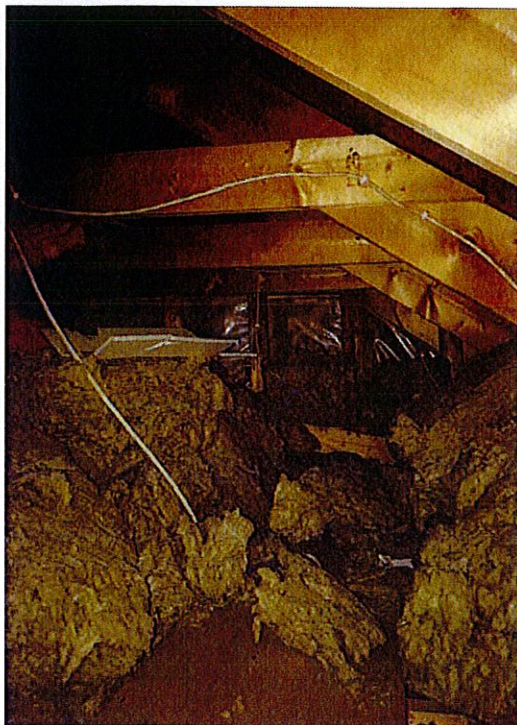
Figure 49, Inadequately Supported Wiring In Attic

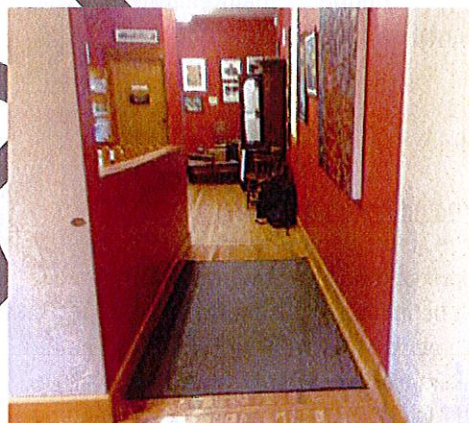
Some deficiencies observed include but are not limited to the following: missing handrails on ramps and stairs in the main gallery, use of knobs on some doors, and inadequate sink clearances in washrooms.

Figure 51, Ramp slope 1:12, no handrailings.

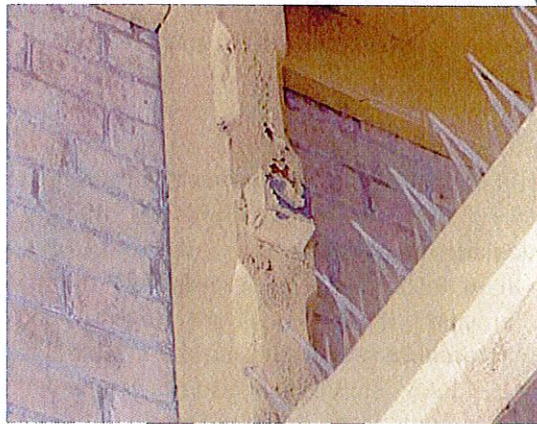
Figure 52, Failing paint on exterior wood elements.

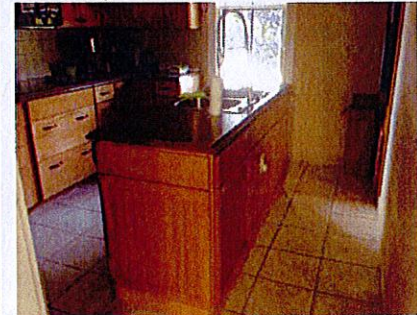
21. Kitchen, Non-B.F. conforming.

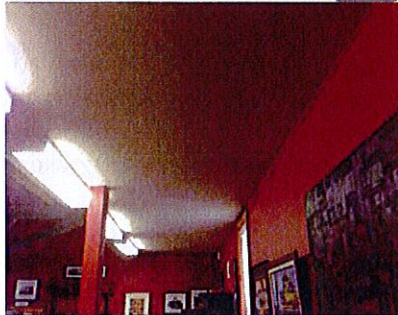
22. Gallery, water stains on ceiling.

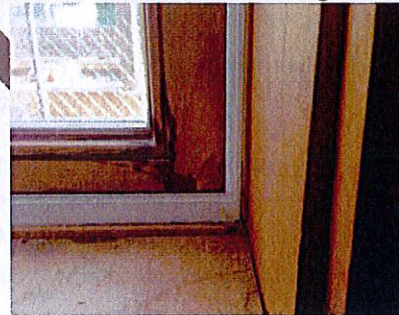
23. Window, water leak.

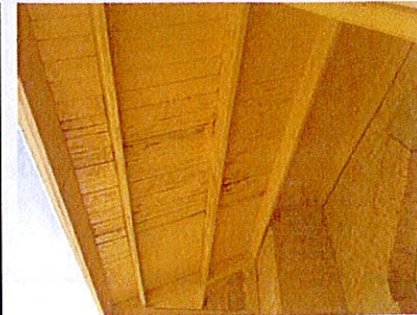
24. GWR, rotted deck boards.
