TOWN OF TILLSONBURG

2019 OSIM INSPECTIONS

NEEDS STUDY

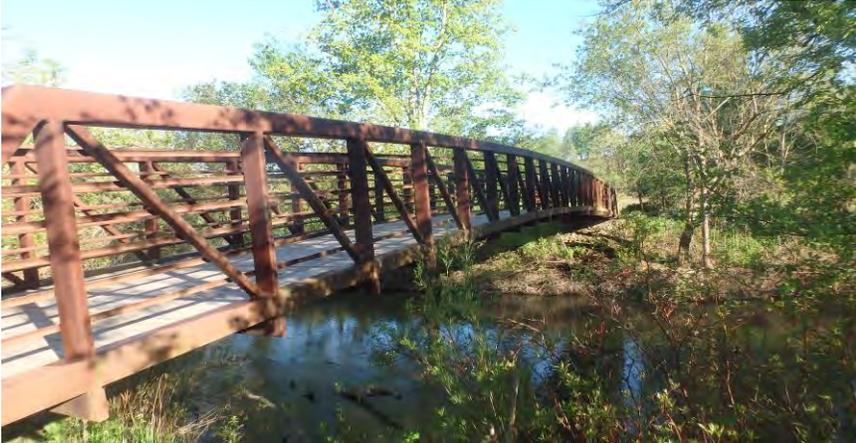
Overall Comments:

The structure is generally in good condition.

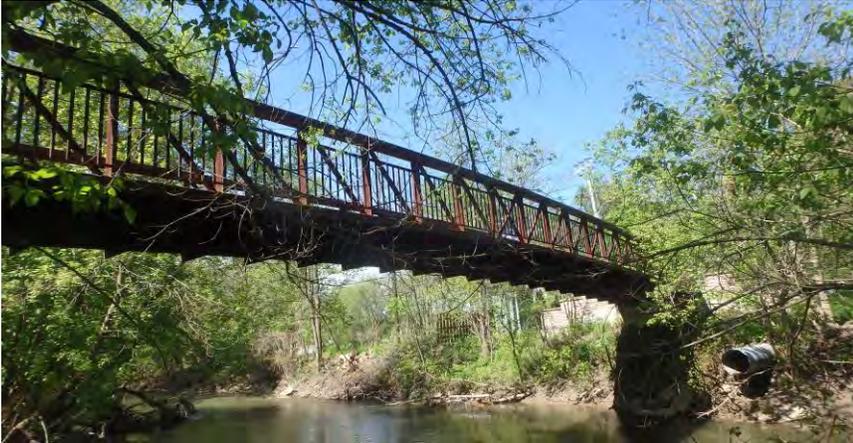
Overall Comments:

The structure is generally in good condition. Maintenance work required.

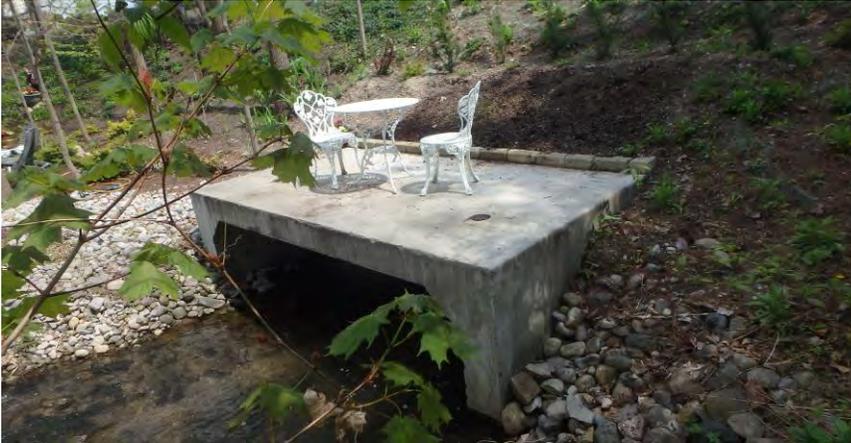
Overall Comments:

The structure is generally in good condition. Maintenance work required.

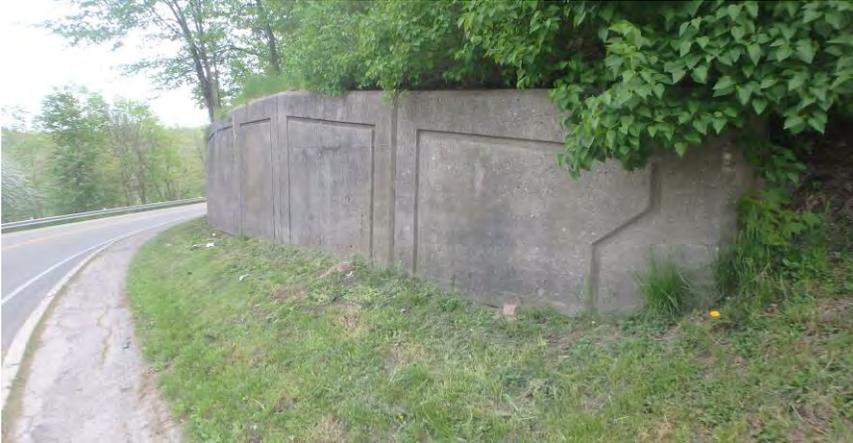
Overall Comments:

Structure is in overall fair to good condition. Minor maintenance work required.

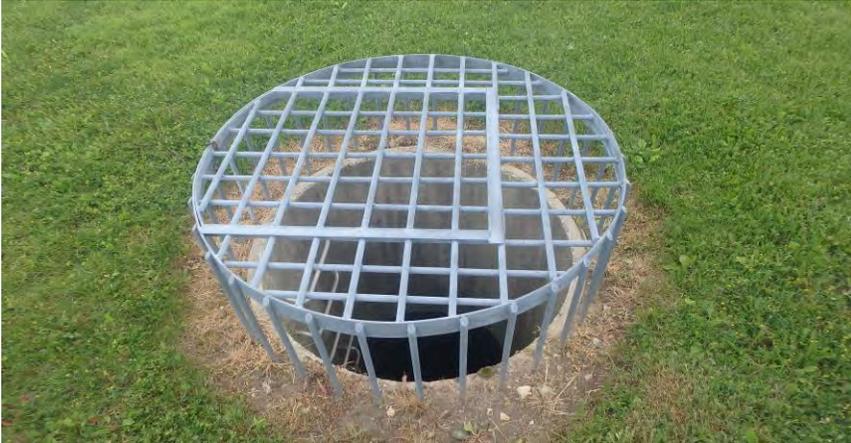
Overall Comments:

Limited inspection of structure due to limited access and size of structure. Structure barrel was not visible from barrel access points.

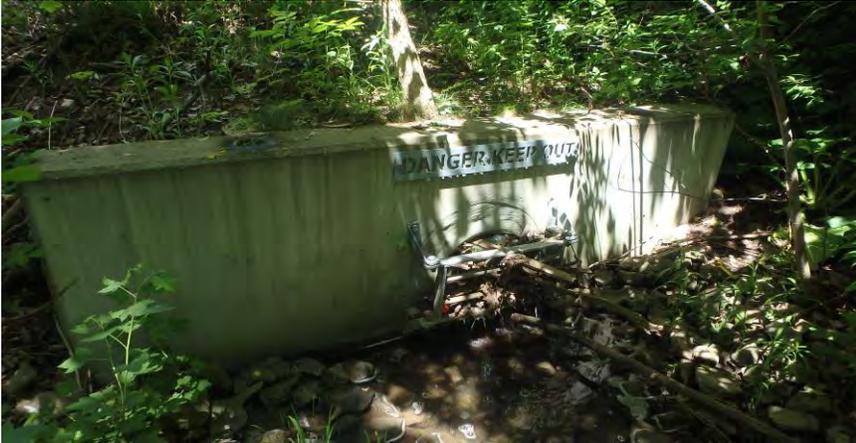
Overall Comments:

Limited inspection of structure due to limited access and size of structure. This inspection only includes the culvert structure and elements located on the east end of the structure. All other elements (i.e. retaining wall and barriers at west end of structure) are recorded in the William St. and Quarter Town Line OSIM report (Site Number: RW_WILL).

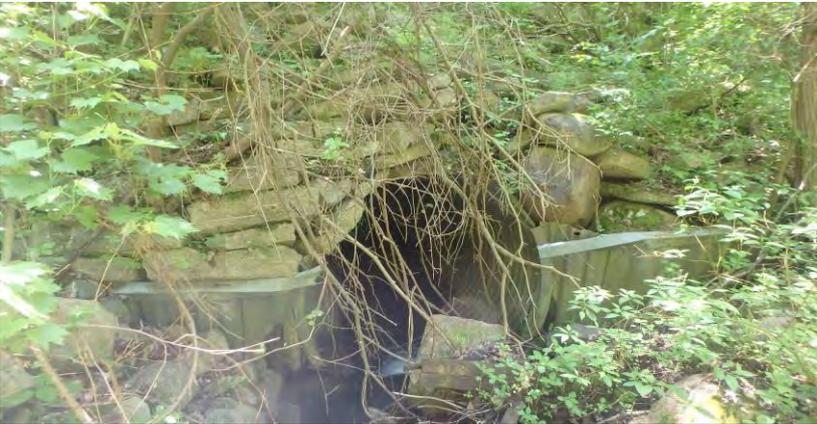
Overall Comments:

The condition of the guide rail barriers as well as the retaining walls on either side of the culvert is recorded in the OSIM reports for the Newell Road/Quarter Town Line Retaining Walls (Site Numbers RW_NEWE0001 and RW_NEWE0002). The Culvert is recommended to be replaced at the same time as the retaining wall.

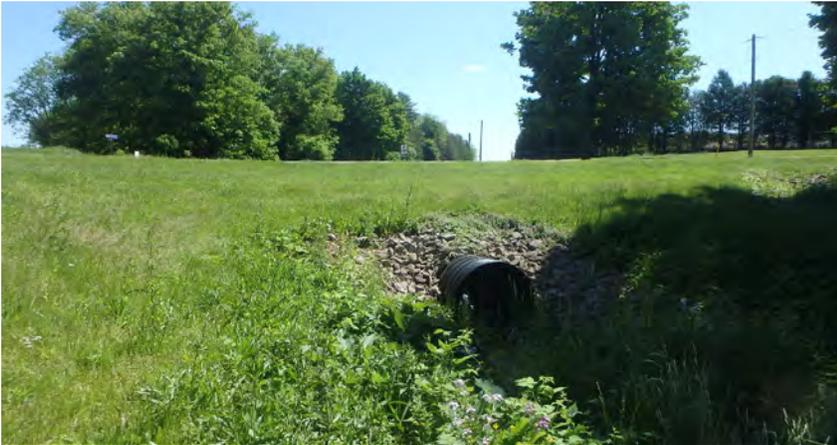
Overall Comments:

The structure is generally in good condition. Maintenance work required.

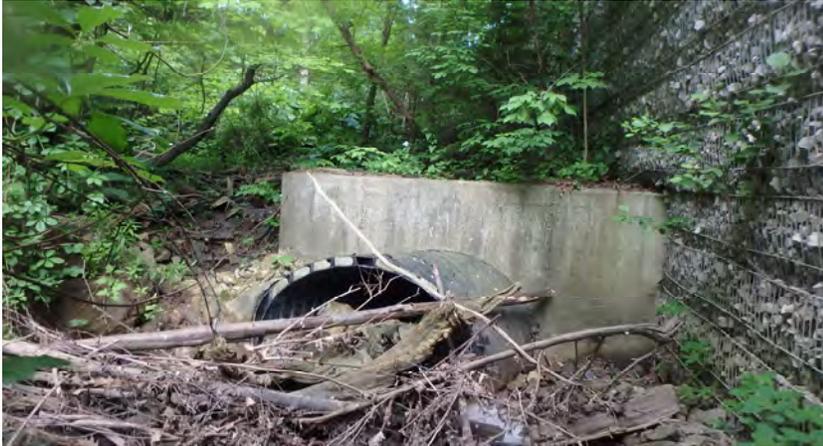
Overall Comments:

This structure is one of three structures that are connected together to create CU_BRIDE0274_1, CU_BRIDE0274_2, and LISG2209_1. Each structure, from the inlet at the north to the outlet at the south, is: CU_BRIDE0274_1 (round culvert 63 in length) and transitions to CU_BRIDE0274_2 (round culvert 77 m in length) which transitions to LISG2209_1 (concrete box culvert 376m... Refer to OSIM for details.

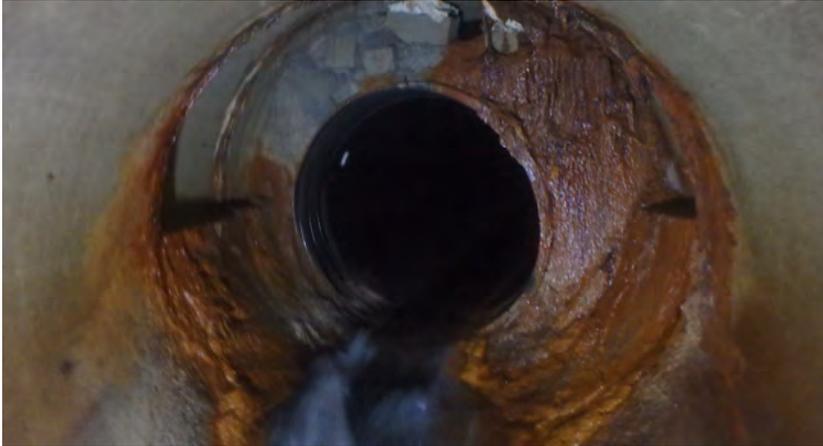
Overall Comments:

This structure is one of three structures that are connected together to create CU_BRIDE0274_1, CU_BRIDE0274_2, and LISG2209_1. Each structure, from the inlet at the north to the outlet at the south, is: CU_BRIDE0274_1 (round culvert 63 in length) and transitions to CU_BRIDE0274_2 (round culvert 77 m in length) which transitions to LISG2209_1 (concrete box culvert 376m... Refer to OSIM for details.

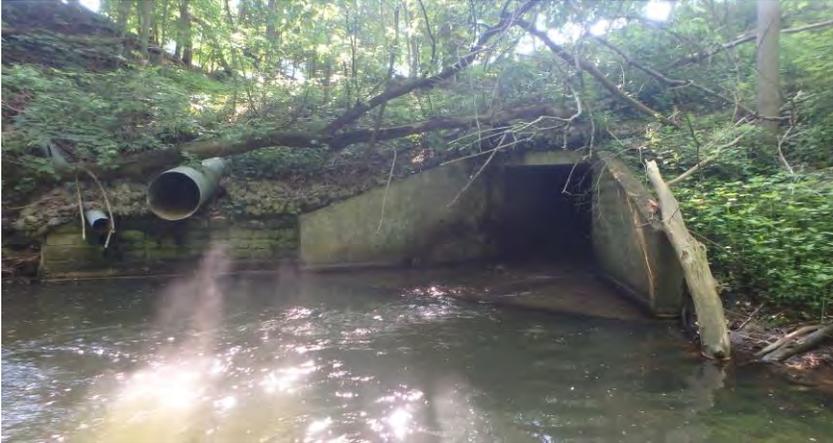
Overall Comments:

This structure is one of three structures that are connected together to create CU_BRIDE0274_1, CU_BRIDE0274_2, and LISG2209_1. Each structure, from the inlet at the north to the outlet at the south, is: CU_BRIDE0274_1 (round culvert 63 in length) and transitions to CU_BRIDE0274_2 (round culvert 77 m in length) which transitions to LISG2209_1 (concrete box culvert 376m... Refer to OSIM for details.

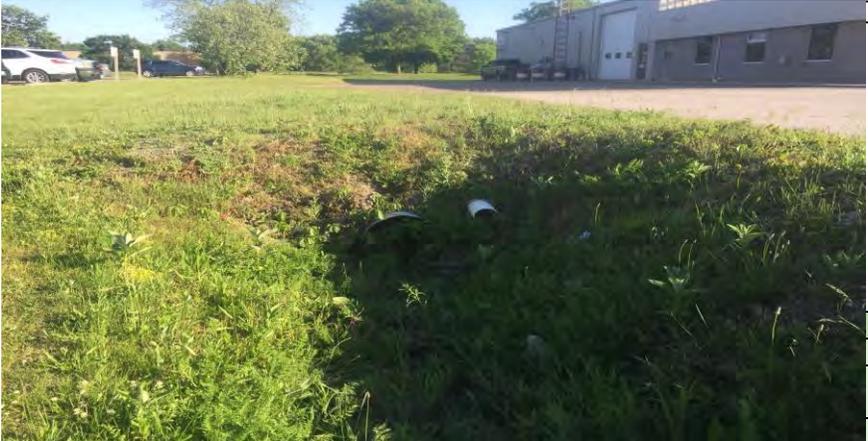
Overall Comments:

Limited inspection of structure due to limited access and size of structure. Structure is generally in good condition.
