# Library Lane Covered Walkway

# Discussion

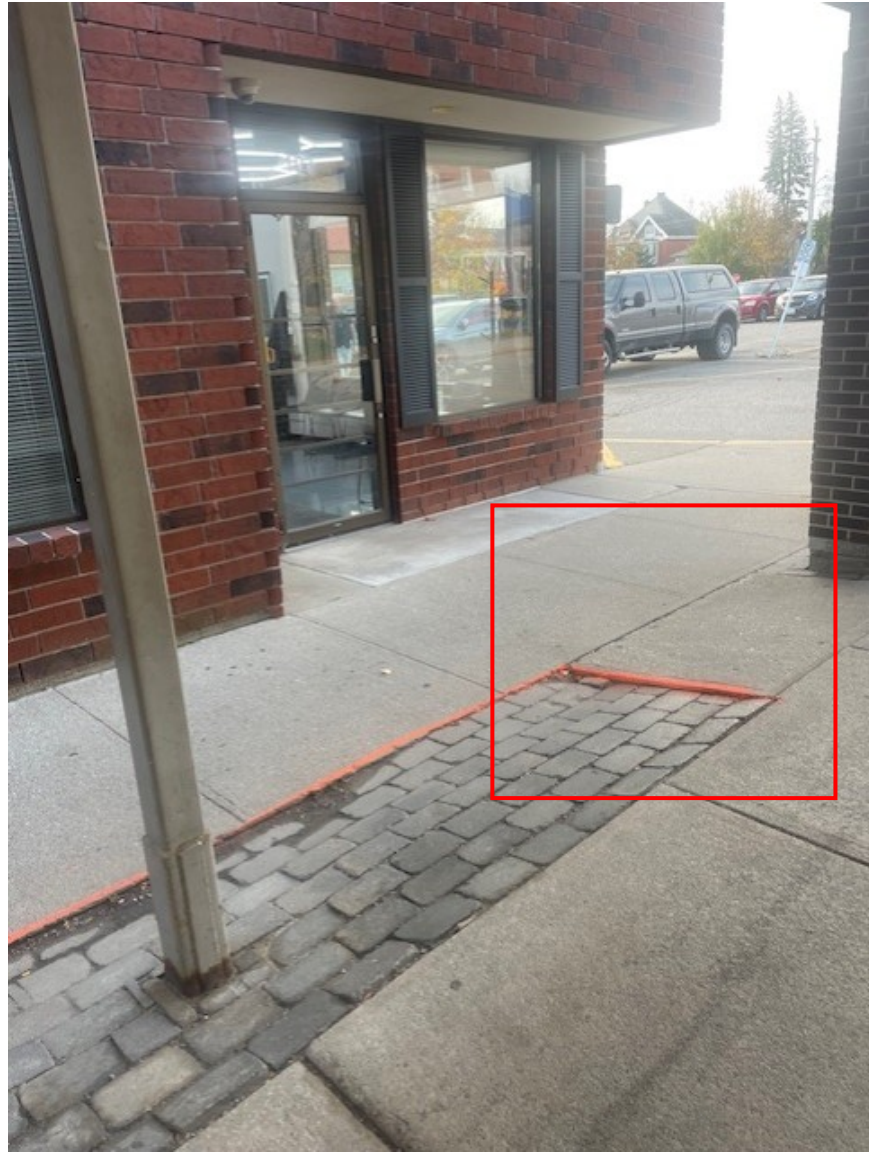
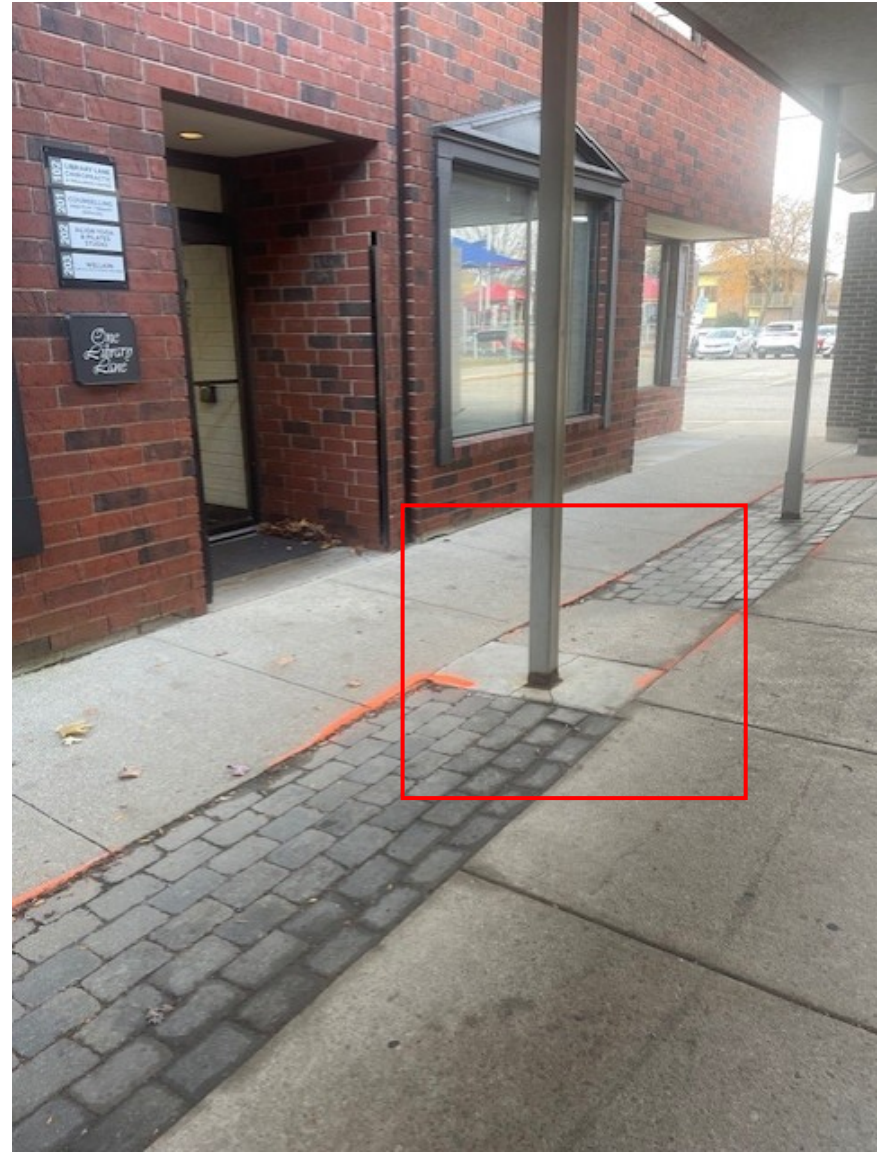
- The walkway leading to and from 1 Library Lane presents several barriers that impact pedestrian accessibility. These include uneven surfaces, inadequate signage, and limited space for individuals with mobility challenges.
- These issues create difficulties for people with disabilities, seniors, and others who may have difficulty navigating the area. As a result, this may deter visitors, customers, and employees from accessing the businesses located at 1 Library Lane or using the walkway safely to access the Public Library or businesses on Broadway.

- The delegation seeks to ensure awareness of these various issues in the hopes we can begin the process of reviewing opportunities to address the key goals:
- **Improving physical access:** Implementing necessary upgrades to level the walkway, install ramps where needed, or remove obstacles that impede pedestrian movement.
- **Enhancing safety:** Addressing the low line of sight, clearing any visual obstructions as per OPP report.
- **Repairing structural damage:** Ensuring that the walkway's infrastructure is maintained to prevent further deterioration and that the roofing and path are either repaired or replaced as soon as possible to ensure safe usage for the public.

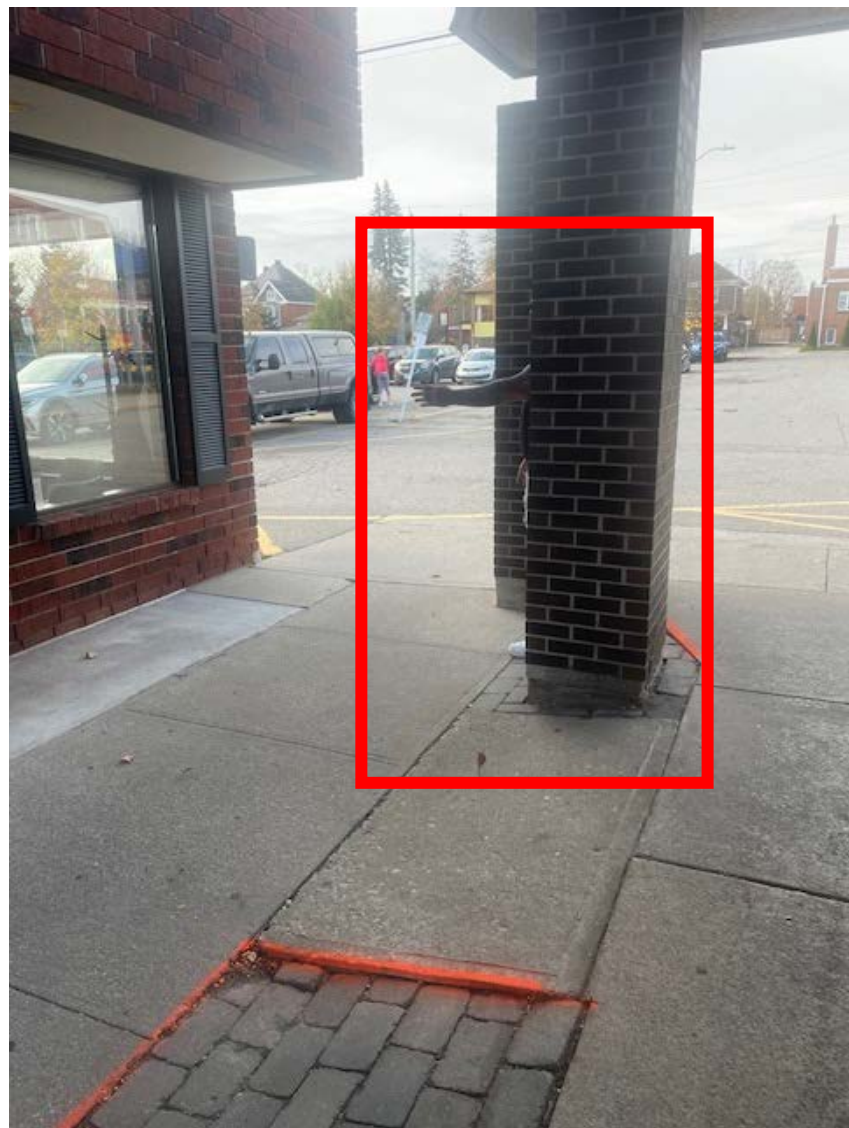
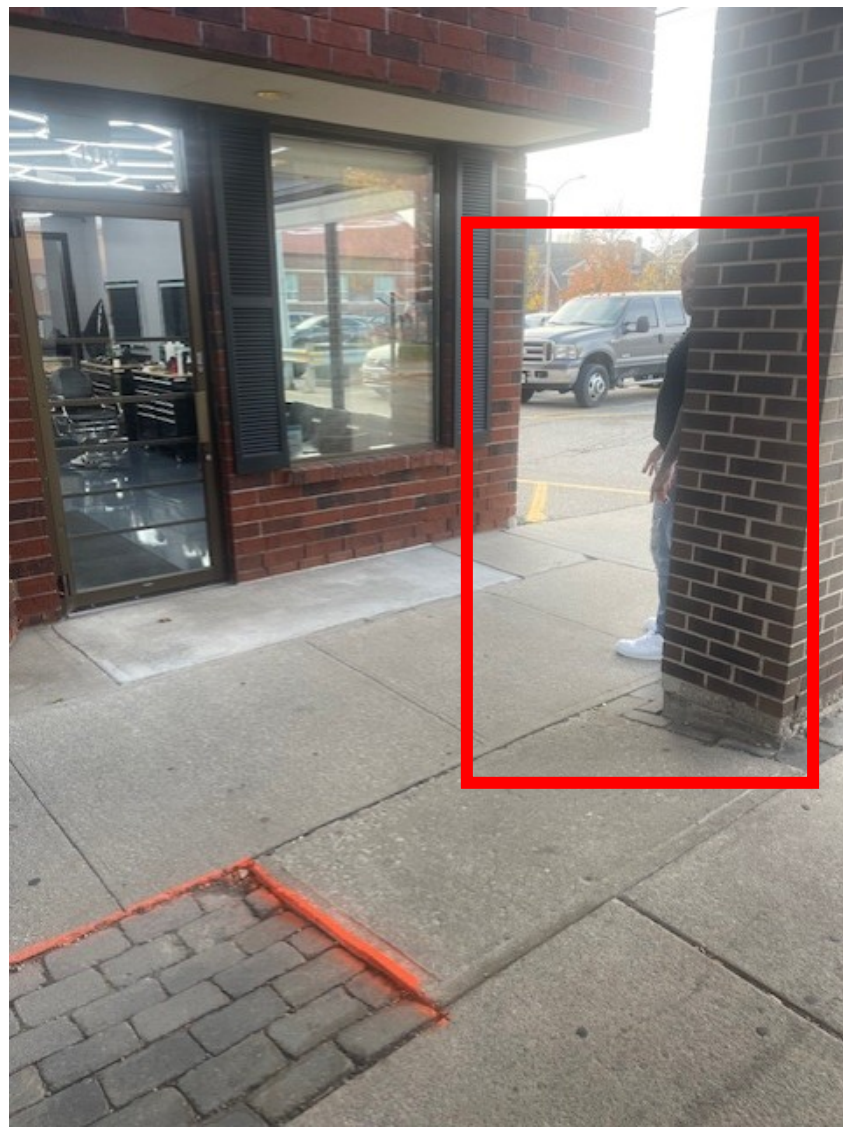
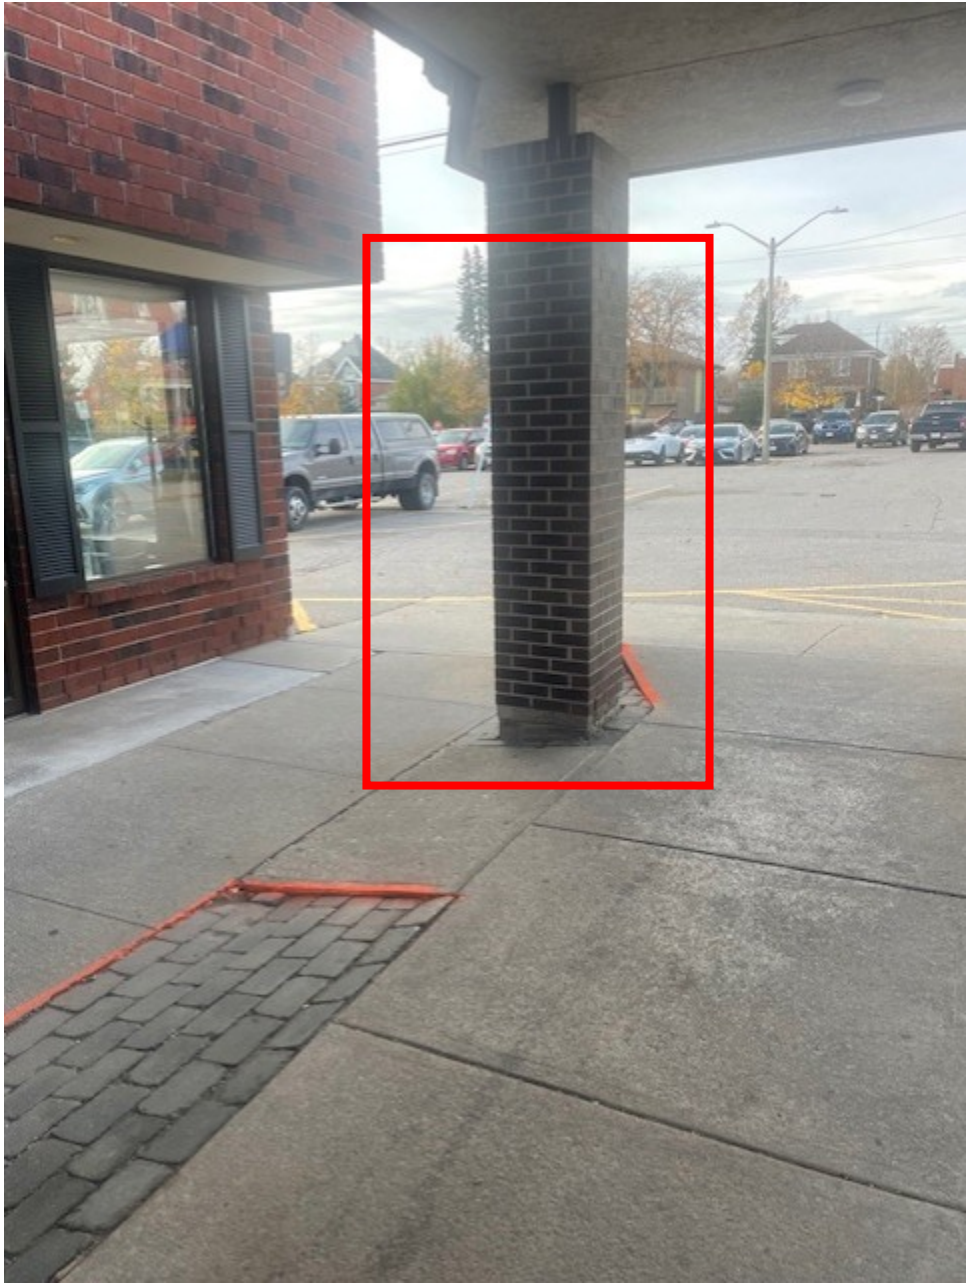
- A significant safety concern raised by the OPP is the poor line of sight through the walkway. This issue is particularly troubling as it can create a sense of vulnerability for pedestrians. Low visibility makes it difficult for people to see potential hazards or other individuals using the walkway, increasing the risk of accidents, criminal activity, or other safety incidents. The lack of clear sightlines also reduces the ability for law enforcement or emergency responders to quickly assess and address any safety concerns in the area.

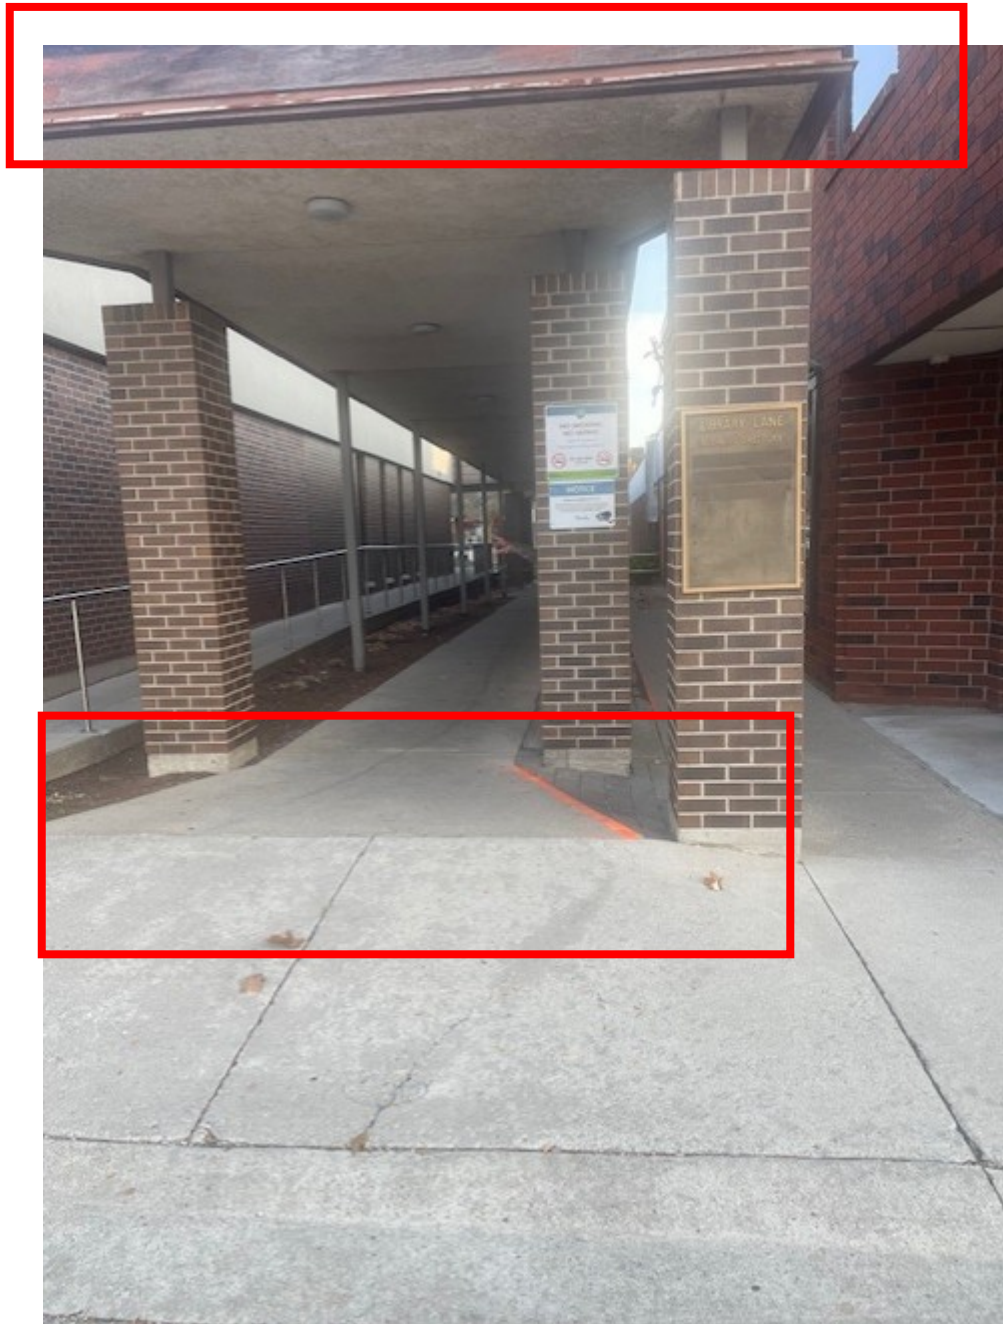
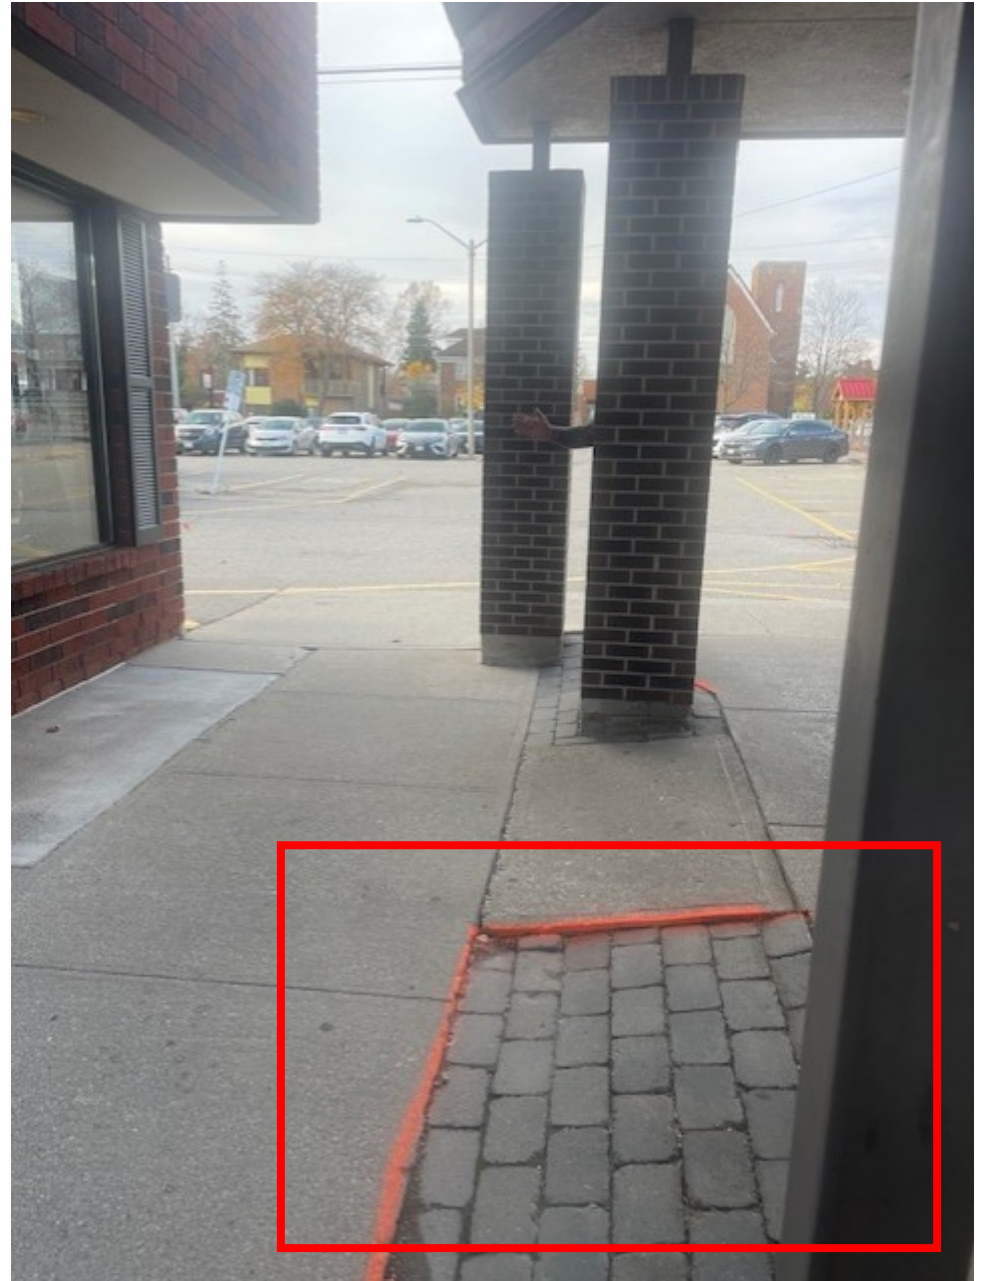
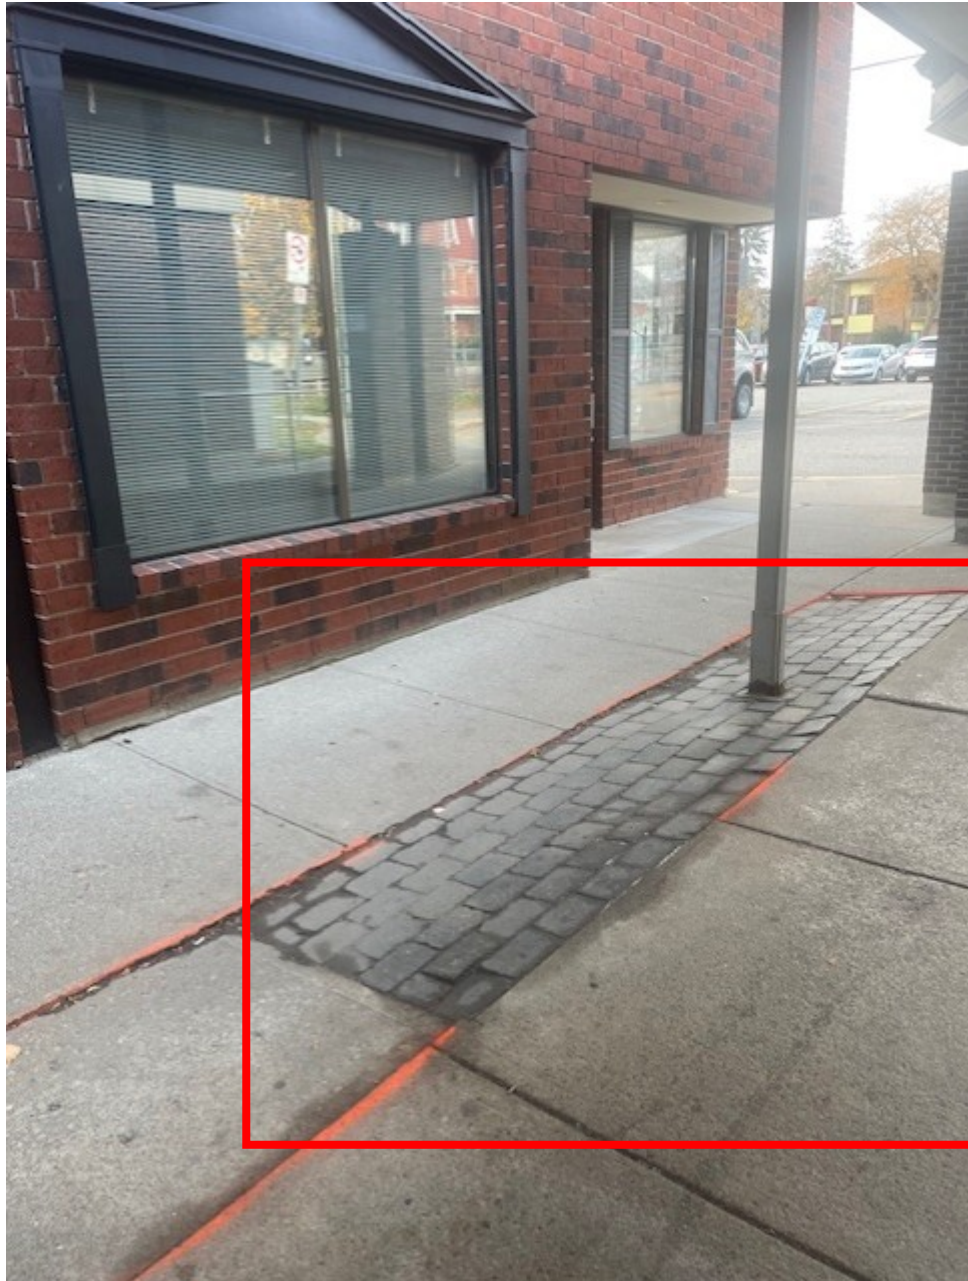
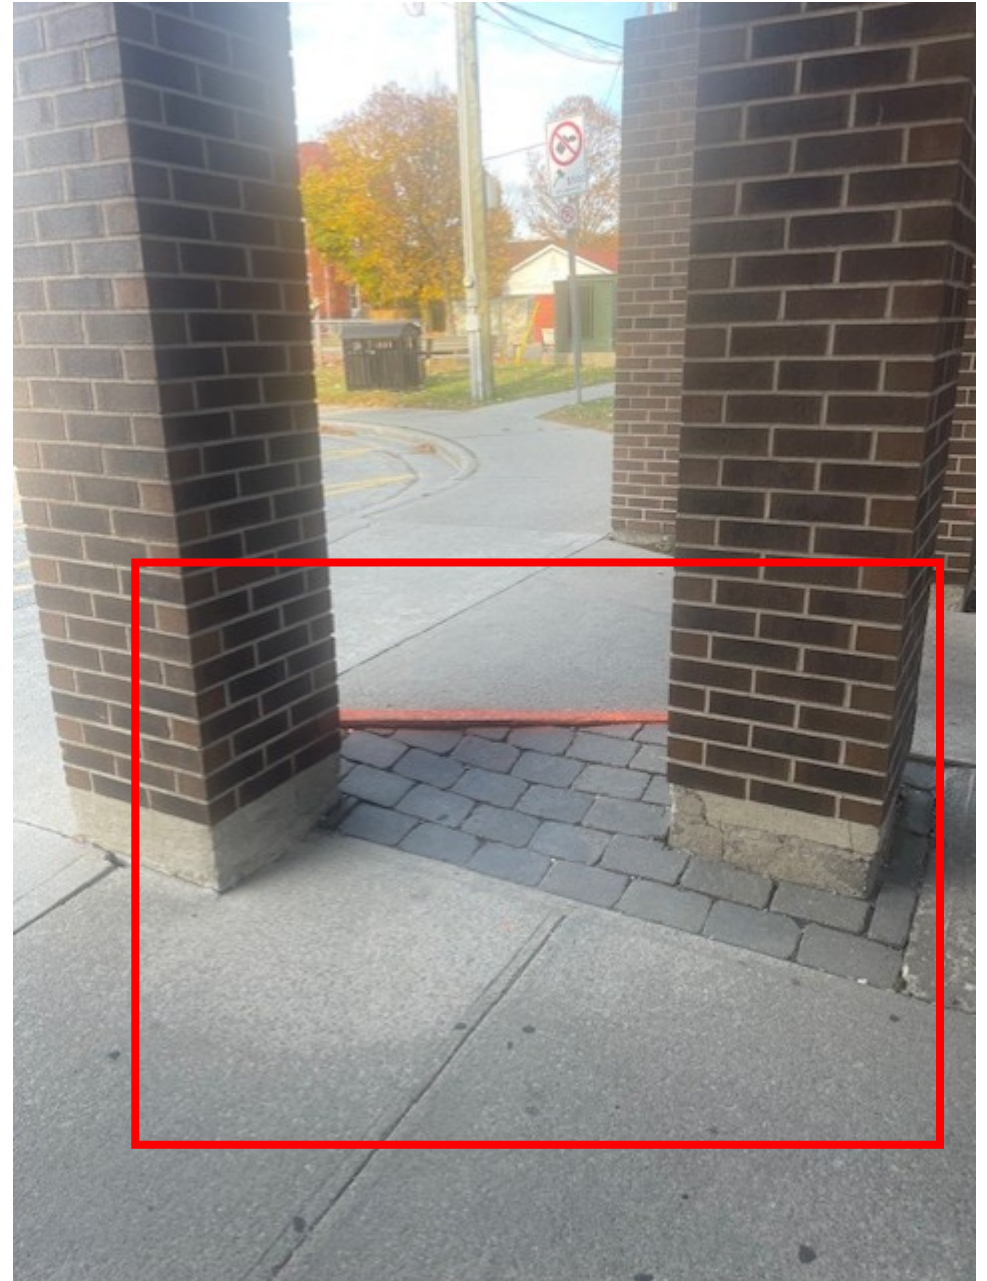
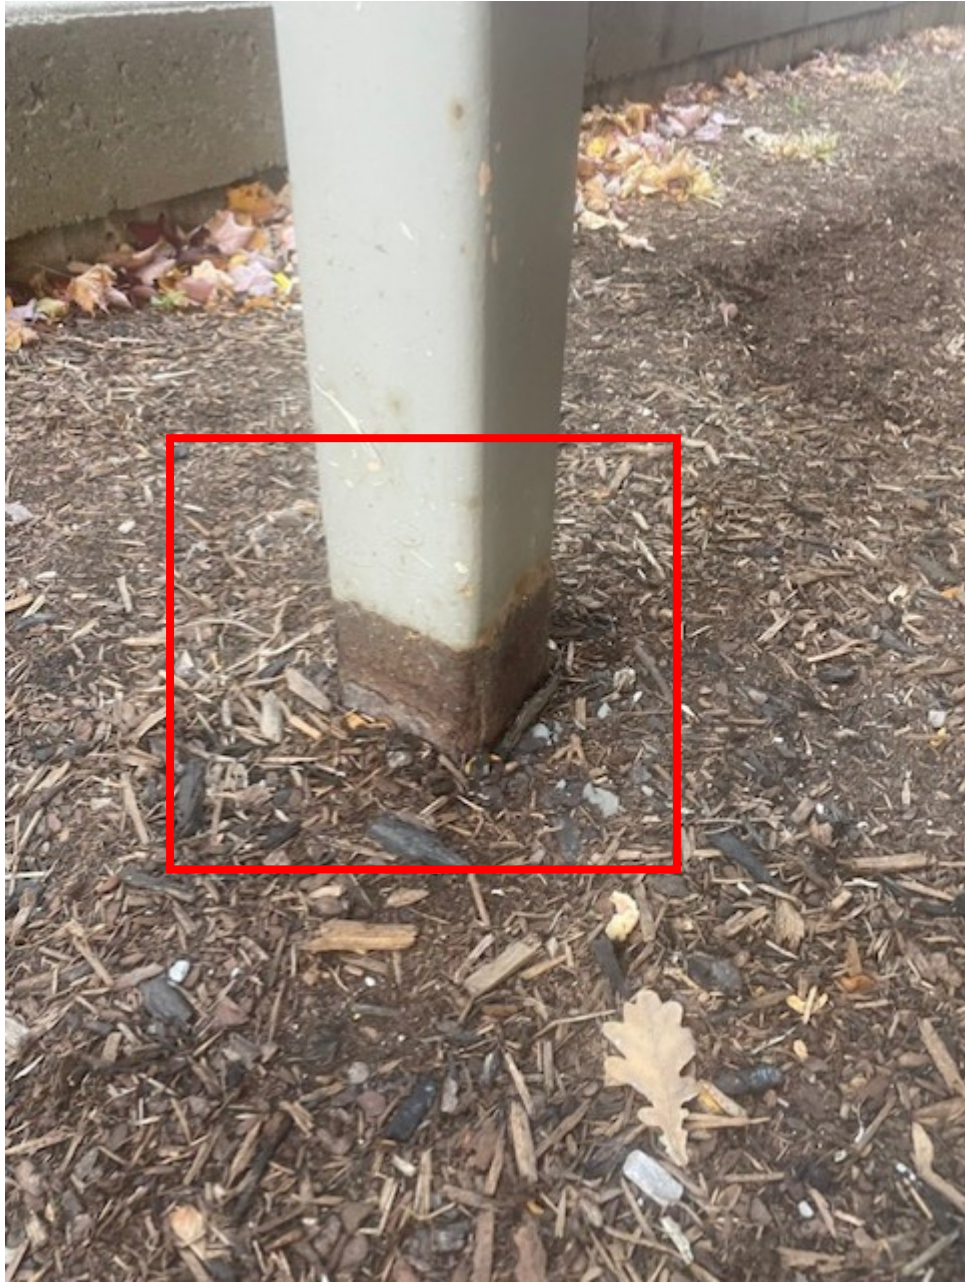
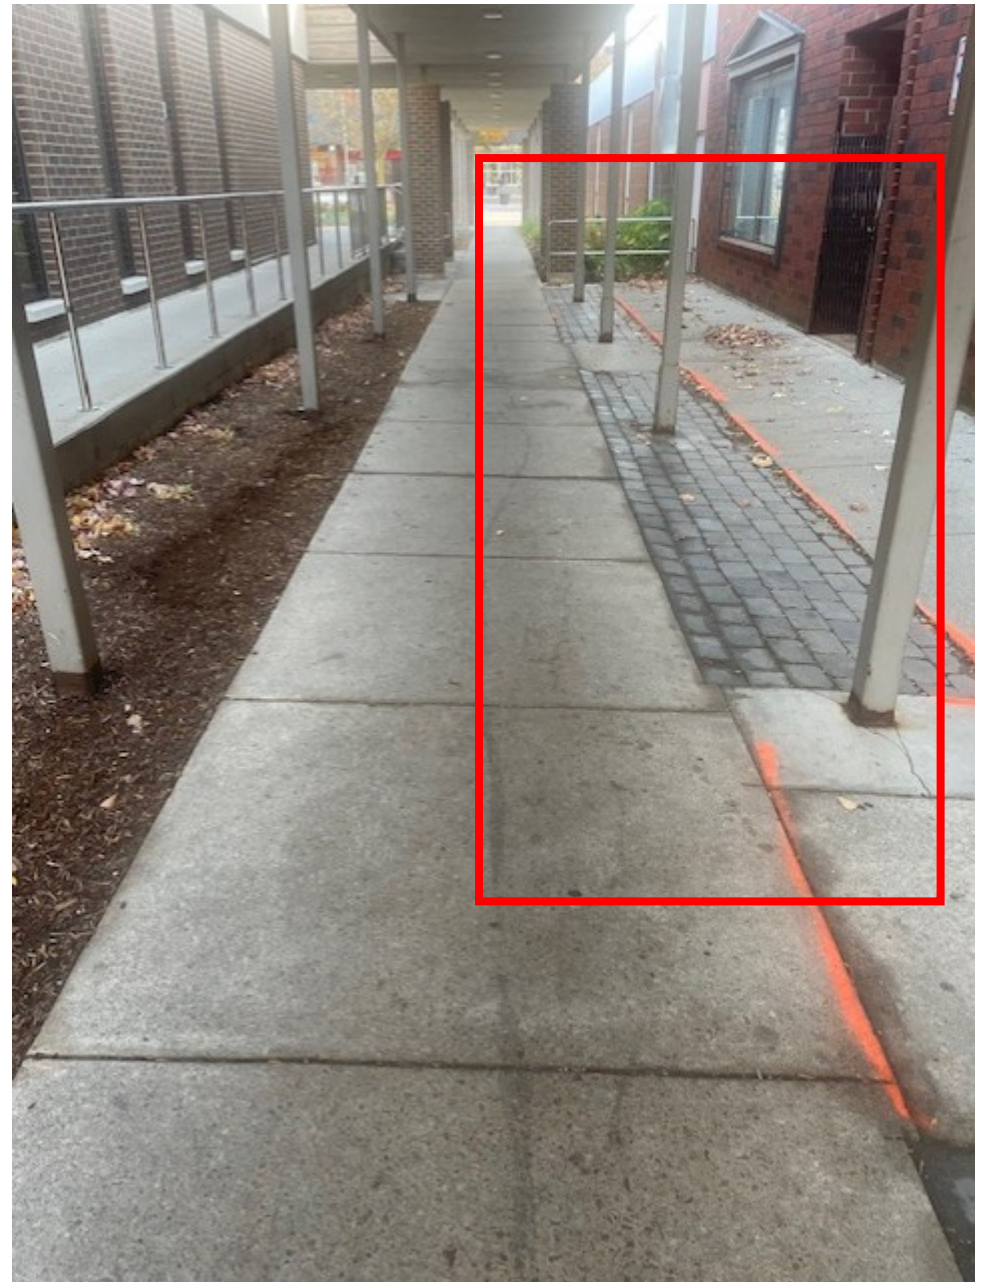
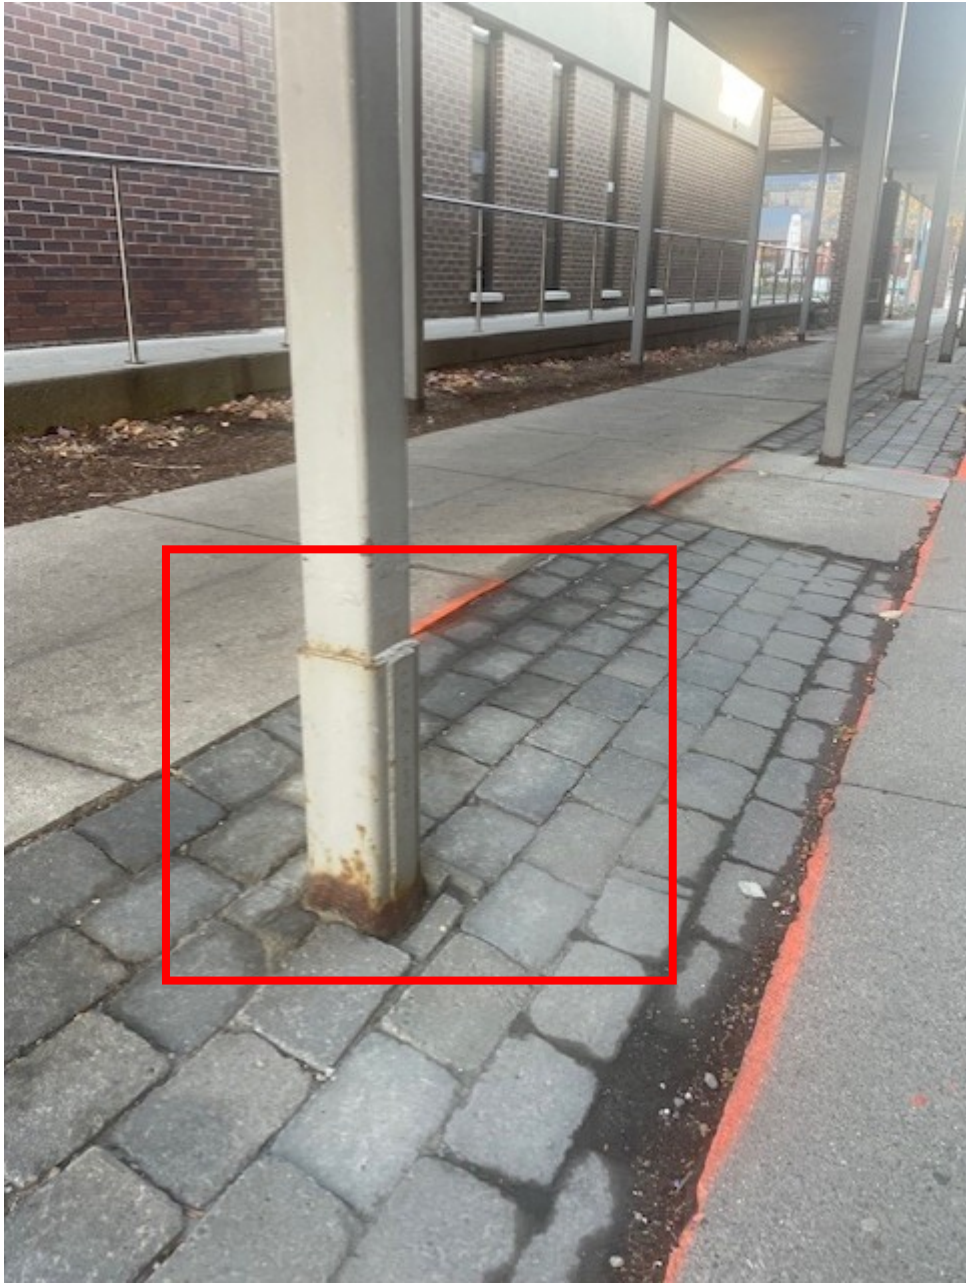
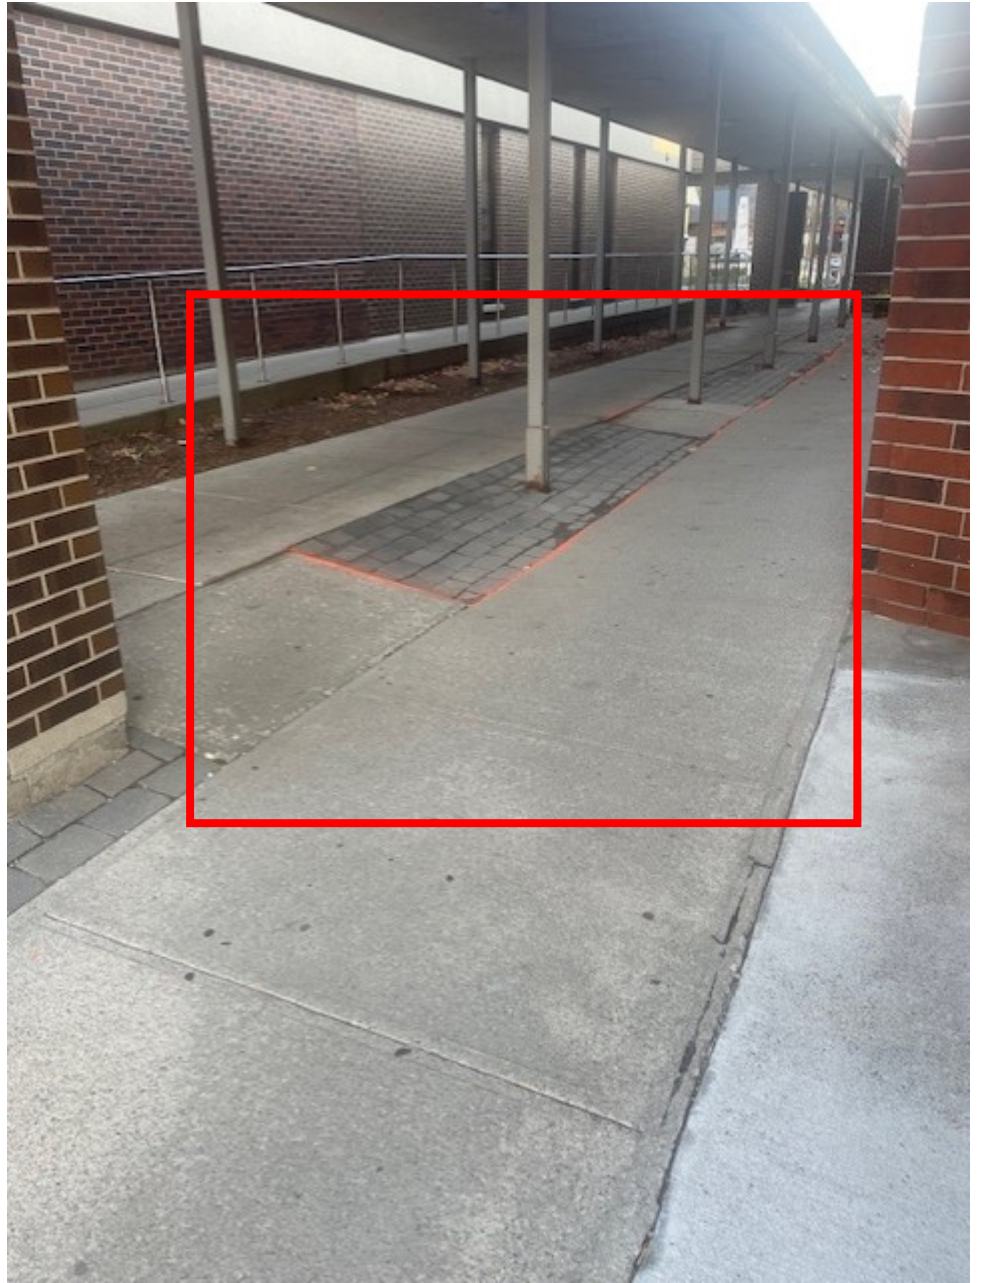
- The current state of the walkway requires attention due to wear and tear from weather exposure and general use. Several areas may require significant repairs either in the immediate future or shortly thereafter. These issues include damaged or uneven flooring, rust or corrosion on structural supports, and deteriorating lighting that could further compromise both safety and accessibility. Addressing these issues promptly is essential to ensure the walkway remains functional and safe for all users. Larger scale capital investments to the overhead structure are likely needed in the near future.
- Current grading is causing flooding onto 1 Library Lane sidewalk; and front door.

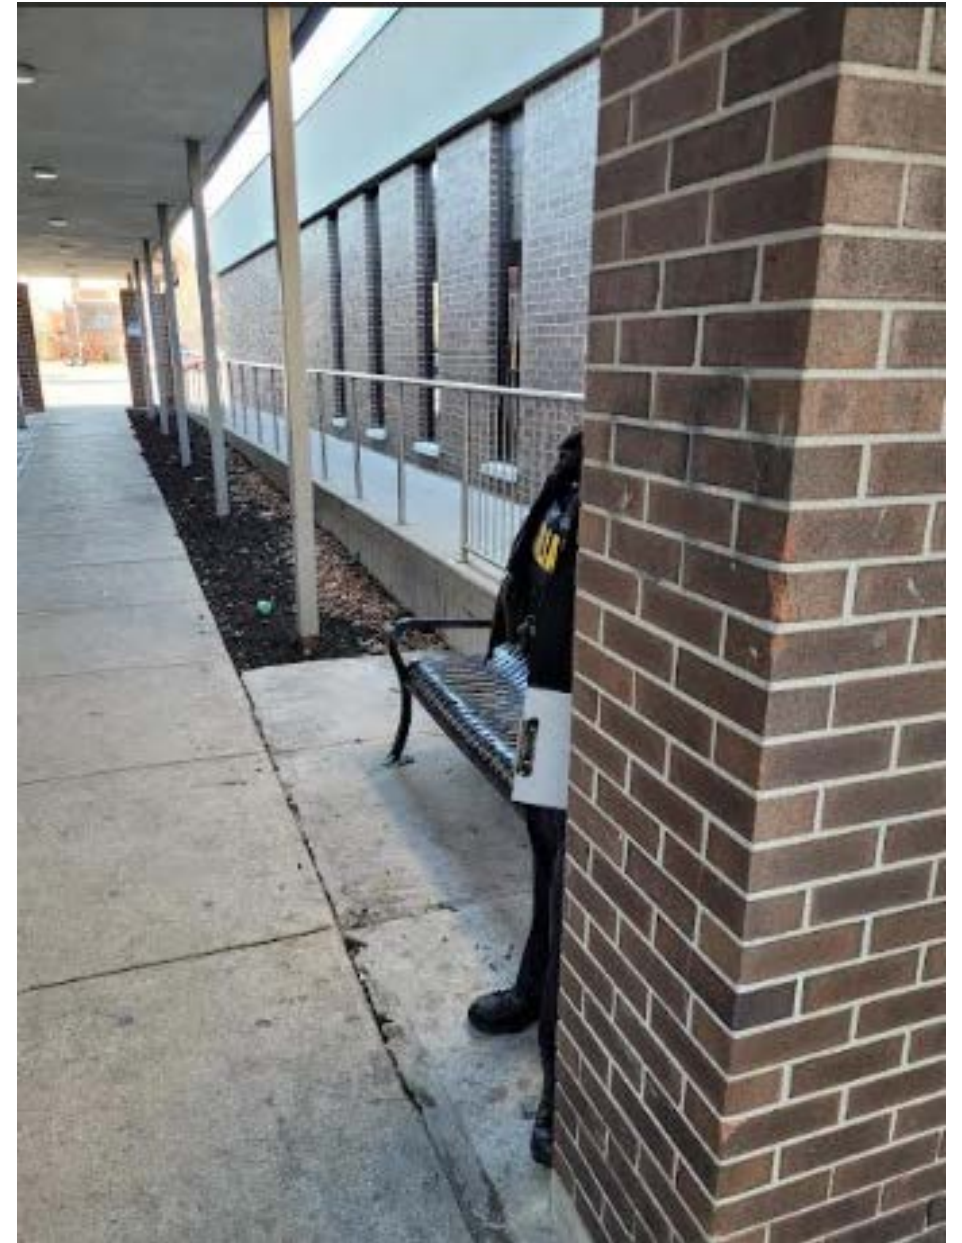
...ing and sleeping.  
The bricked posts provide  
hiding opportunities for  
potential situations and  
only seem to be a decorative  
piece. To gain more of  
a clear sightline whilst  
using the walkway, we suggest  
removing the brick on the end  
with, to match others, and

KS  
this would also prevent  
shadowed areas in the  
dark.
