# **BUILDING CONDITION ASSESSMENT AND CAPITAL PLANNING STUDY 8 ROSS STREET, TILLSONBURG, ON**

OCTOBER 12, 2017

**LAKE LISGAR WATER PARK  
AND SUMMER PLACE  
8 ROSS STREET  
TILLSONBURG, ON**

**TOWN OF TILLSONBURG**

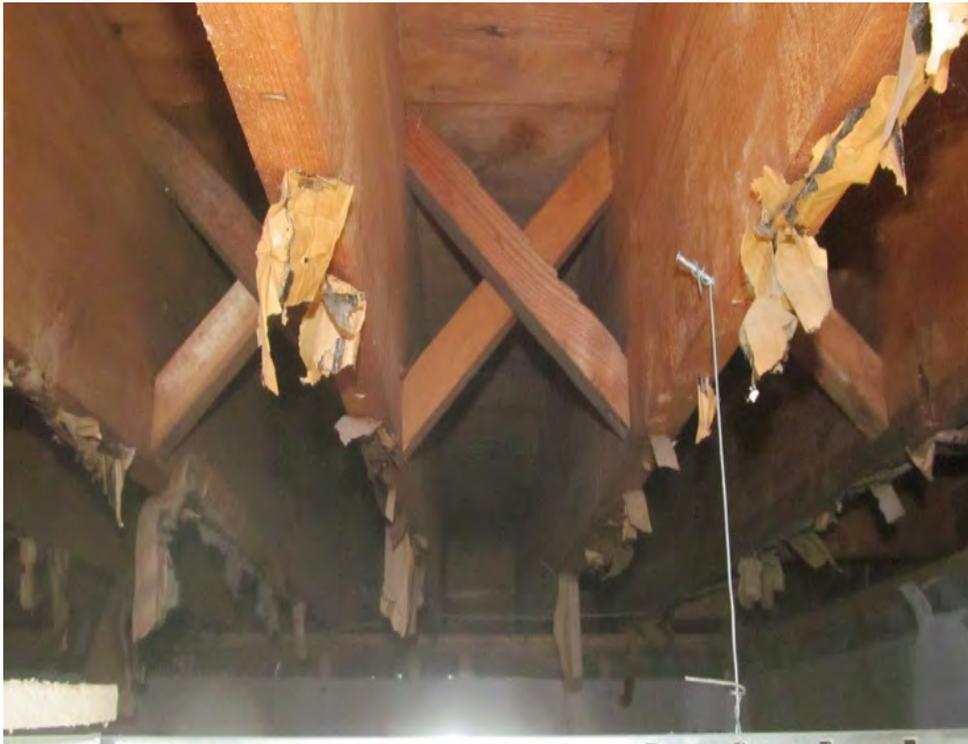
Photograph 6. Typical wood framing in south section of Summer Place

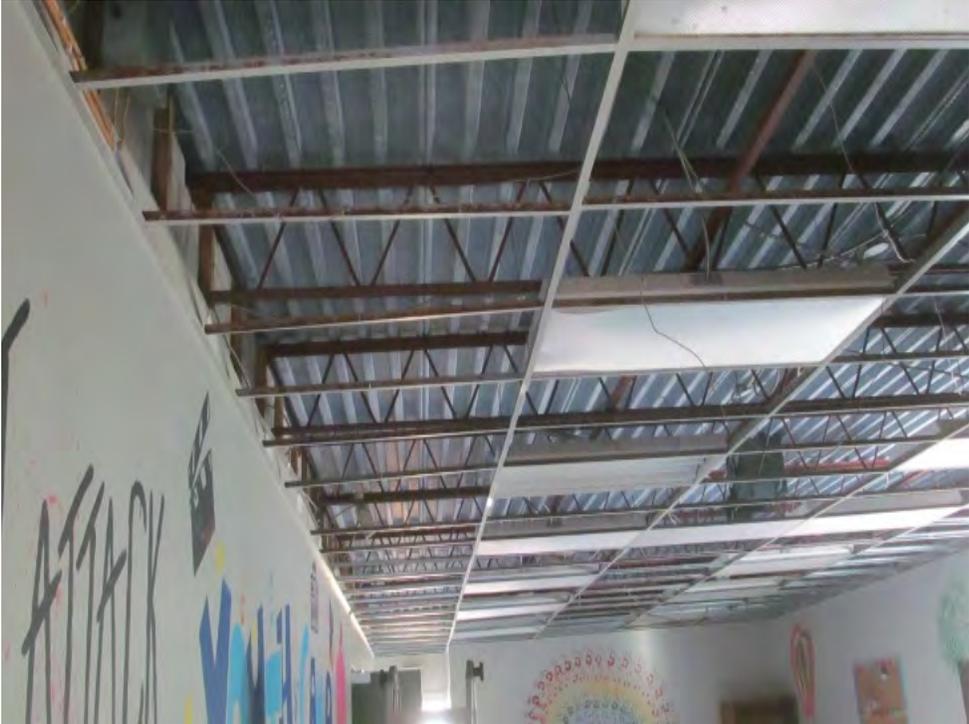
Photograph 7. Typical open web steel joist and metal deck framing in north section of Summer Place

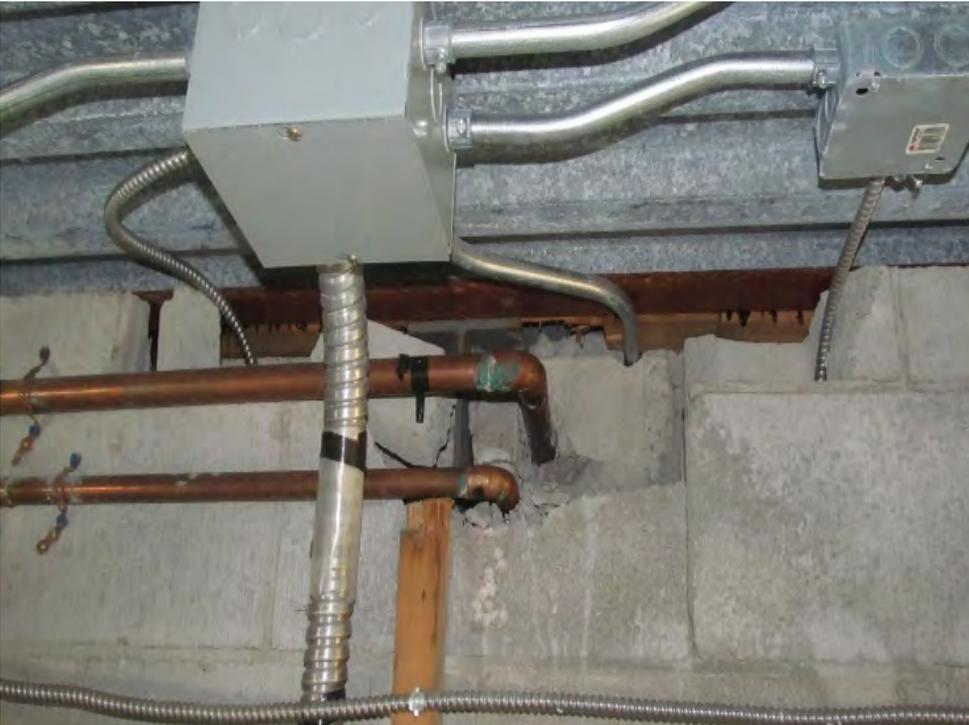
Photograph 8. Unsupported closure angle in north section of Summer Place

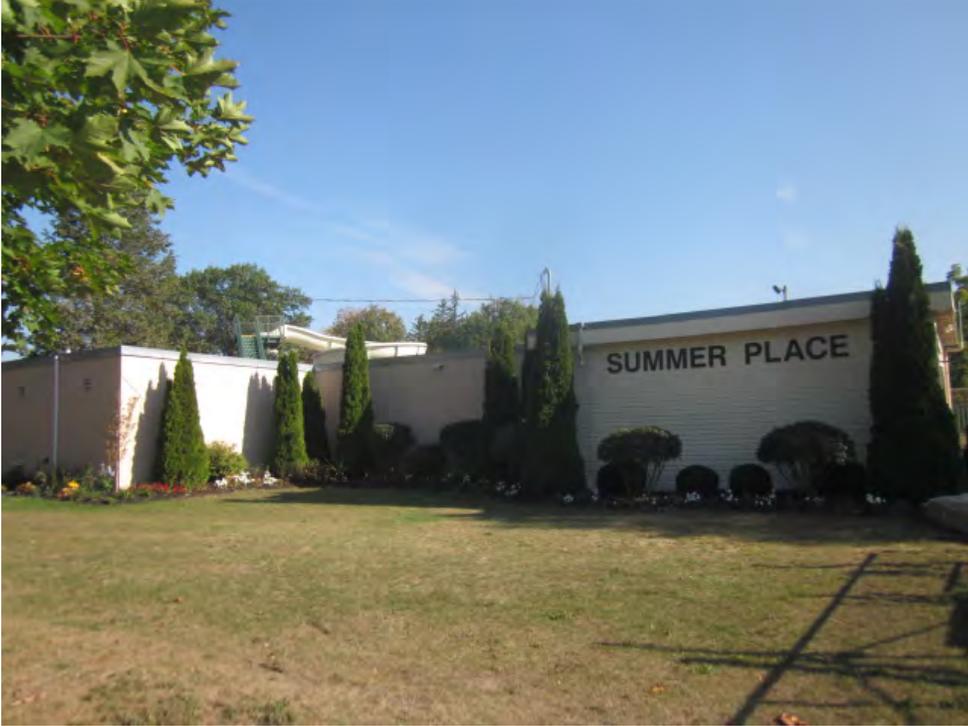
Photograph 11. West elevation of Summer Place

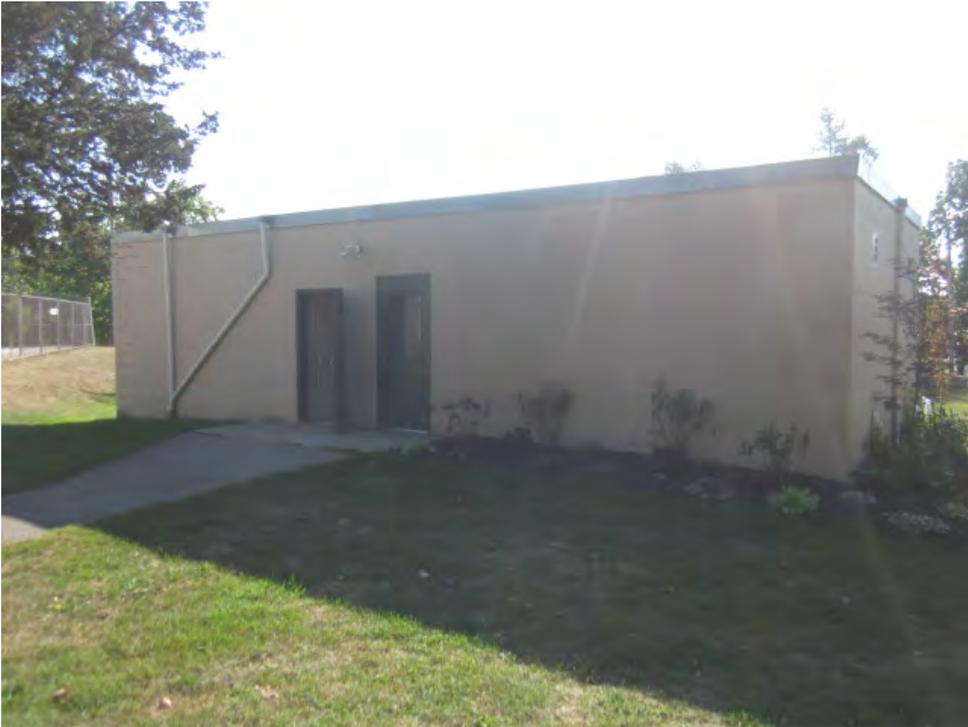
Photograph 12. North elevation of Summer Place

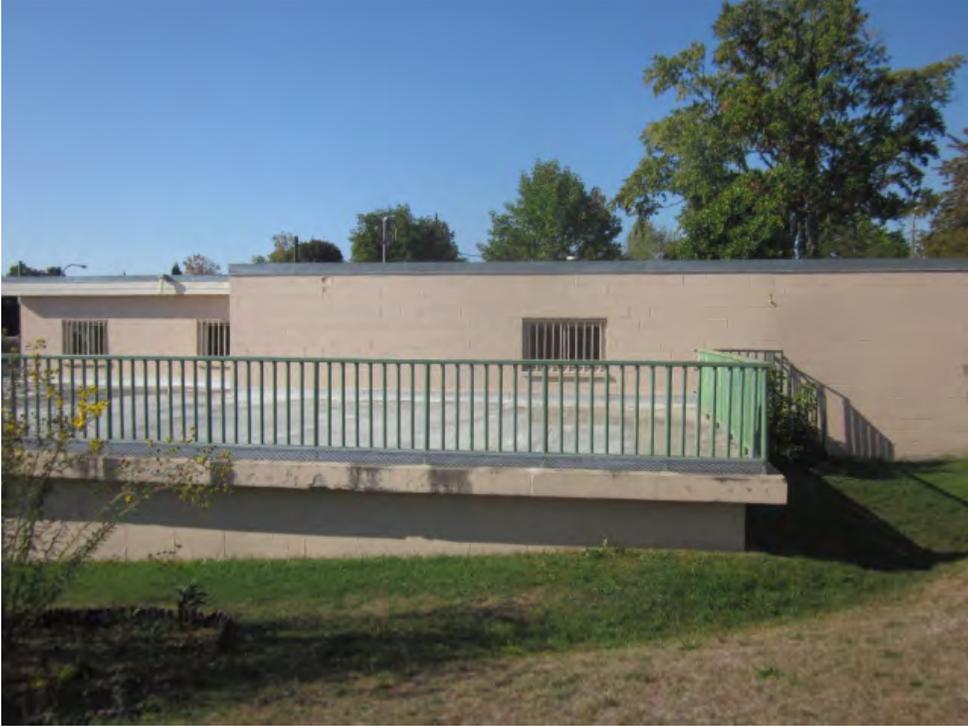
Photograph 13. East elevation of Summer Place

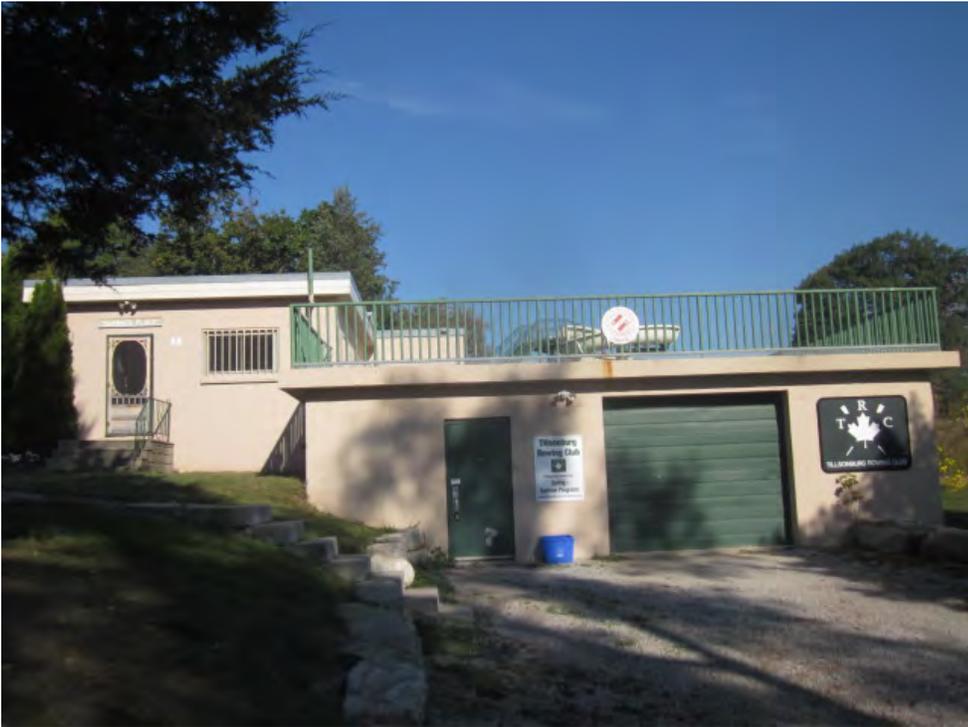
Photograph 14. South elevation of Summer Place

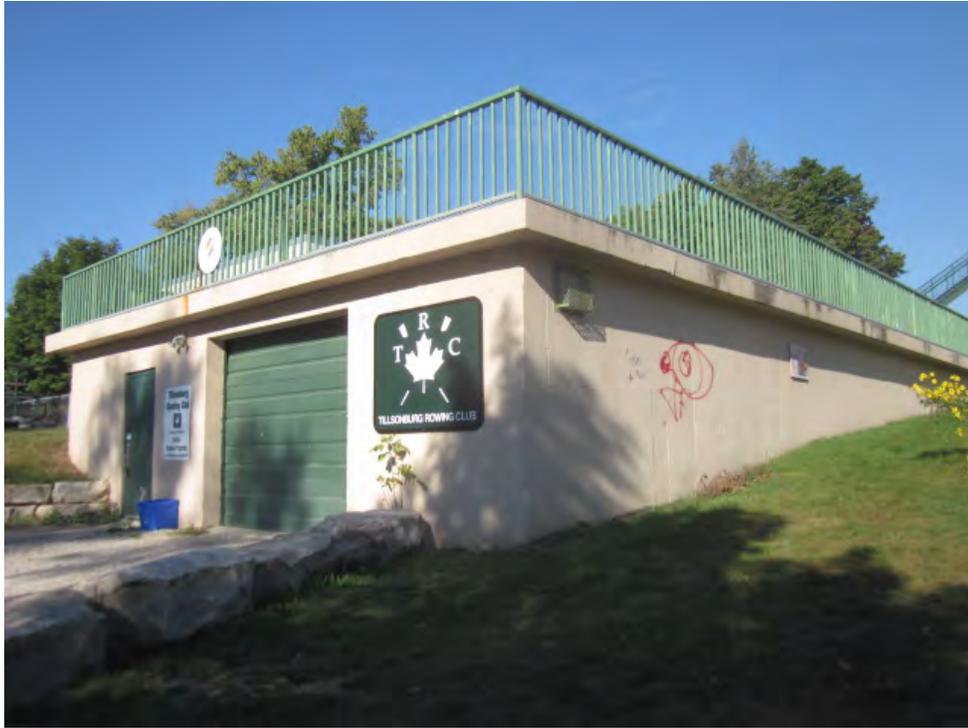
Photograph 15. South east elevation of Tillsonburg Rowing Club

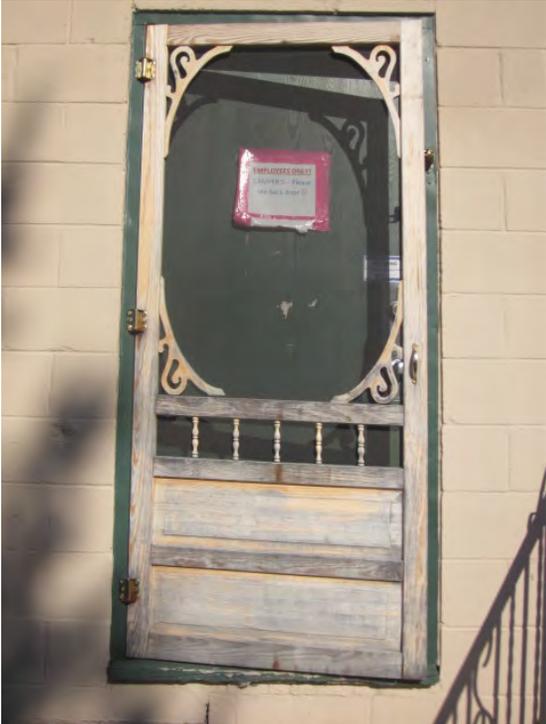
Photograph 20. Wood screen door at south entrance to Summer Place

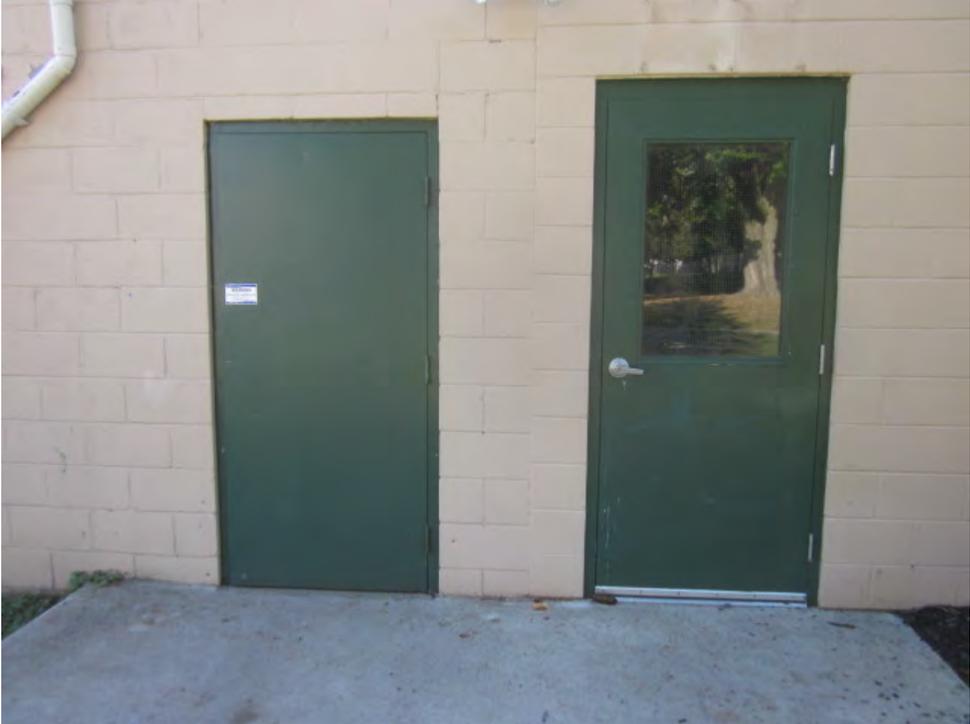
Photograph 21. Metal doors on north elevation of Summer Place

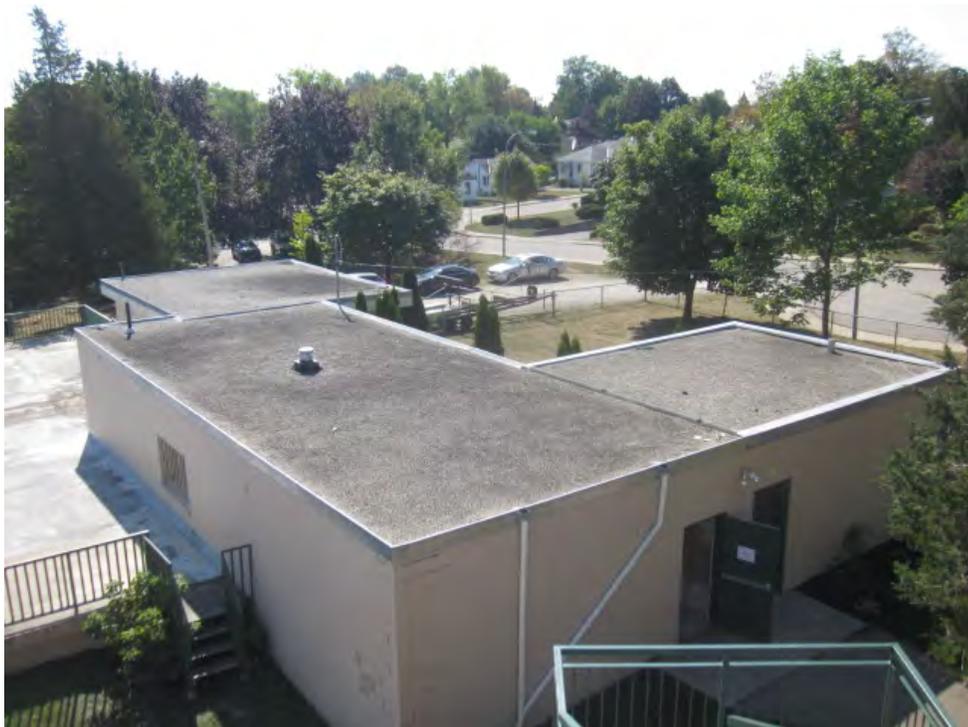
Photograph 26. General view of roof area at Summer Place

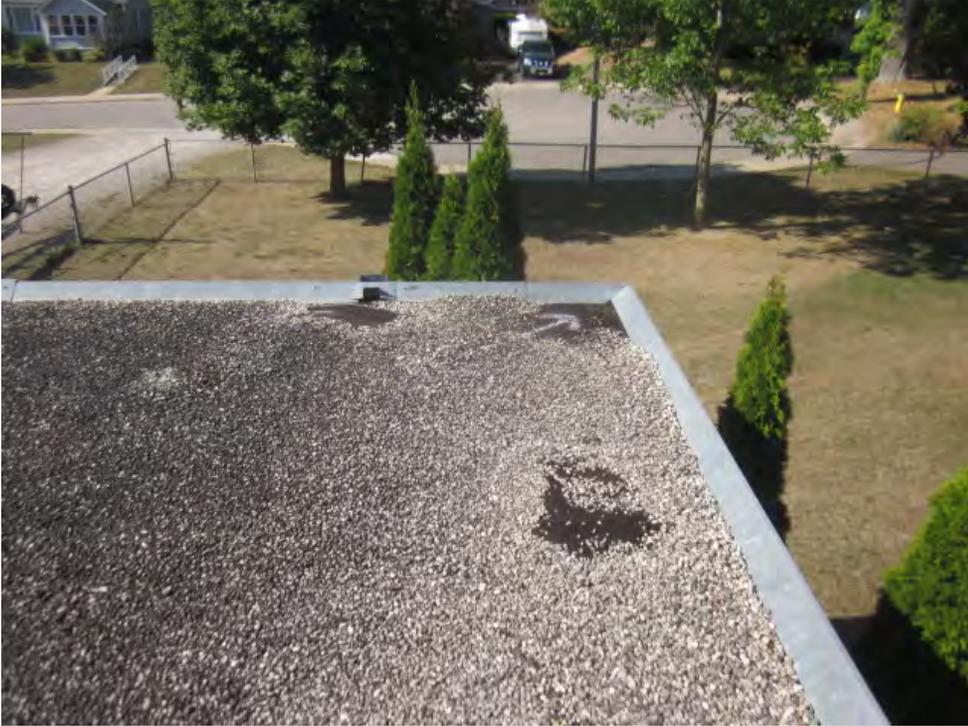
Photograph 27. Exposed asphalt membrane and blisters at south section of Summer Place roof

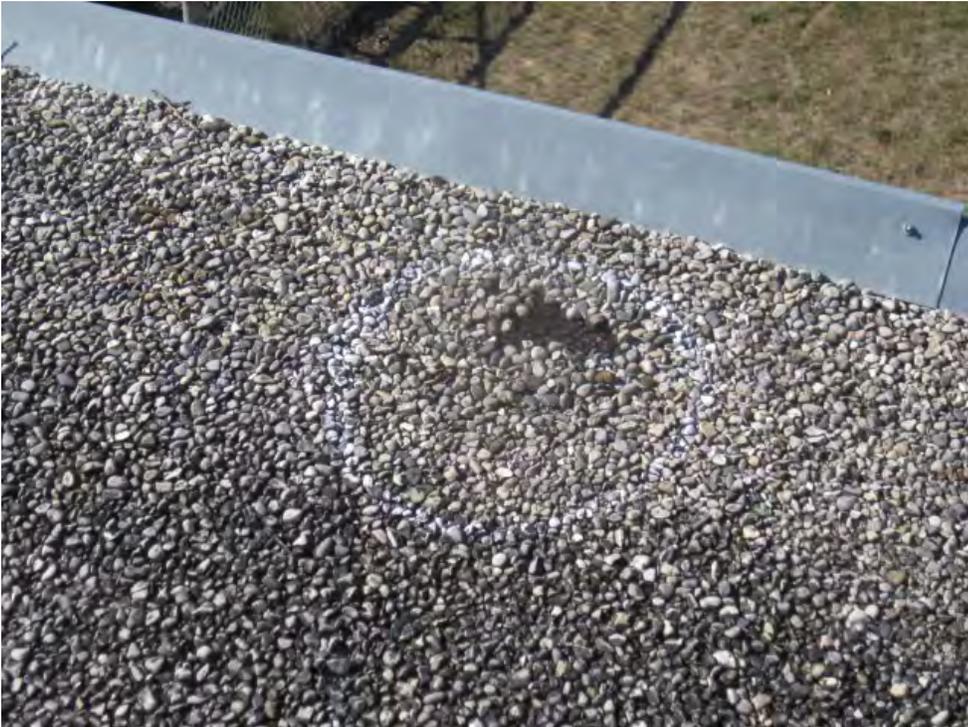
Photograph 28. Blister in roof membrane at south section of Summer Place

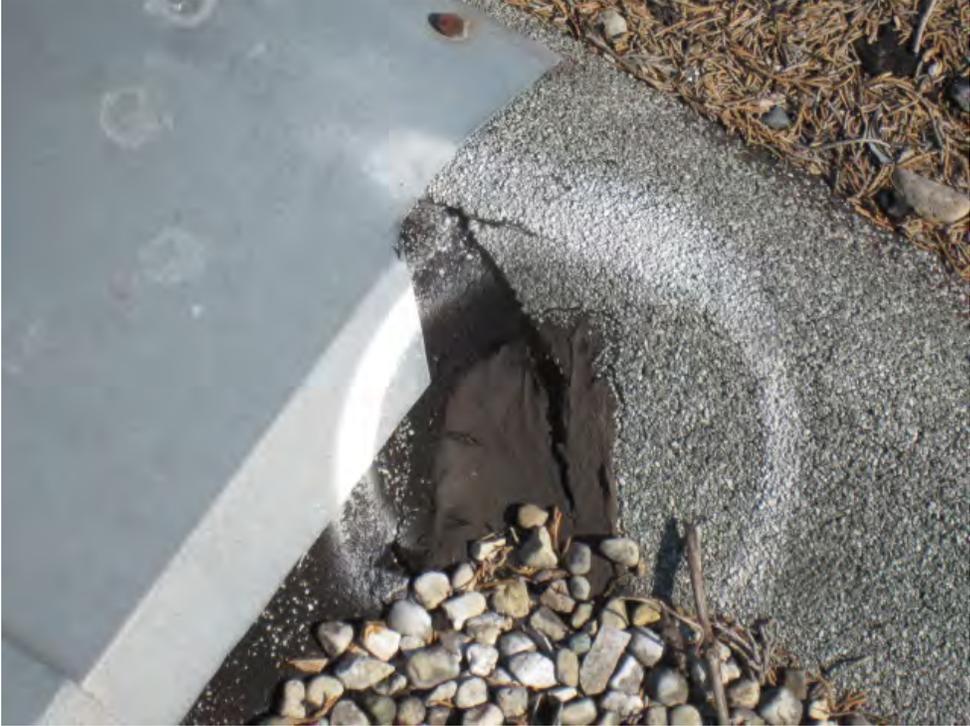
Photograph 29. Split membrane at north section of roof at Summer Place

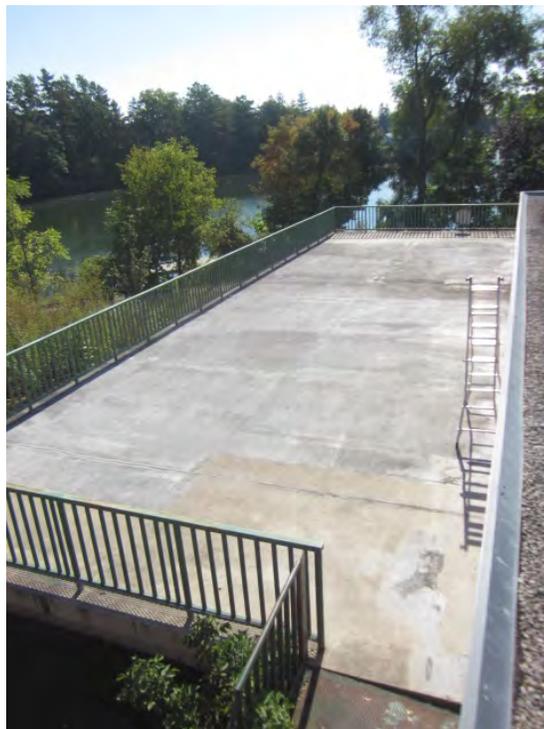
Photograph 34. East roof area above Tillsonburg Rowing Club

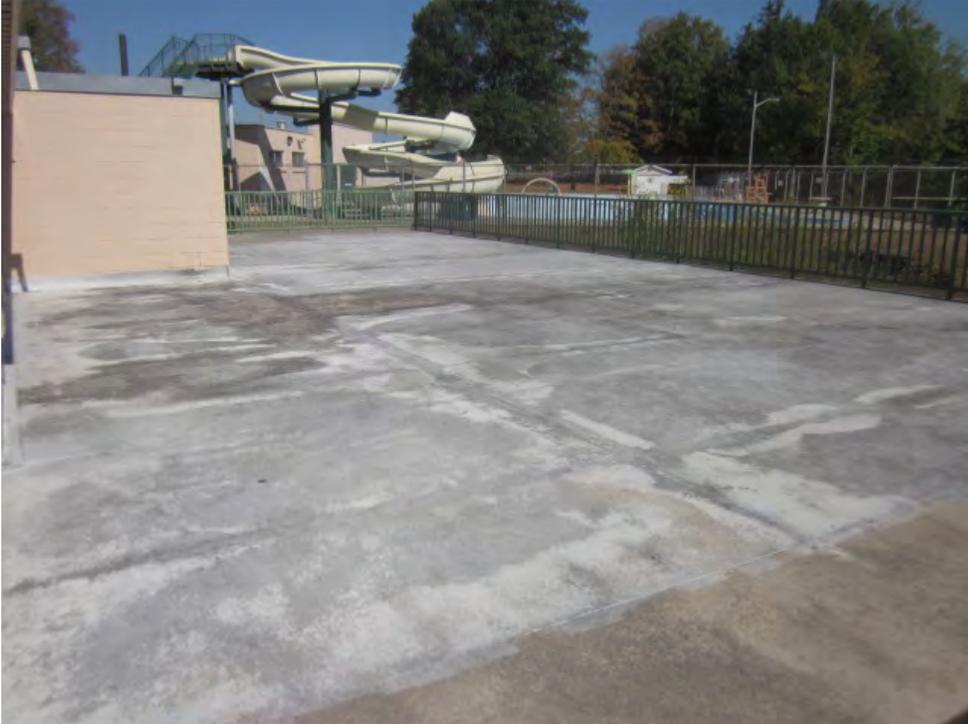
Photograph 35. South roof area above Tillsonburg Rowing Club

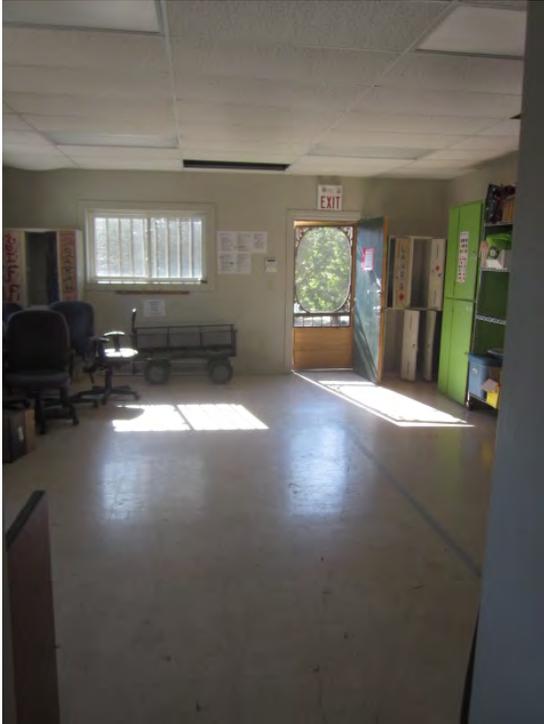
Photograph 42. Typical interior finishes in south section of Summer Place

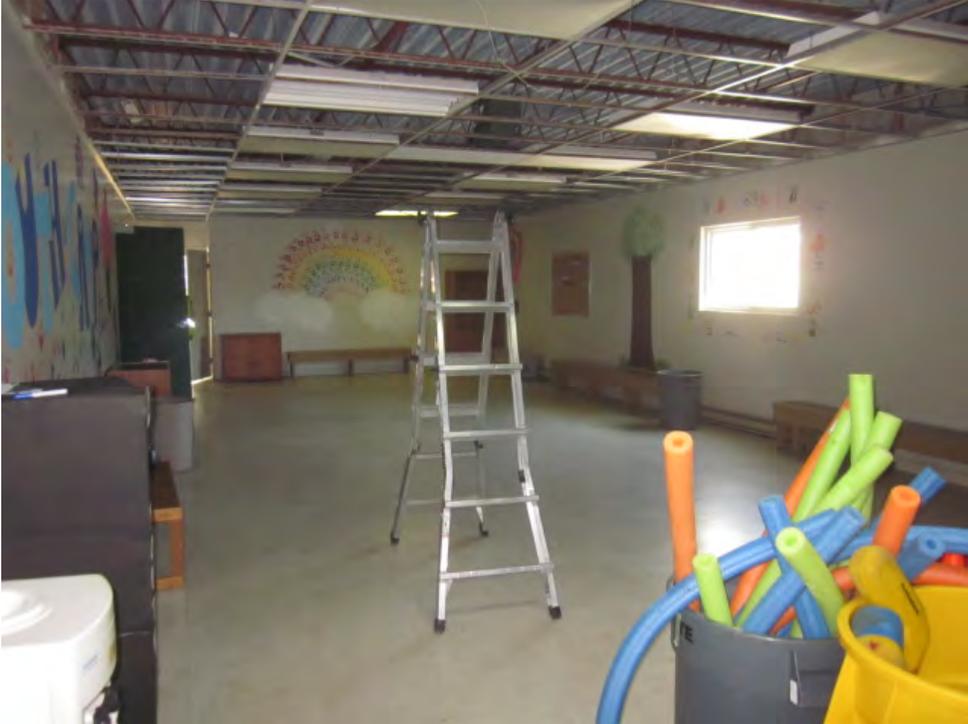
Photograph 43. Typical interior finishes in north section of Summer Place

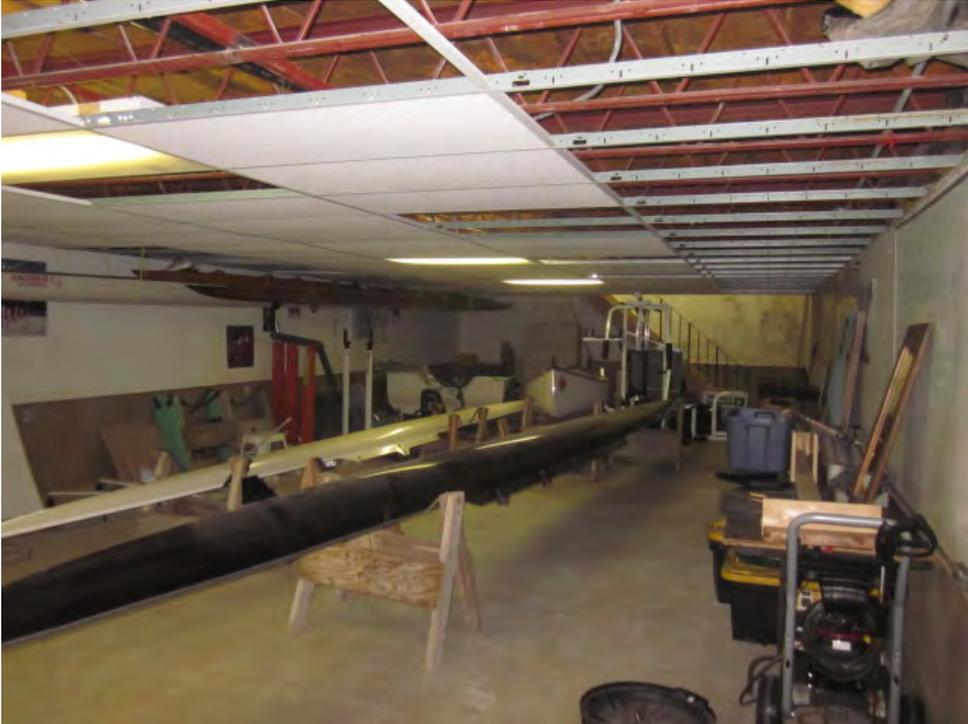
Photograph 44. Typical interior finishes in basement of Summer Place

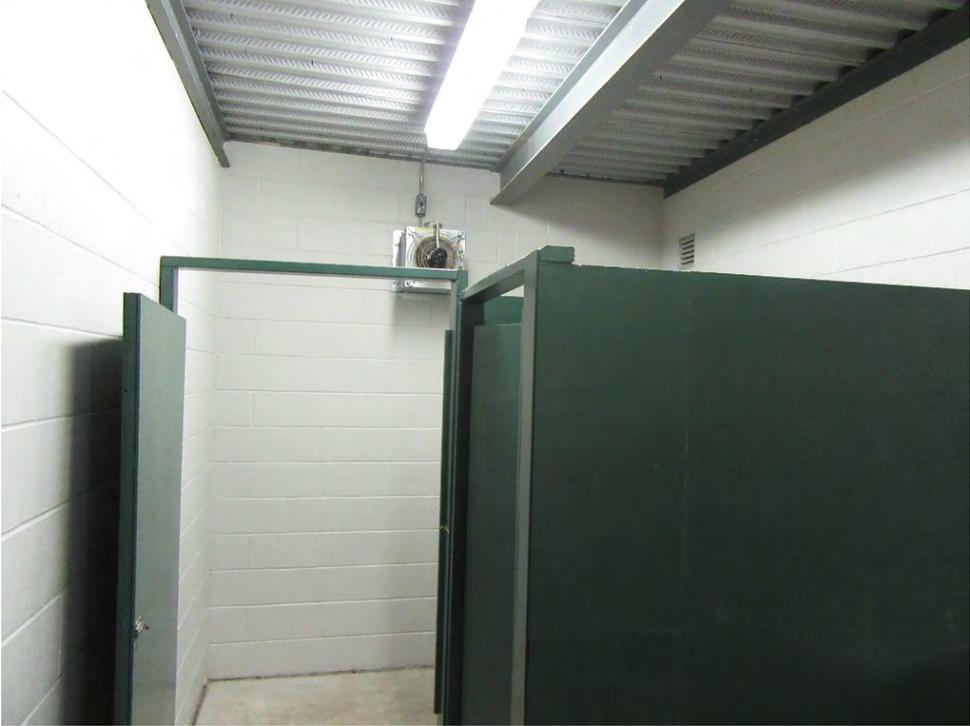
Photograph 45. Washroom exhaust fan in Summer Place

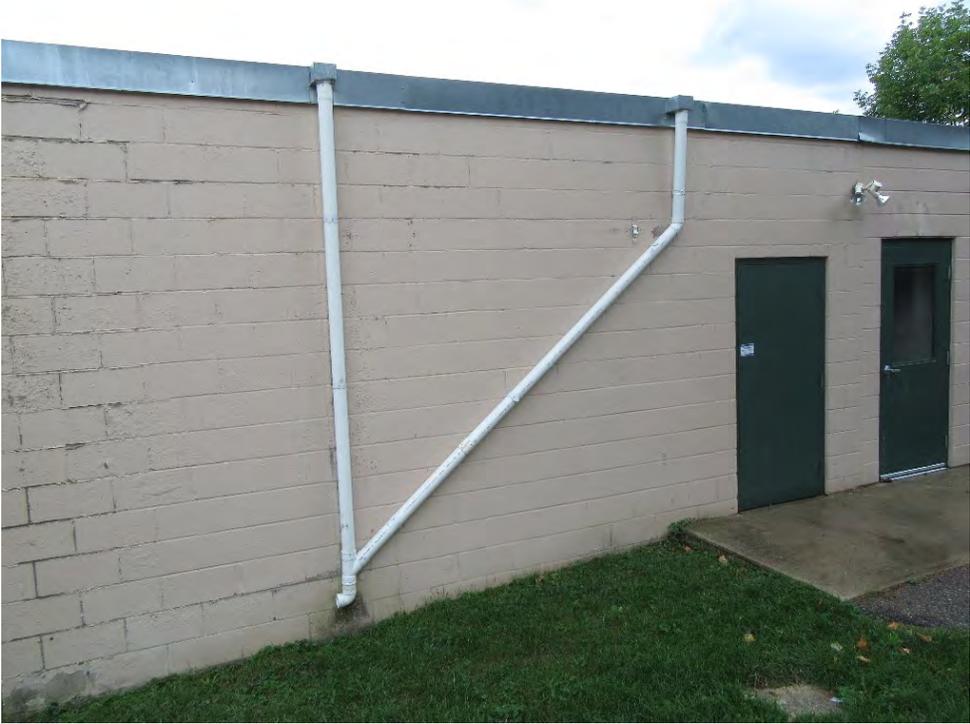
Photograph 46. Roof drainage at Summer Place

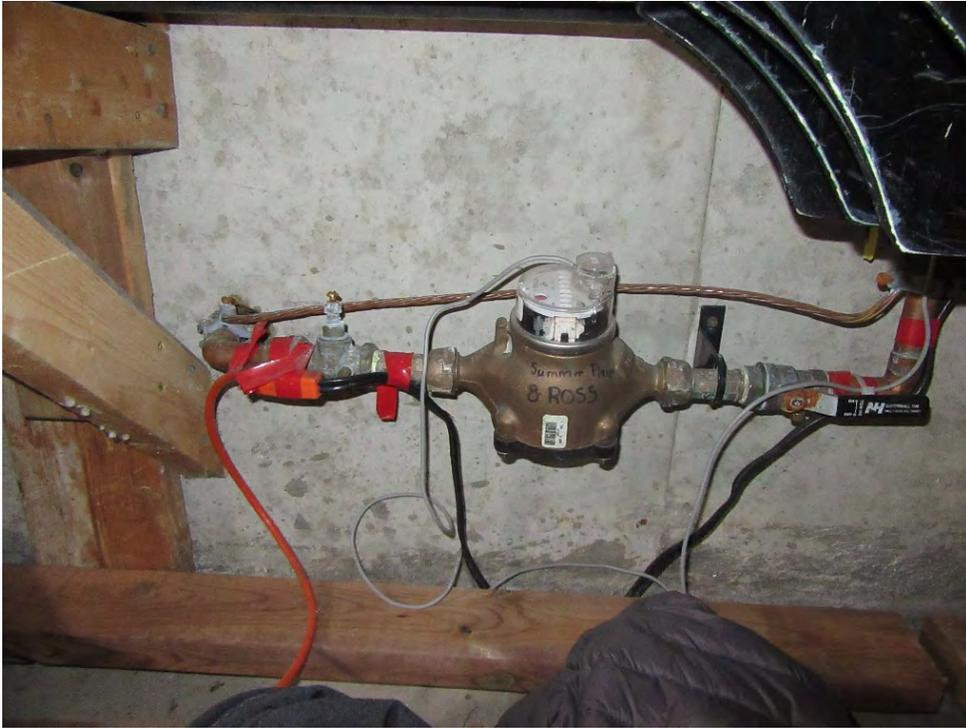
Photograph 47. Domestic water service disconnect at Summer Place

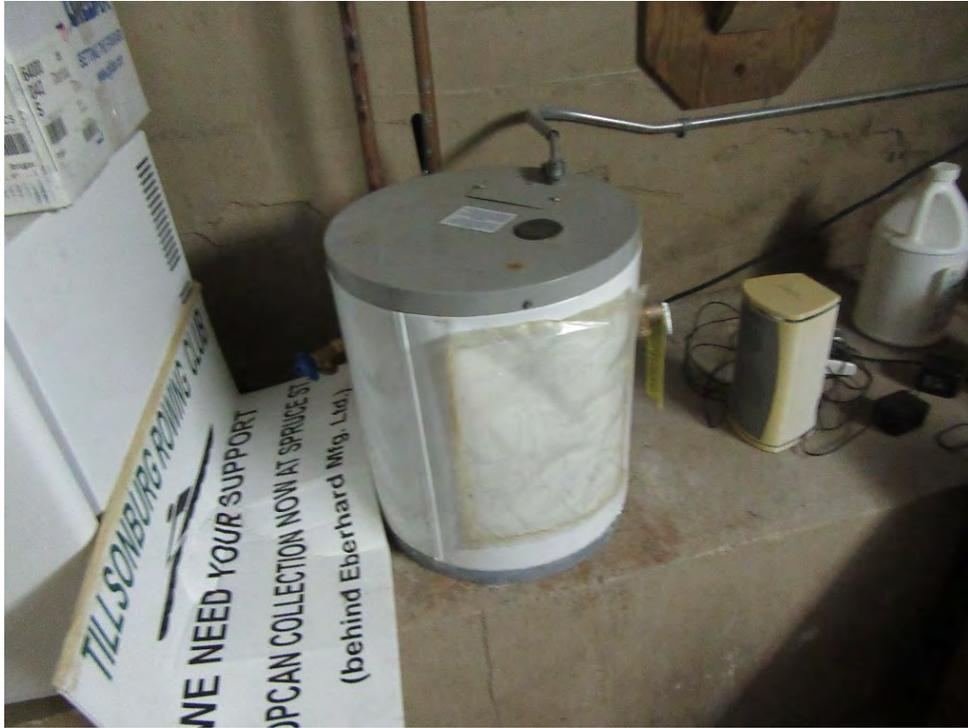
Photograph 49. Domestic water heater at Summer Place

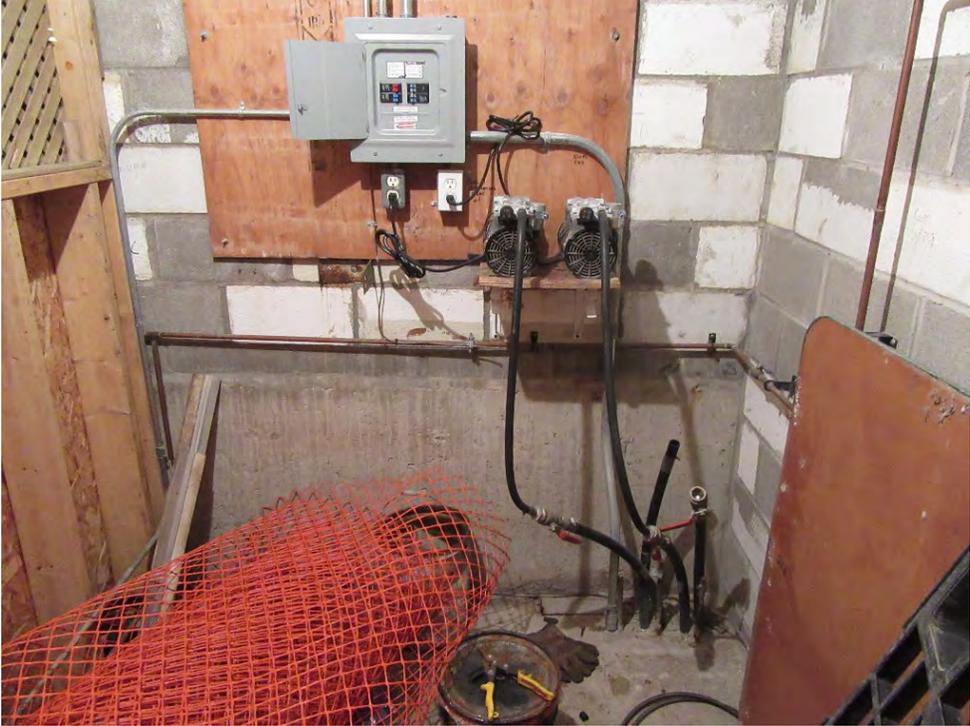
Photograph 51. Lake aeration system equipment at Summer Place

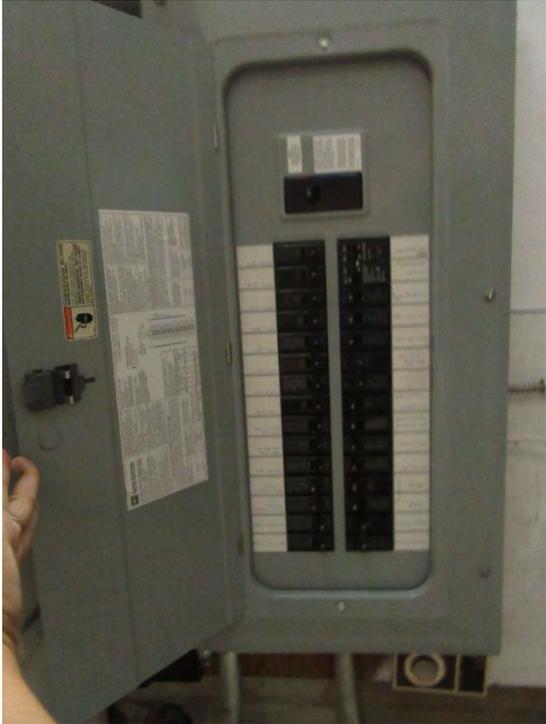
Photograph 52. Main electrical breaker panel at Summer Place

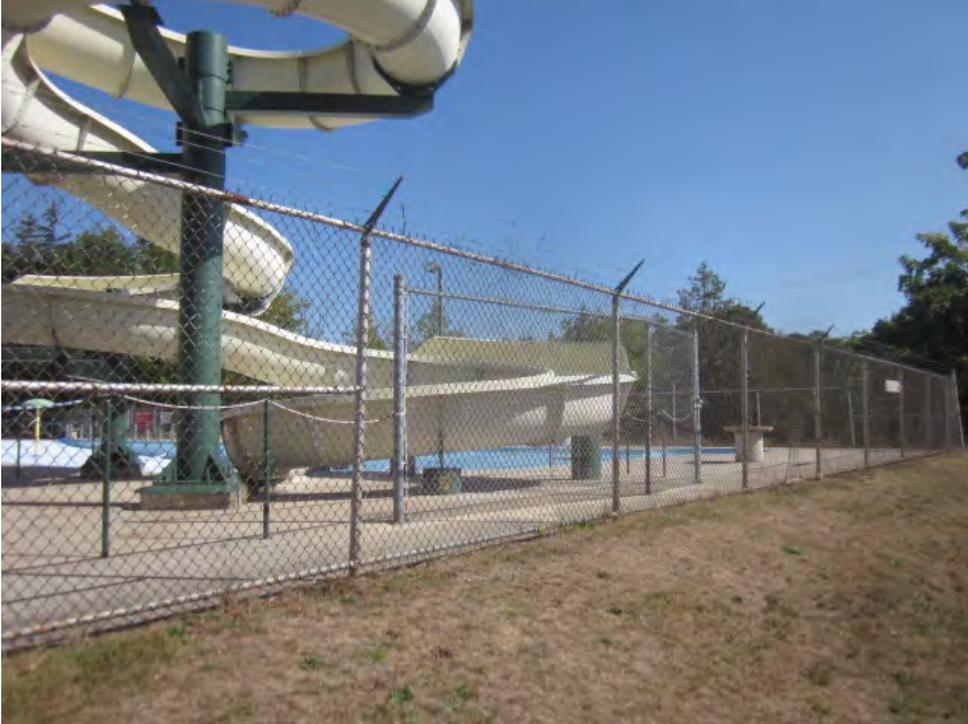
Photograph 53. Perimeter chain link fence at Lake Lisgar Water Park

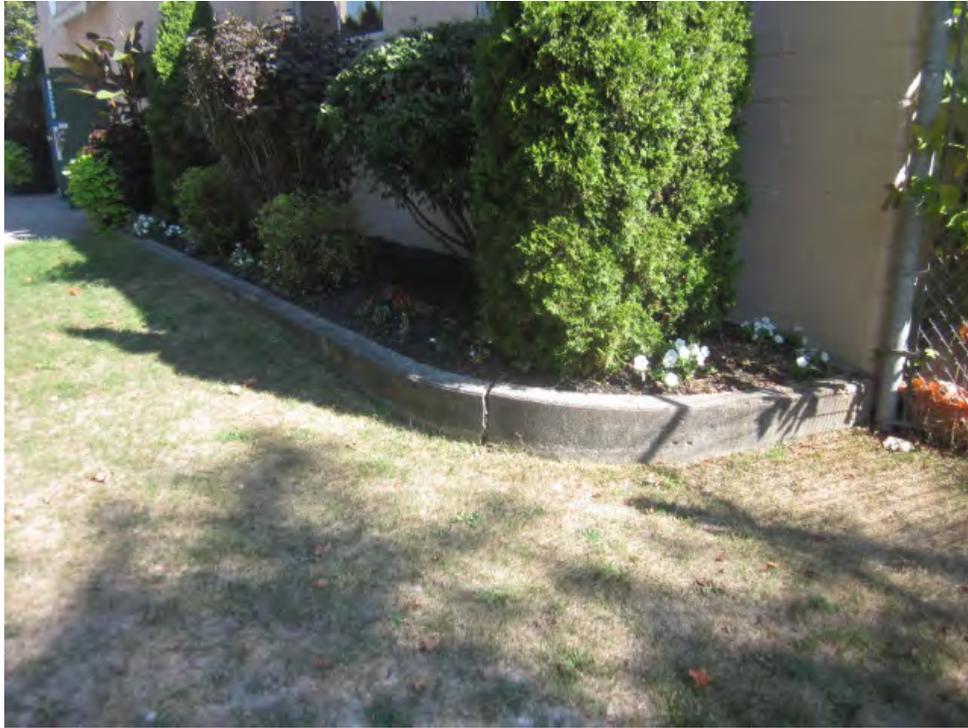
Photograph 55. Concrete curb planter at west side of Lake Lisgar Water Park building

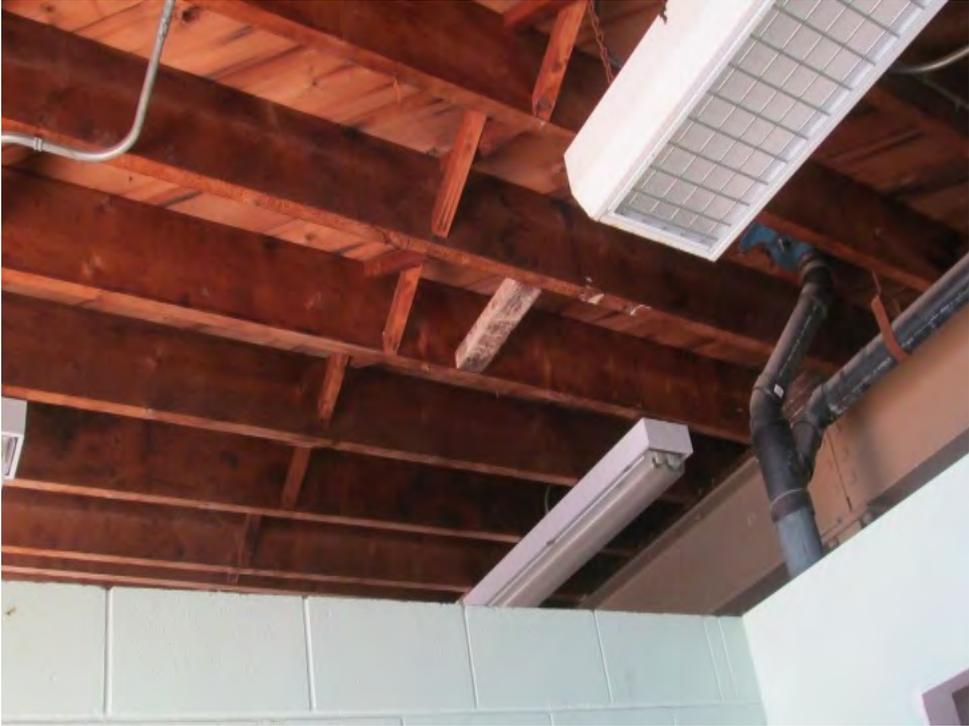
Photograph 61. Typical wood framing in the Lake Lisgar Water Park building

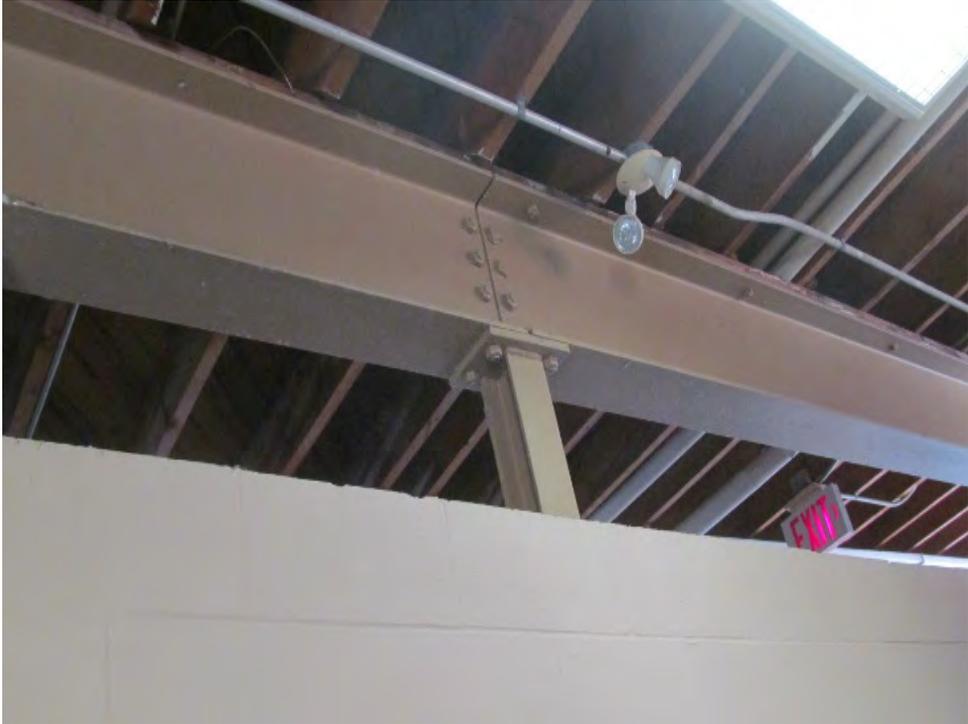
Photograph 63. Steel framing in the Lake Lisgar Water Park building

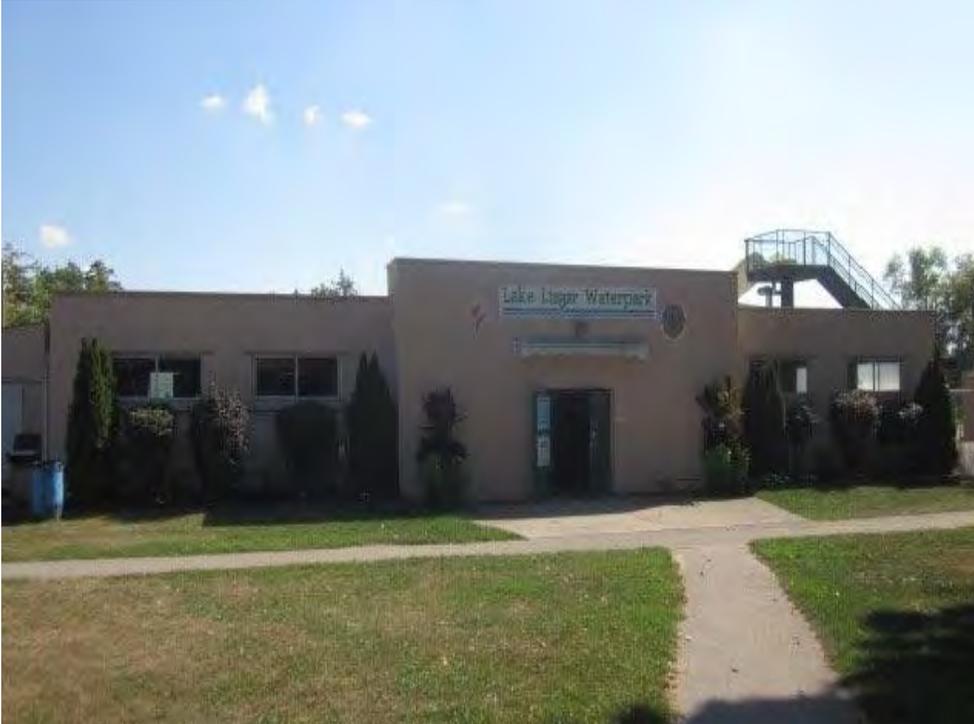
Photograph 67. West elevation of Lake Lisgar Water Park building

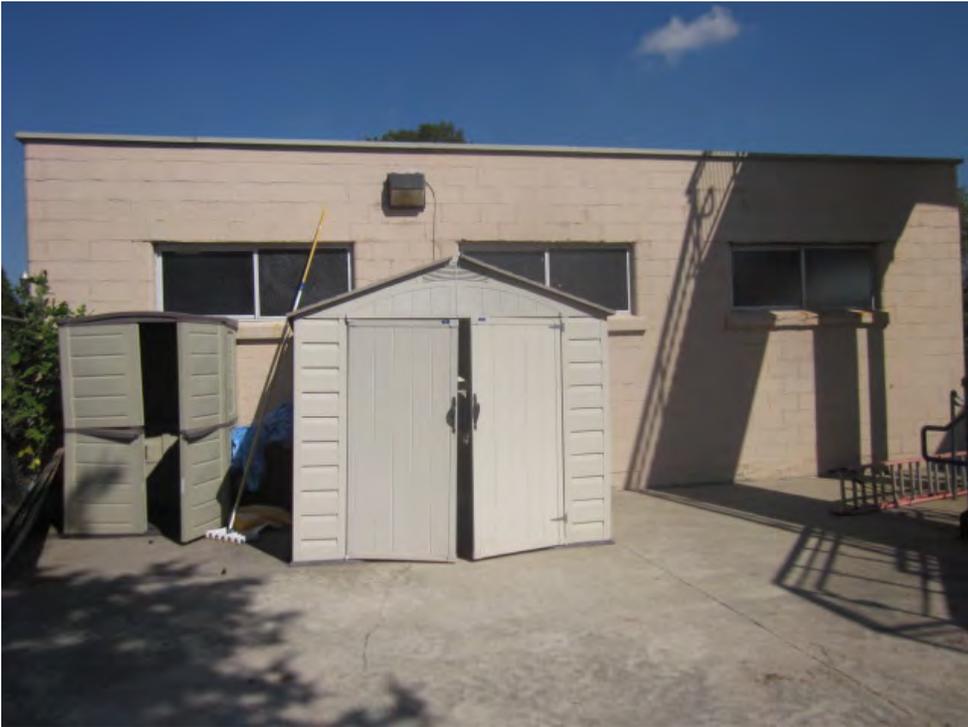
Photograph 68. South elevation of Lake Lisgar Water Park building

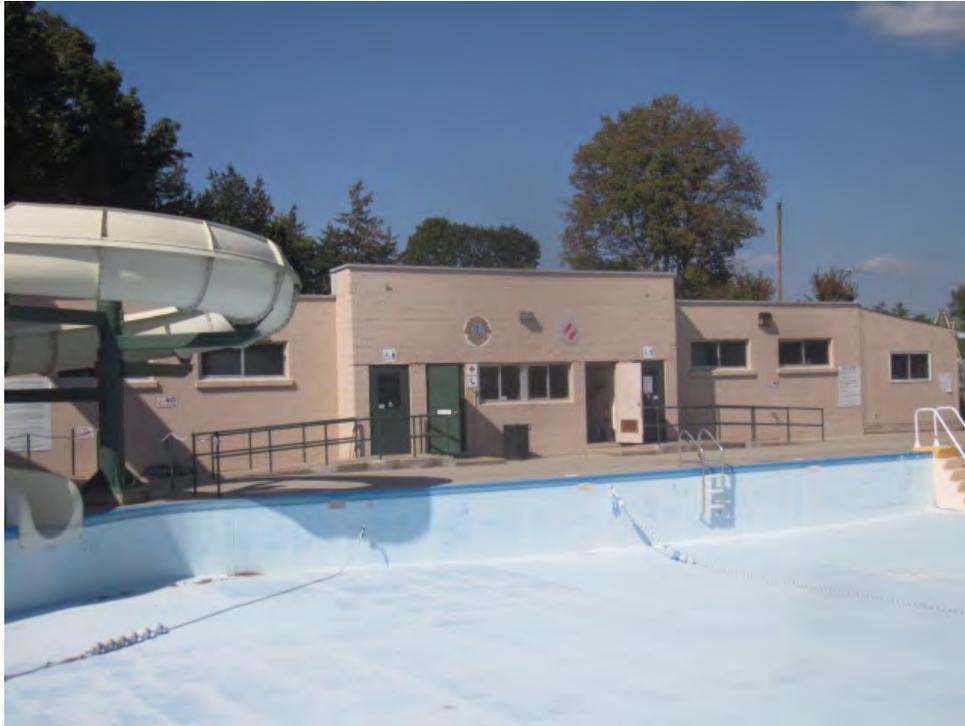
Photograph 69. East elevation of Lake Lisgar Water Park building

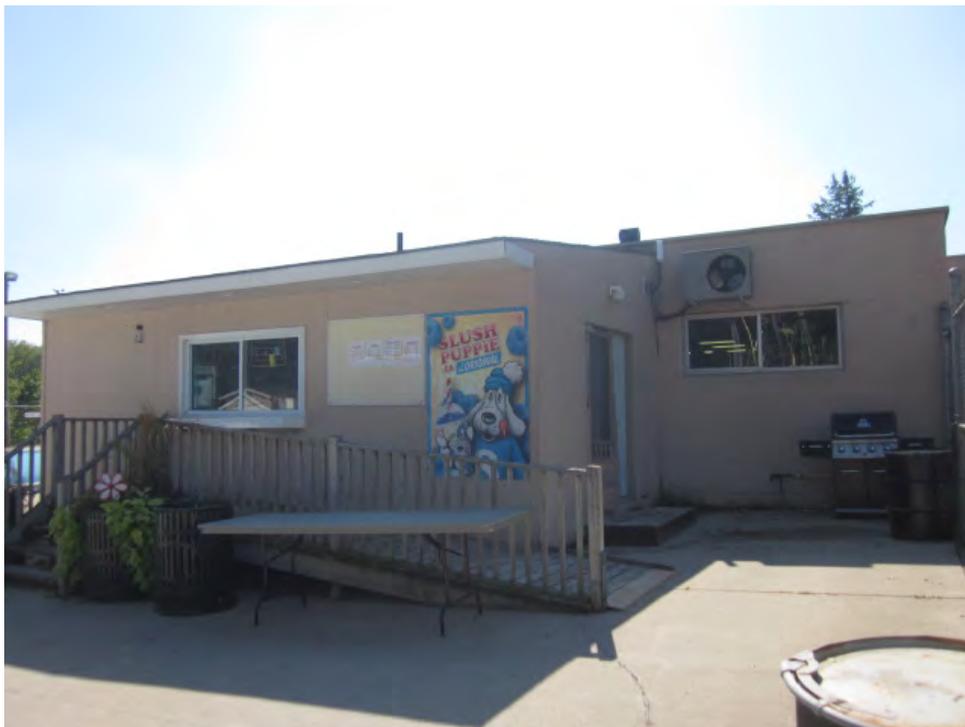
Photograph 70. North elevation of Lake Lisgar Water Park building

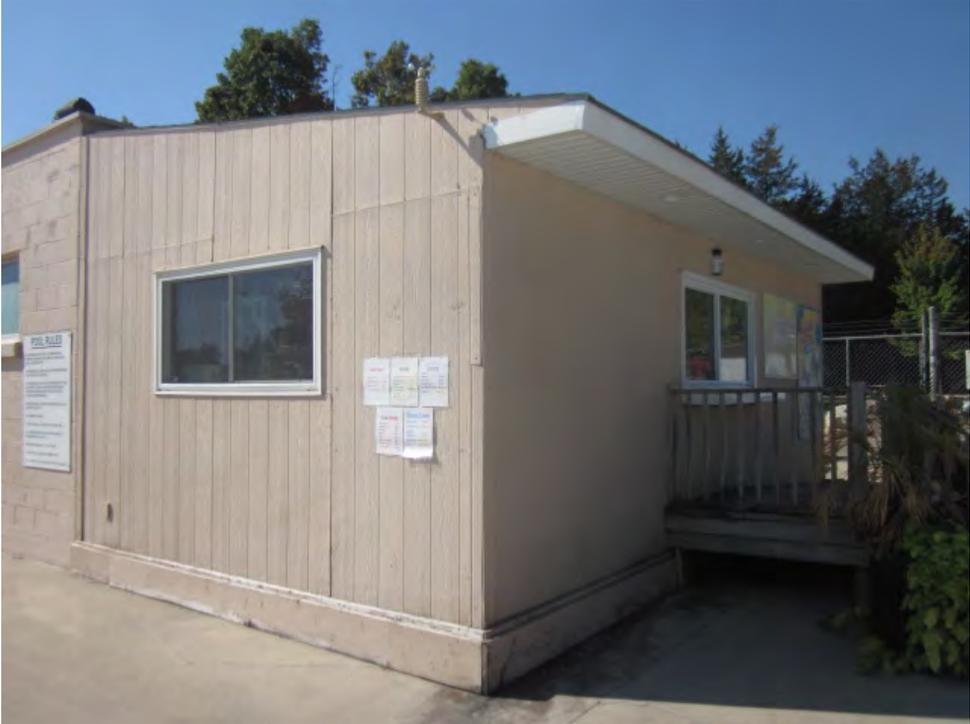
Photograph 71. North east elevation of canteen at Lake Lisgar Water Park building
