# **BUILDING CONDITION ASSESSMENT AND CAPITAL PLANNING STUDY 8 ROSS STREET, TILLSONBURG, ON**

OCTOBER 12, 2017

**LAKE LISGAR WATER PARK  
AND SUMMER PLACE  
8 ROSS STREET  
TILLSONBURG, ON**

**TOWN OF TILLSONBURG**

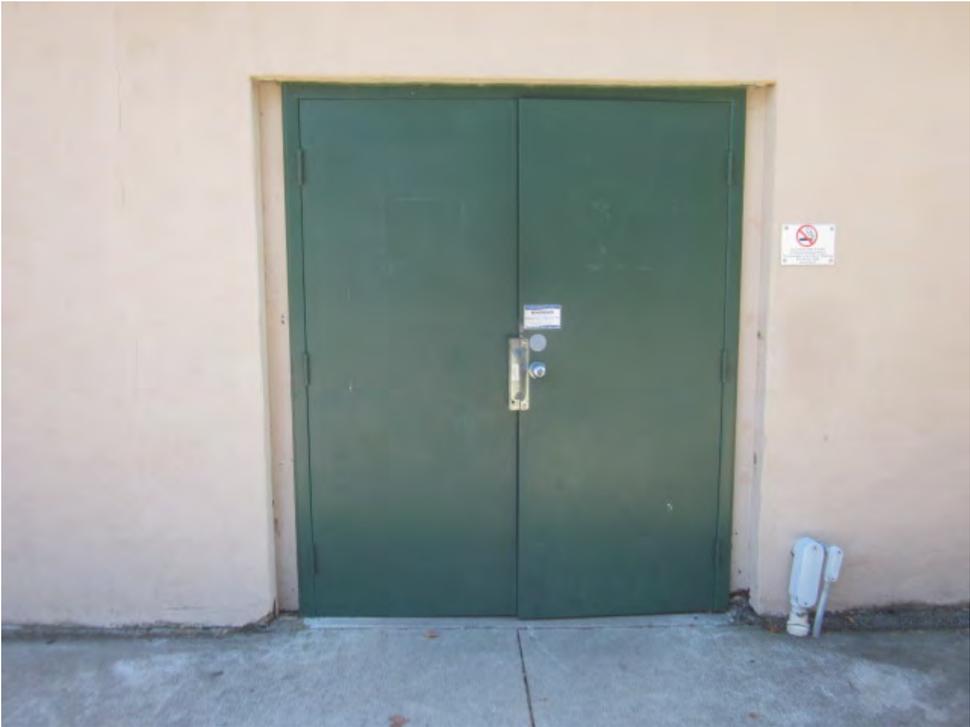
Photograph 78. Entrance doors to Lake Lisgar Water Park building

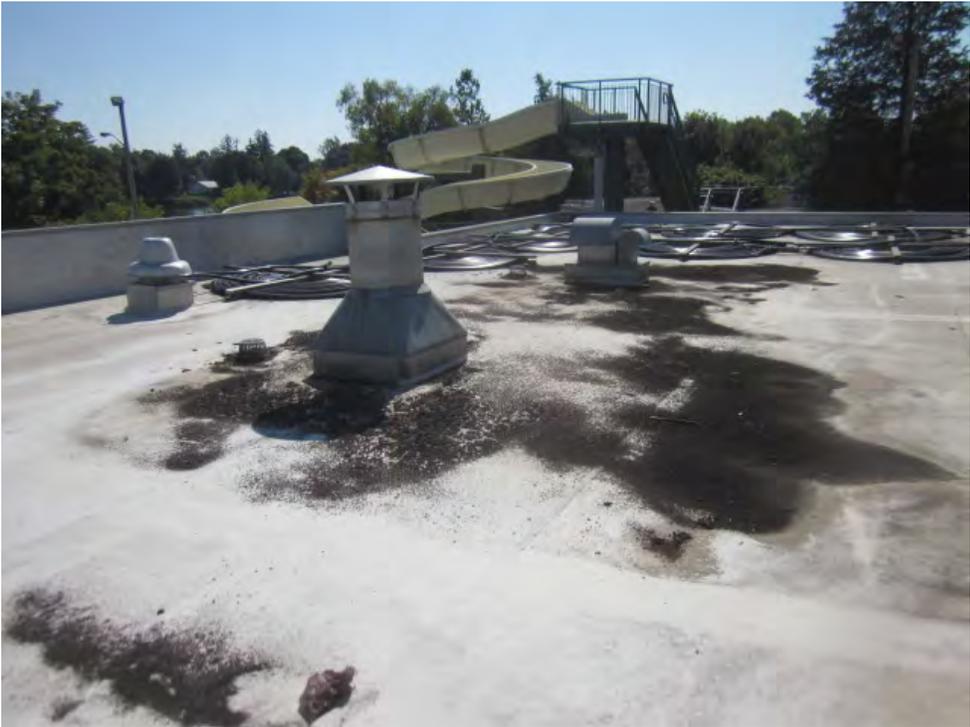
Photograph 80. General view of roof at Lake Lisgar Water Park building

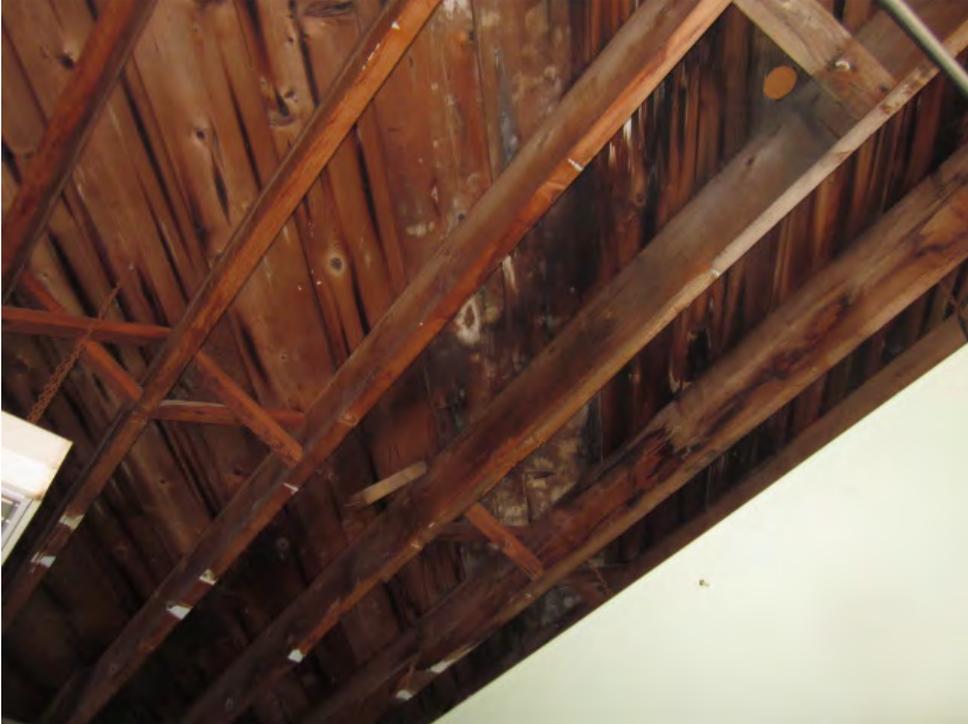
Photograph 81. Evidence of water penetration on soffit of roof deck at Lake Lisgar Water Park building

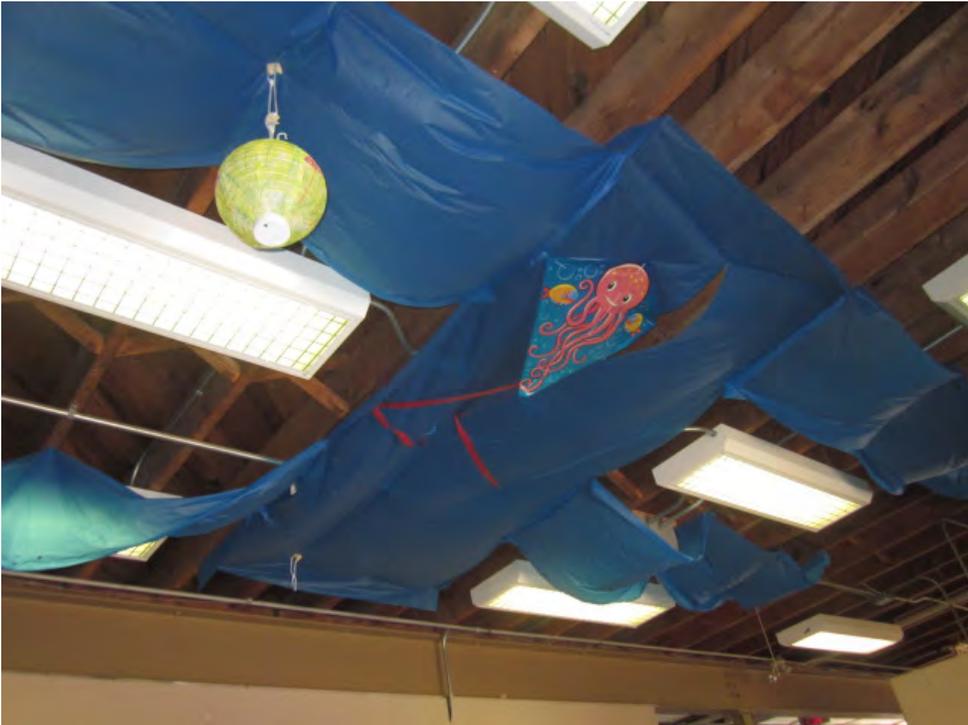
Photograph 82. Evidence of water penetration on soffit of roof deck at Lake Lisgar Water Park building

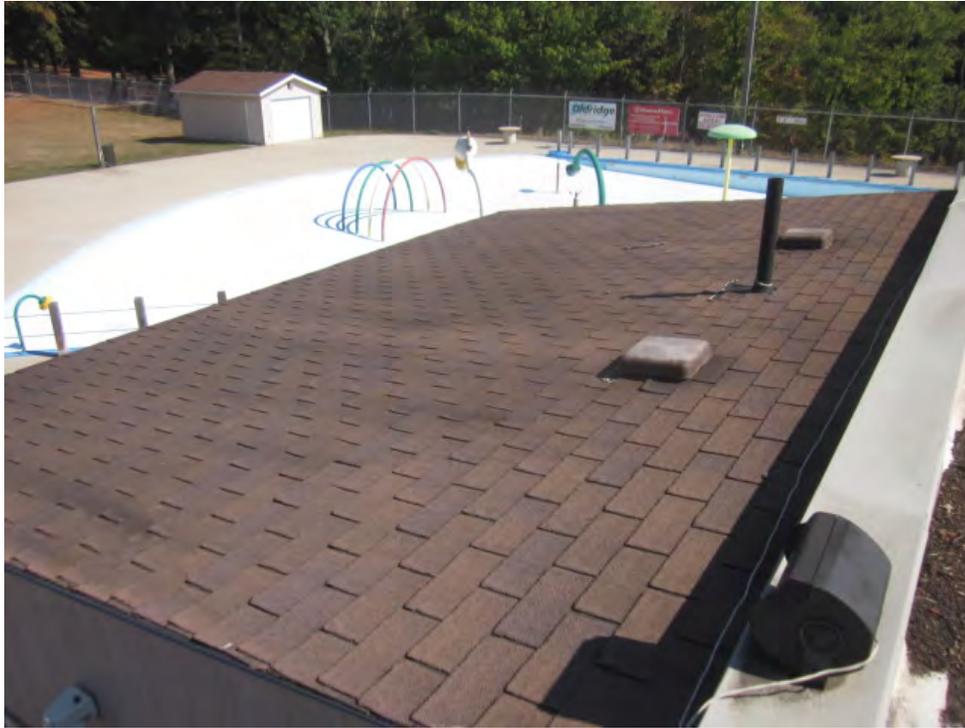
Photograph 83. General view of roof over canteen at Lake Lisgar Water Park building

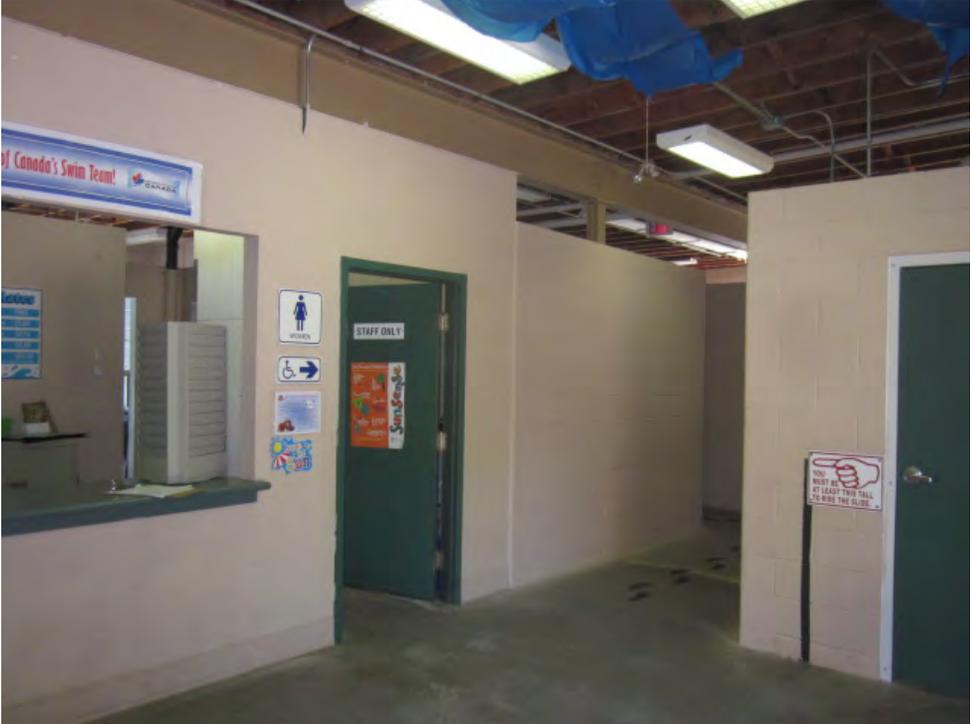
Photograph 85. Typical interior finishes in vestibule of Lake Lisgar Water Park building

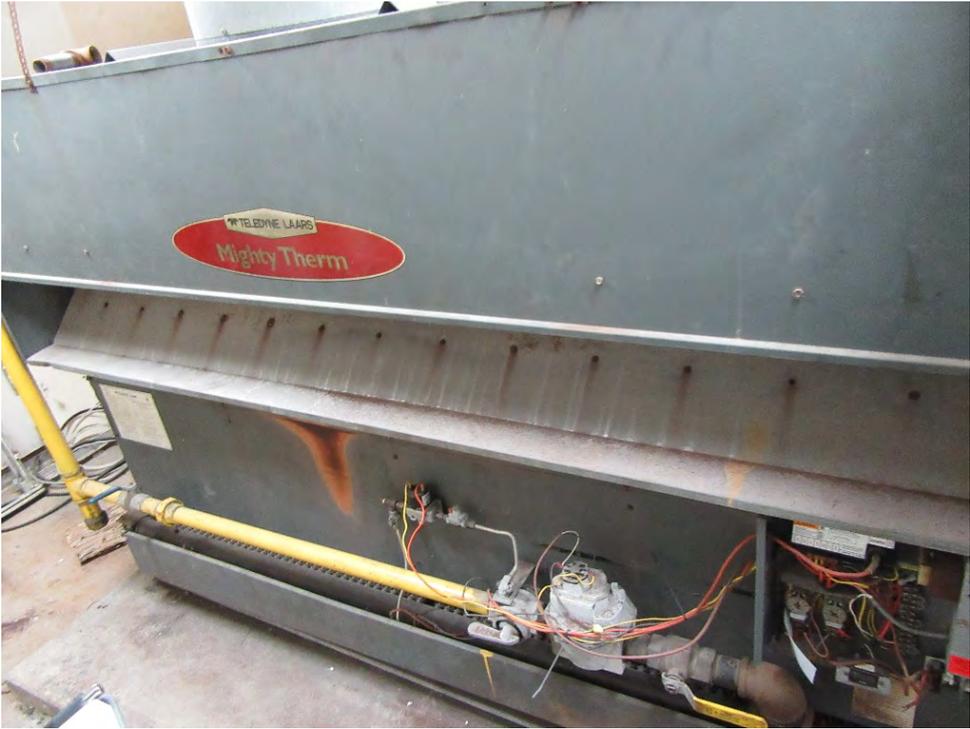
Photograph 86. Heating boilers at Lake Lisgar Water Park

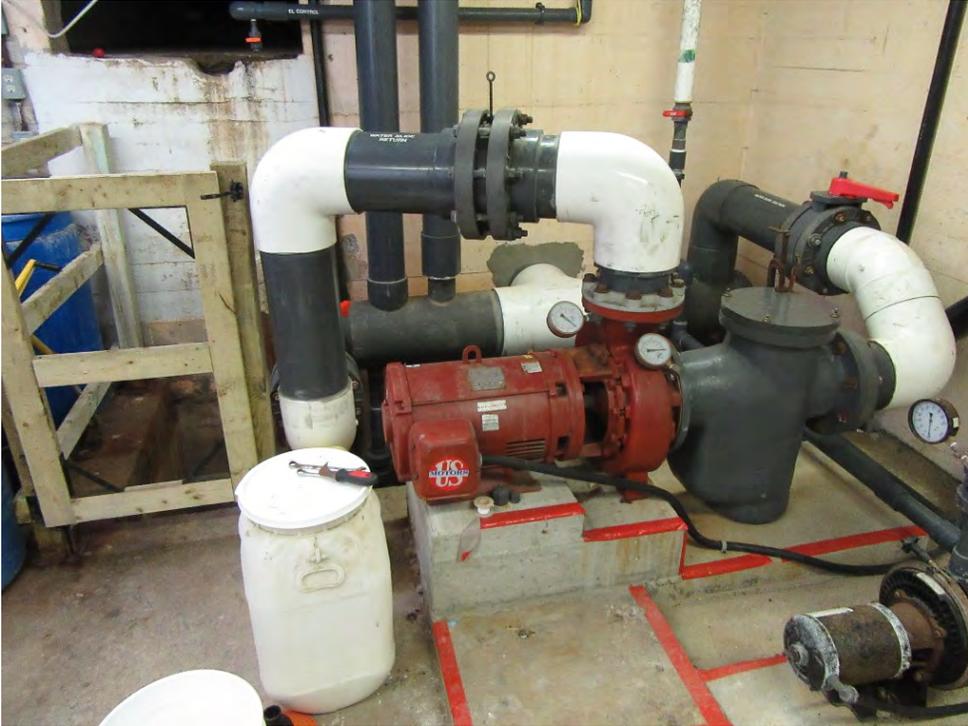
Photograph 87. Pool circulation pump at Lake Lisgar Water Park

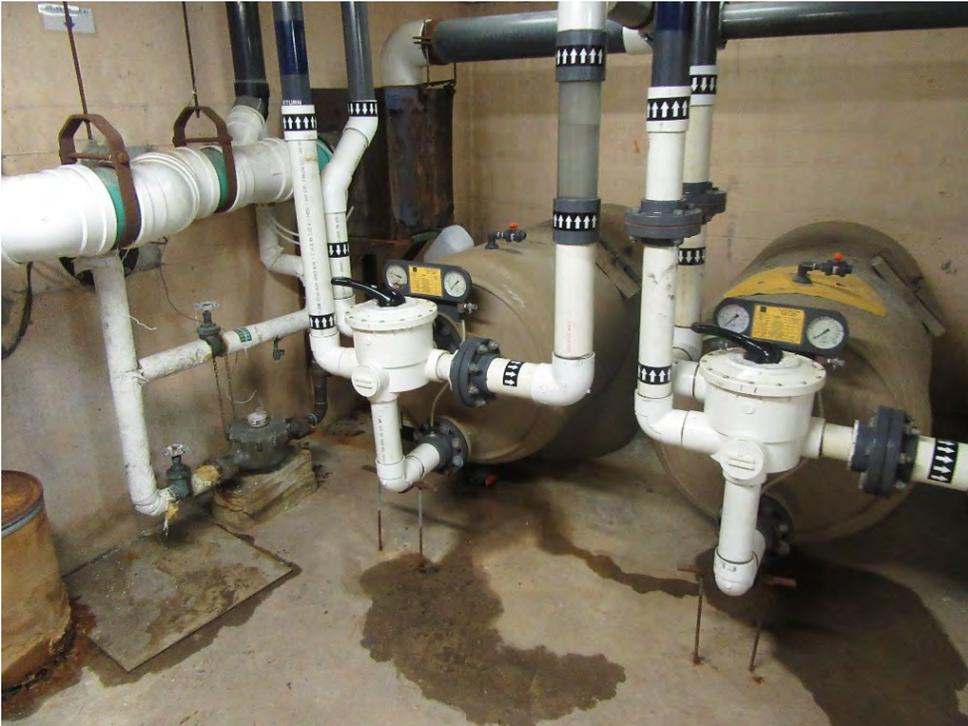
Photograph 88. Pool filtration equipment at Lake Lisgar Water Park

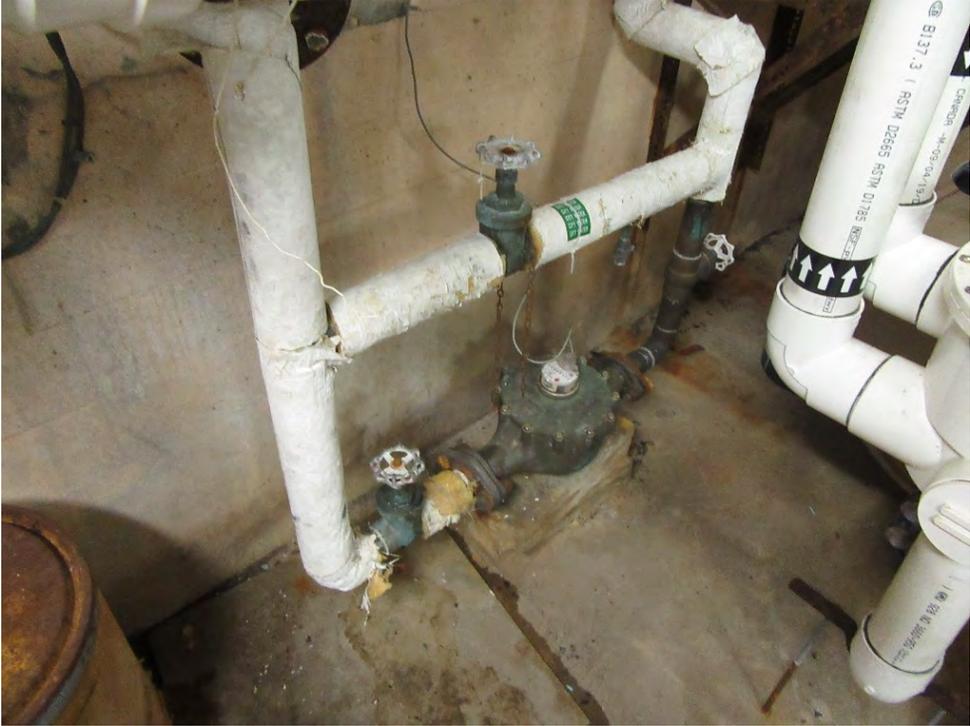
Photograph 89. Domestic water service at Lake Lisgar Water Park

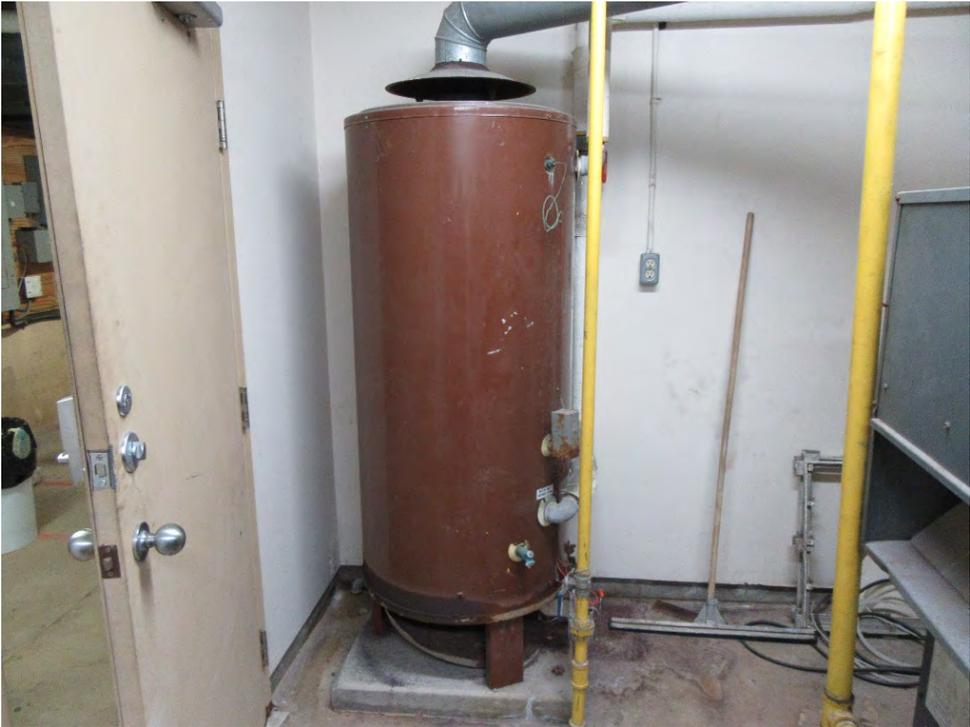
Photograph 90. Domestic hot water heater at Lake Lisgar Water Park

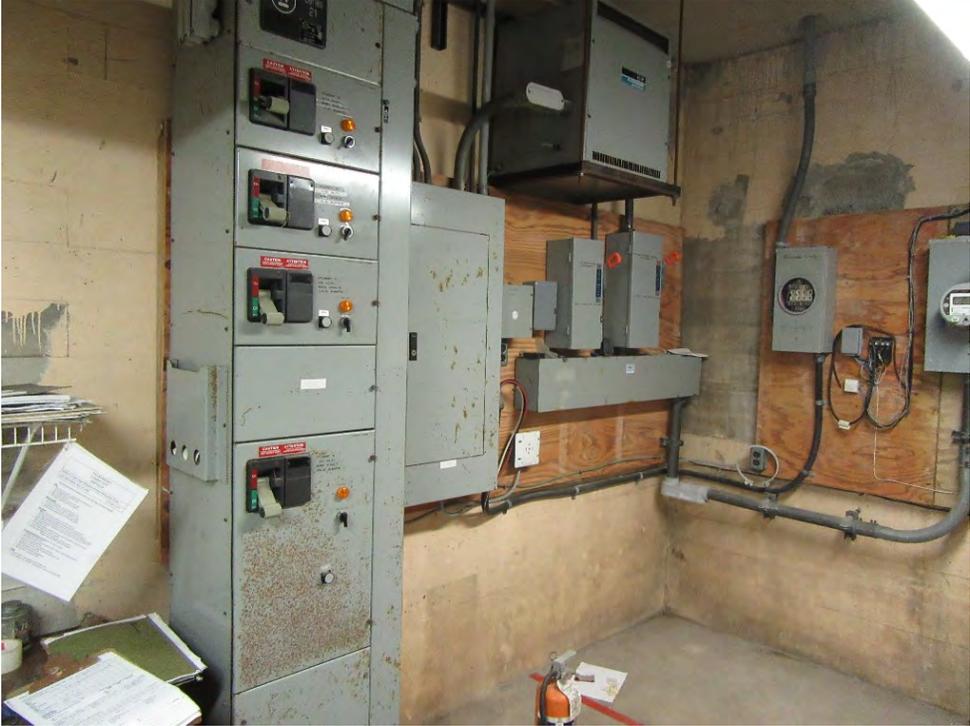
Photograph 91. Electrical distribution equipment at Lake Lisgar Water Park

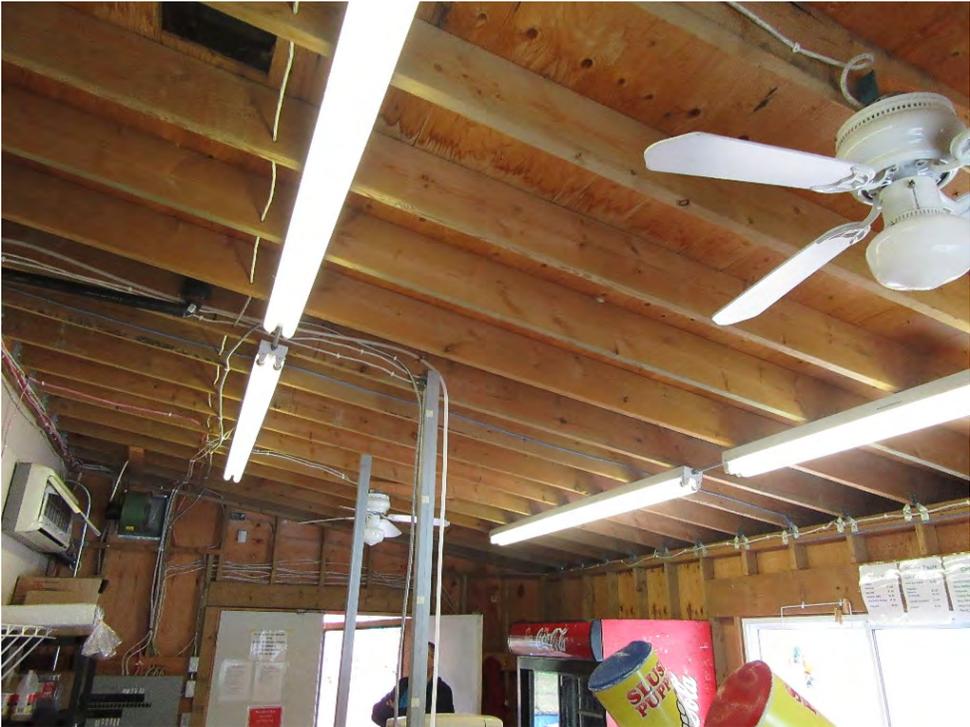
Photograph 92. Interior lighting at Lake Lisgar Water Park

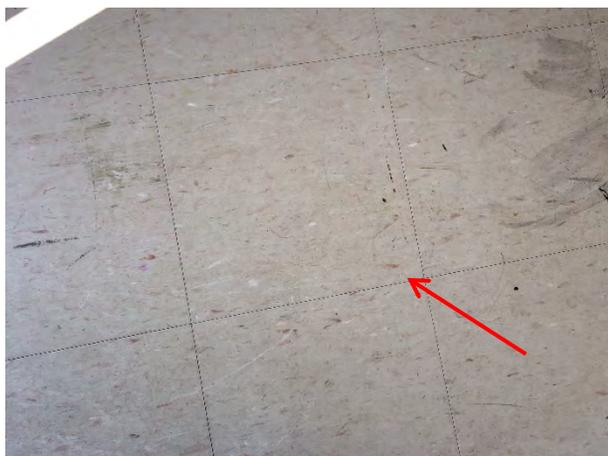
Photo #1: 12"x12" beige vinyl floor tiles with red and white blots within the employee area and top of stairs to basement.

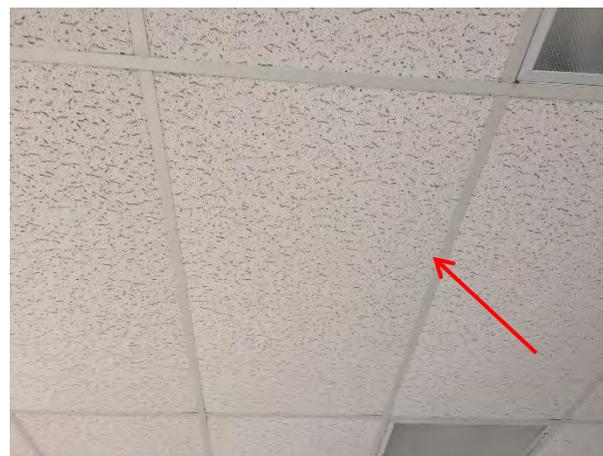
Photo #2: 2'x4' acoustic ceiling tiles long length wise fissures with pinpricks within the employee area.

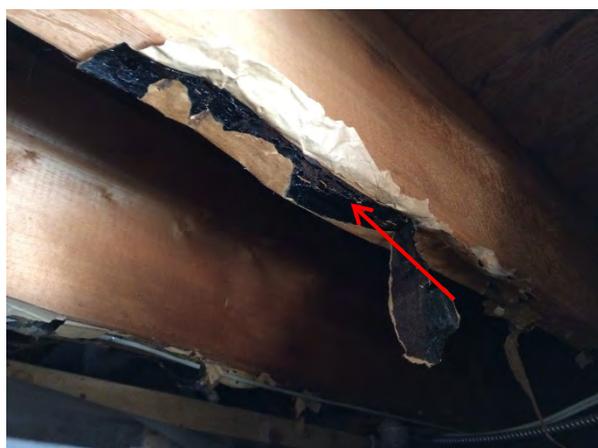
Photo #3: Black tar on residual insulation paper within the employee area.

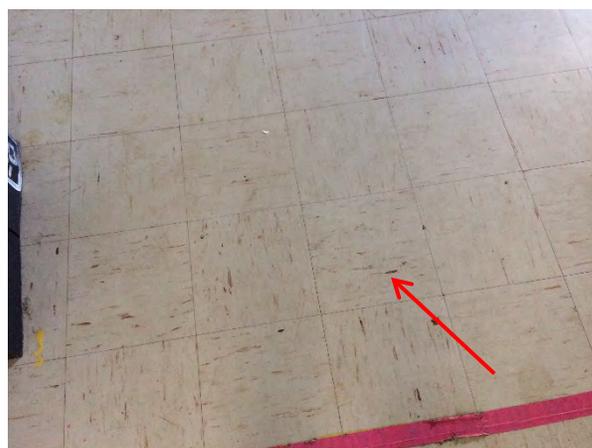
Photo #4: 12"x12" off-white vinyl floor tile with maroon and brown streaks within the youth camp area.

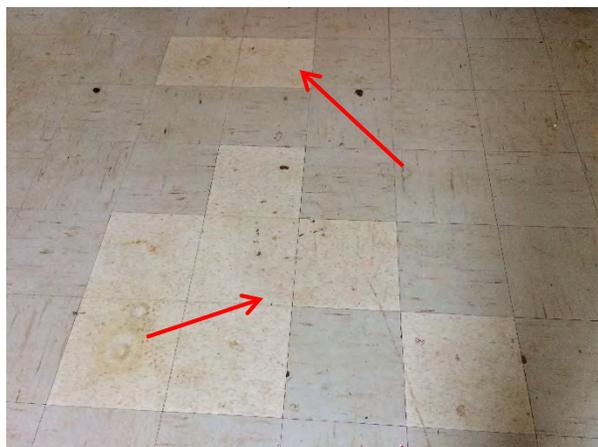
Photo #5: 12"x12" off-white vinyl floor tile with grey blots within the youth camp area.

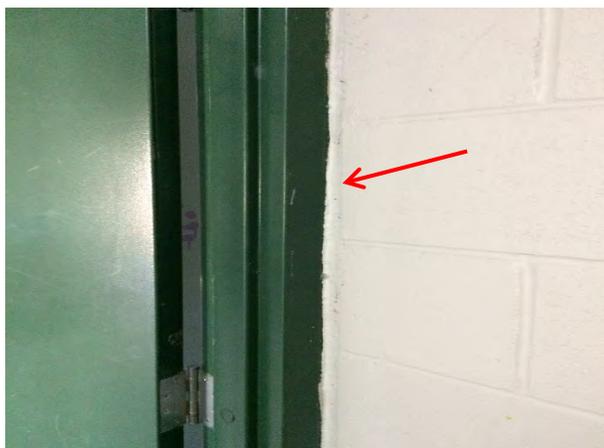
Photo #7: Caulking around door to washroom area on main floor

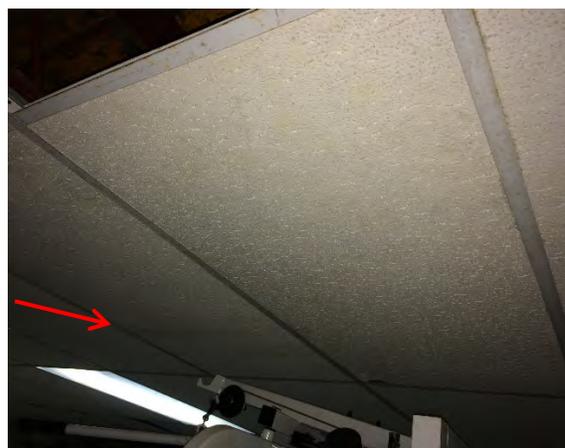
Photo #8: 2'x4' acoustic ceiling tiles with length wise fissures with pinpricks in the stairwell to the basement and the basement

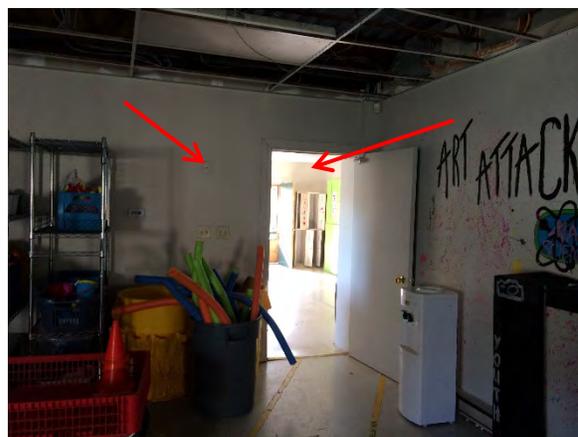
Photo #10 Drywall joint compound on walls throughout the building..

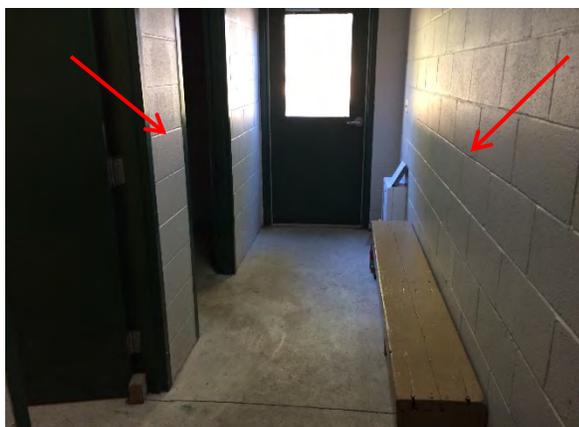
Photo #11: ACM vermiculite may exist within, as well as mortar between the concrete blocks throughout the building.

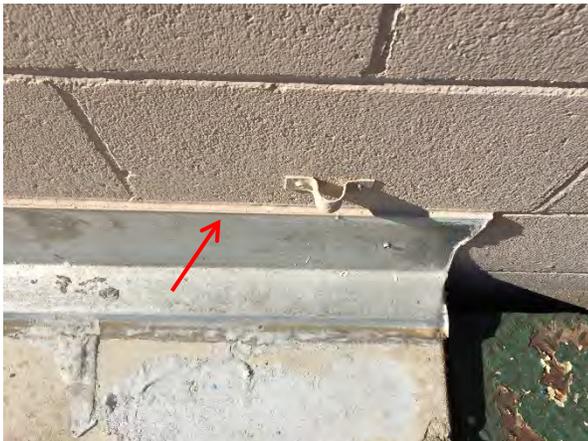
Photo #13: Caulking along flashing on the concrete rowing club roof.

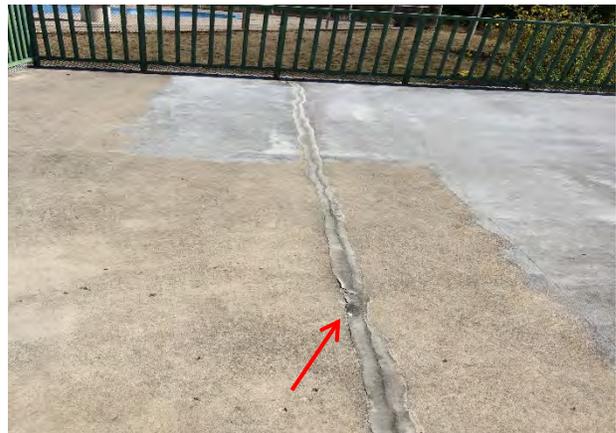
Photo #14: Sealant between concrete pads on the concrete rowing club roof.

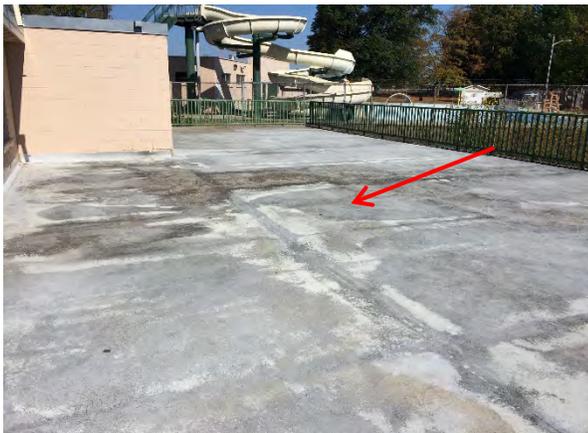
Photo #15: Sealant over concrete pads on the concrete rowing club roof.

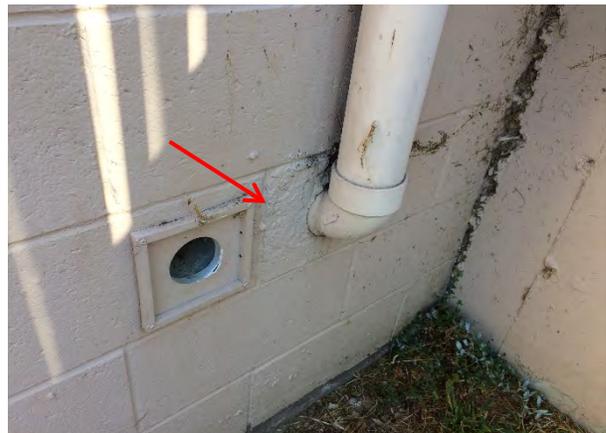
Photo #16: Cementitious parging around wall penetration on the exterior of the building.

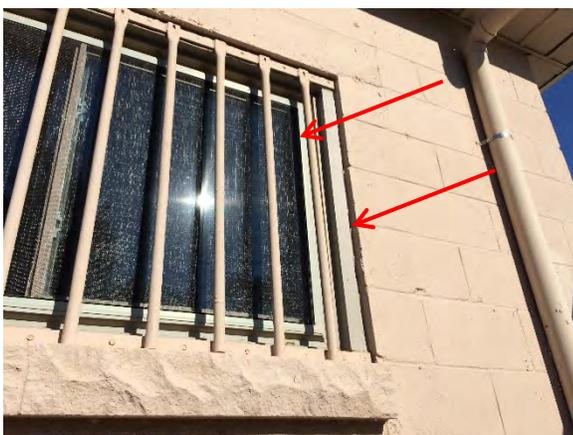
Photo #17: Window caulking around exterior window frames of the building.

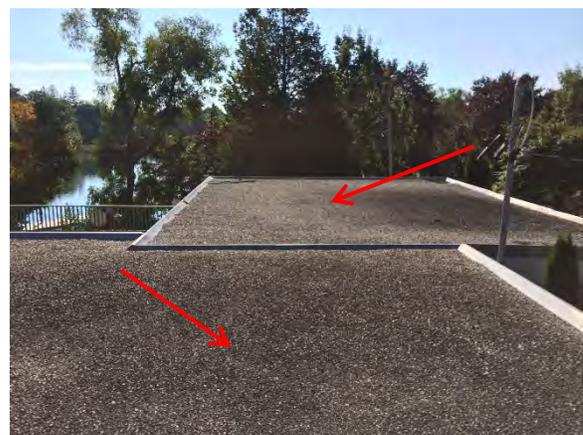
Photo #18: Built up roofing system observed on the roof of the building.

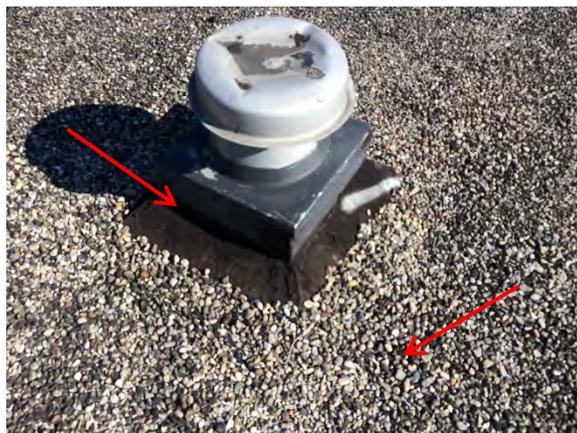
Photo #19: Tar coating on roof vents.

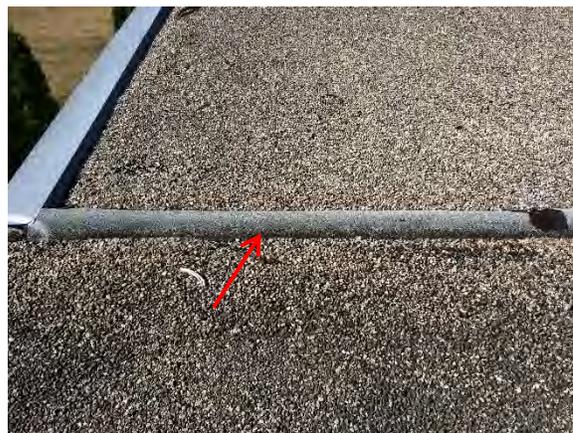
Photo #20: Roofing shingles observed on roofing seam.

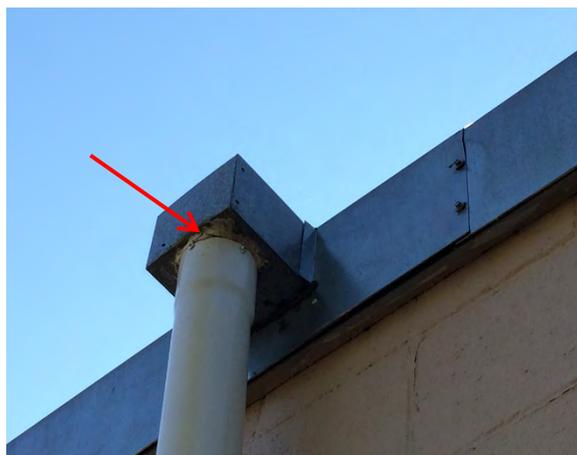
Photo #21: Caulking observed around roof drains on the exterior of the building.

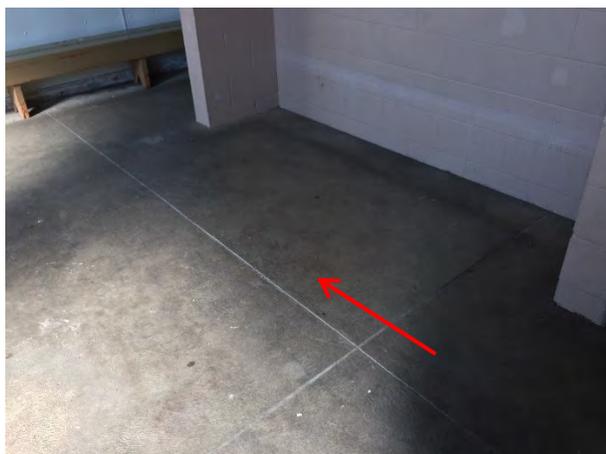
Photo #1: Textured sealant over concrete flooring within the men and woman's changerooms.

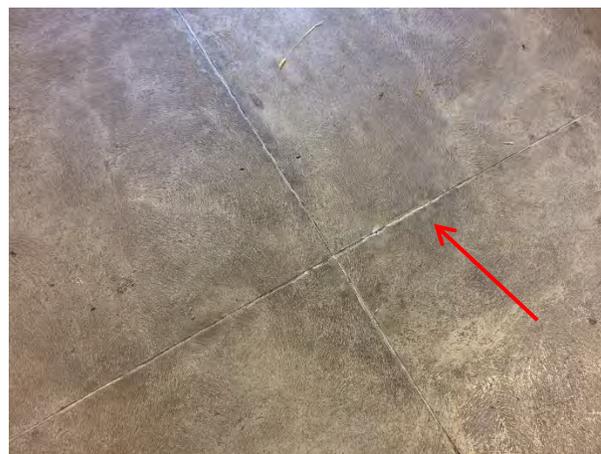
Photo #2: Sealant between concrete within the men and woman's changerooms.

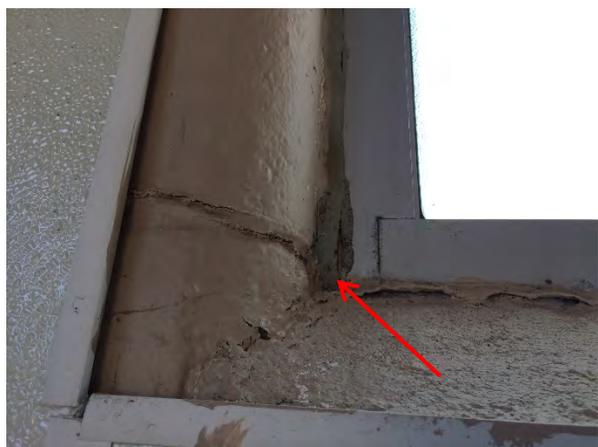
Photo #3: Window caulking observed around interior window frames throughout the building.

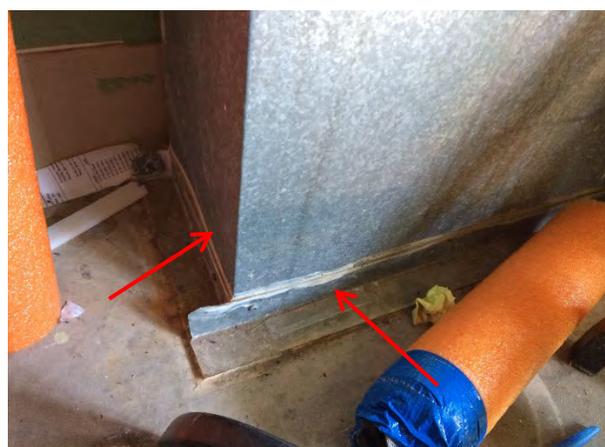
Photo #4: Sealant on ductwork in the office area.

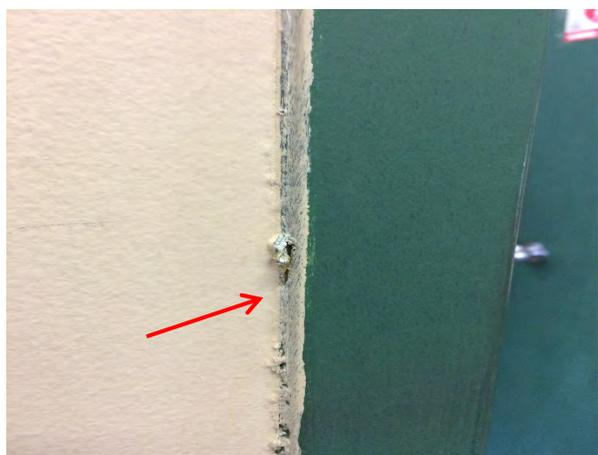
Photo #5: Caulking around interior door frames throughout the building.

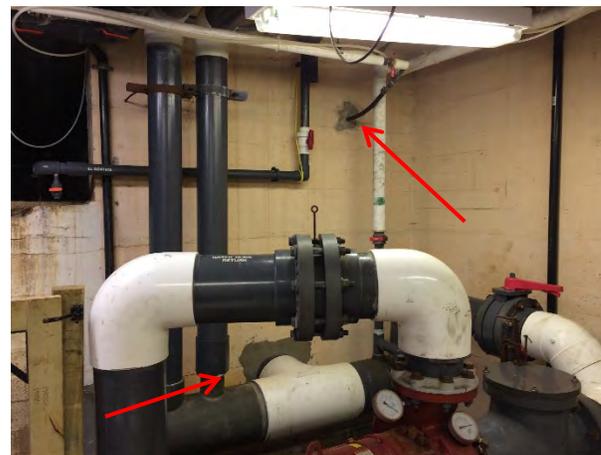
Photo #6: Cementitious parging around wall penetrations

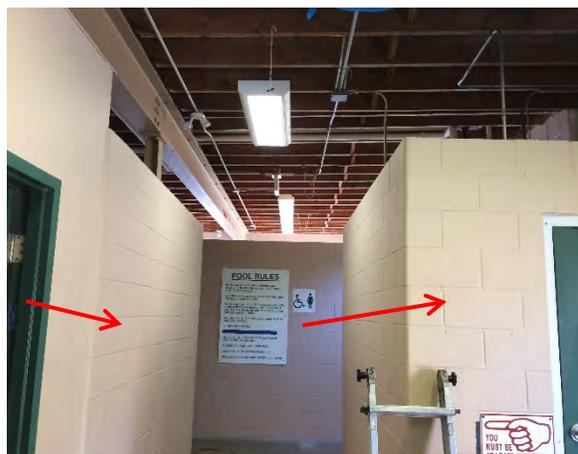
Photo #8: ACM vermiculite may exist within, as well as mortar between the concrete blocks throughout the building.

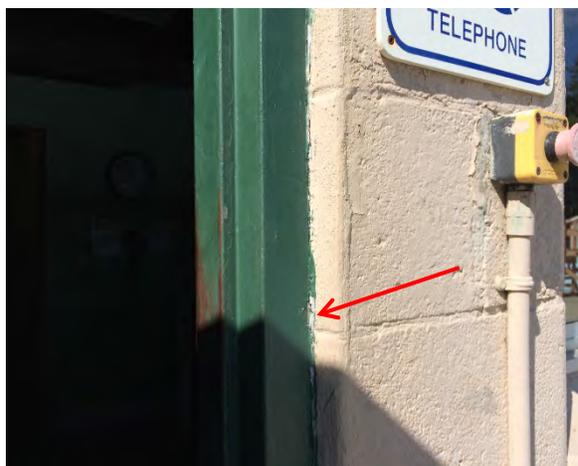
Photo #9: Fire doors throughout the building may contain ACM insulation.

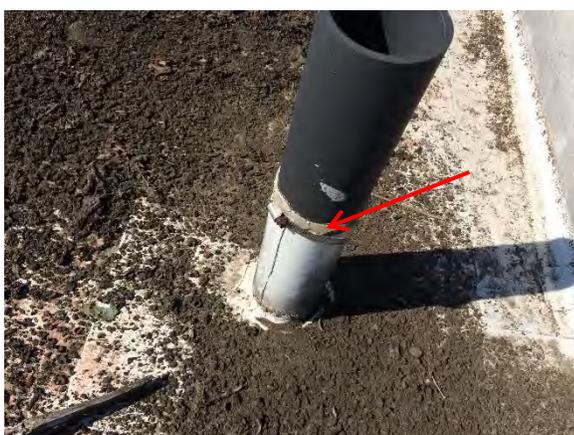
Photo #16: Caulking on the seams of the main building roof flashing.

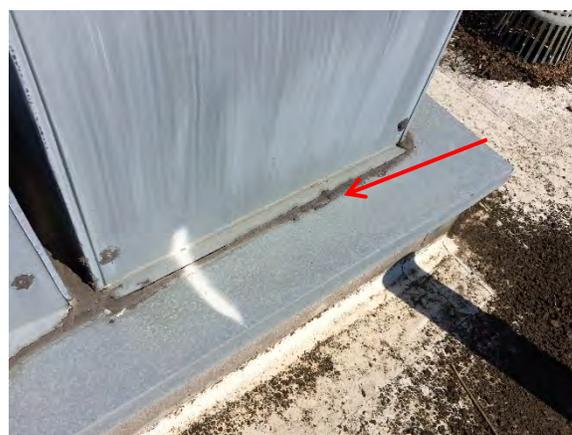
Photo #17: Tar/caulking on vents on the main building roof.

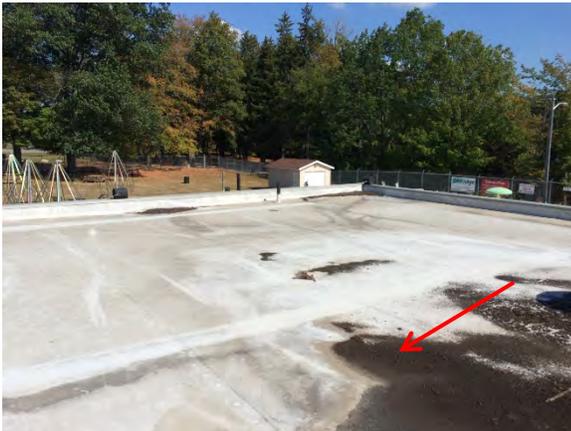
Photo #18: Black tar/caulking around ductwork and vents on the main building roof.
