Station Arts Centre Building Condition Assessment Report

The Corporation of the
Town of Tillsonburg
Station Arts Centre
41 Bridge Street, West
Tillsonburg, Ont.
N4G 5P2

a+LiNK Architecture Inc.
126 Wellington Road
London, Ont.
N6C 4M8

20 November, 2018

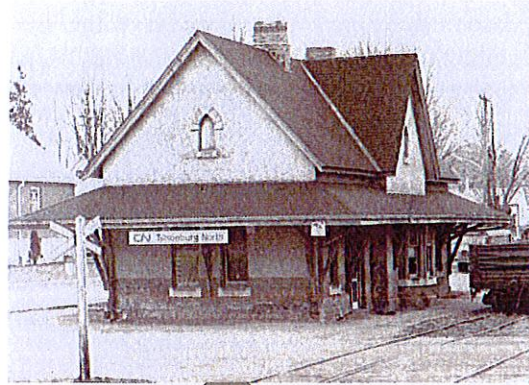
Figure 3, Original grading levels.²

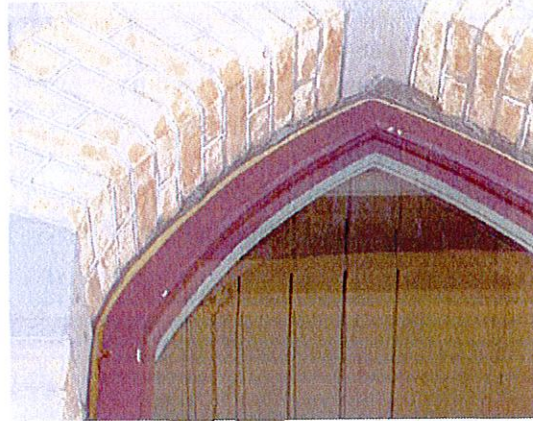
The exterior masonry is laid up in a “Common – Header Bond” pattern with a header bond course every 4th course and a projecting plinth brick at the base of wall. The original mortar appears to be lime based and the joints have a traditional single bead tooling. Brick arches have tapered (gauged) bricks and decorative cut stone elements at the spring line and keystone locations. The mortar joints in the arches are uniform in width and incorporate a white penciling treatment. This noteworthy treatment should be preserved as a heritage element.

Figure 8, Brick arch with white penciling treatment.

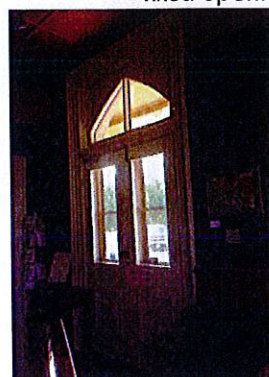
Figure 14, East heritage doors.

- a) Recommend – Heritage doors to be fixed open.

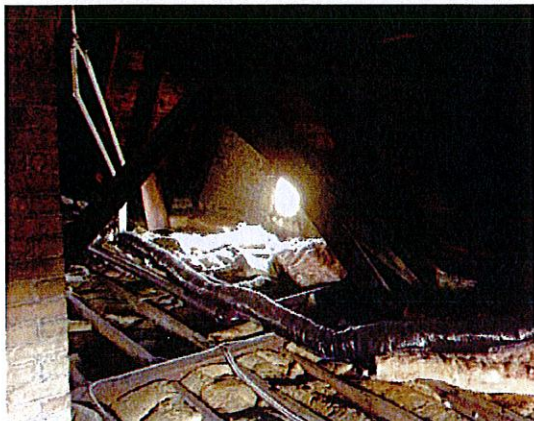
Adding additional insulation is an effective means of improving heat loss through the roof. The existing attic ventilation is insufficient and it is recommended that a ventilation strategy be reviewed and implemented as part of the new roofing project.

Figure 21, GWR station attic.

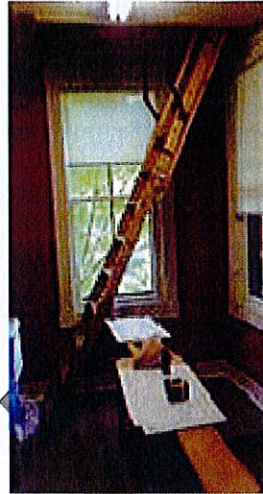
5.4.4.2 Based on the observations and modified condition of the ladder, contrary to the manufacturers recommendation, the access ladder should be replaced.

Figure 32, Attic ladder.

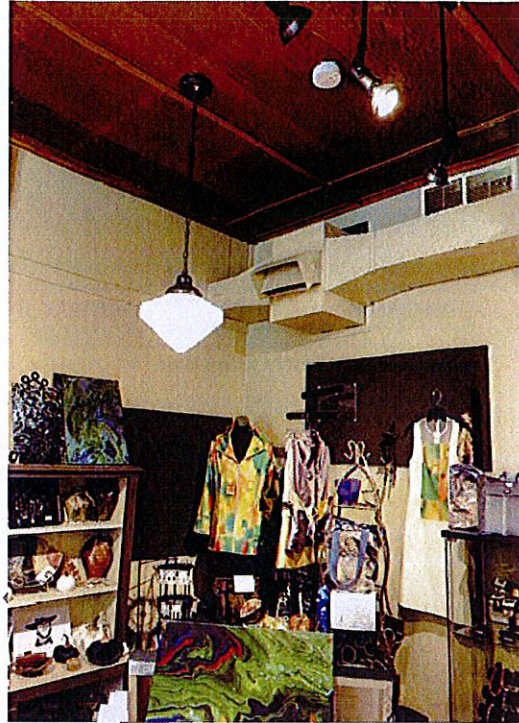
6.2.5 Ductwork for the furnaces serving the TLEPR and the 1995 addition route at the ceiling level of the basement and discharge air to the space through floor grilles. There are no fire dampers between floors as the floor has not been constructed with a fire resistance rating. There are also no fire resistance ratings for the mechanical rooms.

Figure 33, GWR Ductwork in Baggage Room Area

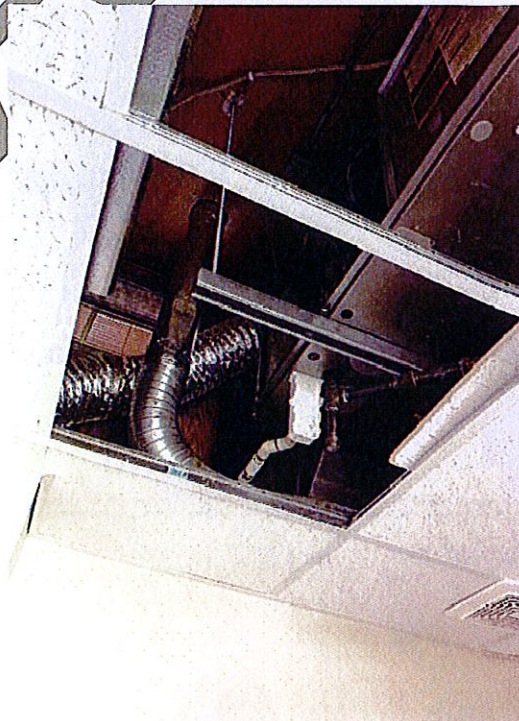
Figure 34, GWR Furnace in Ceiling Space of Washroom

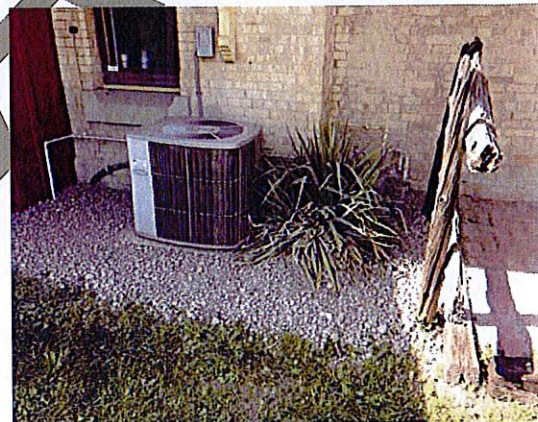
Figure 38, 1995 Addition Condensing Unit

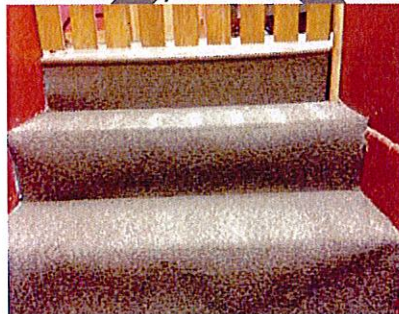
10. GWR stair, un-uniform risers.

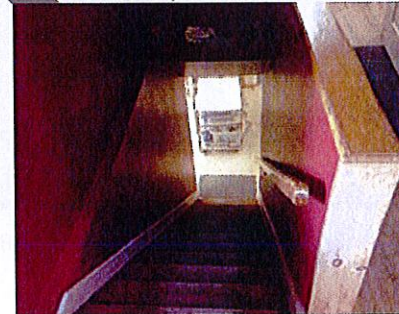
11. TLEPR, stair low headroom.

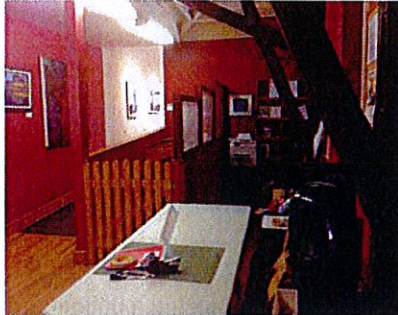
16. GWR, stair ground floor.

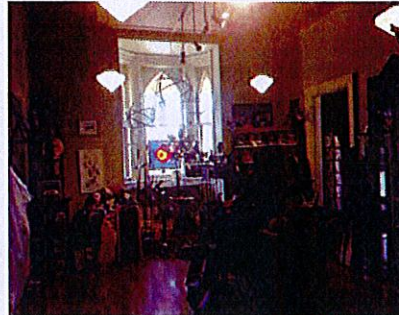
17. Baggage room.

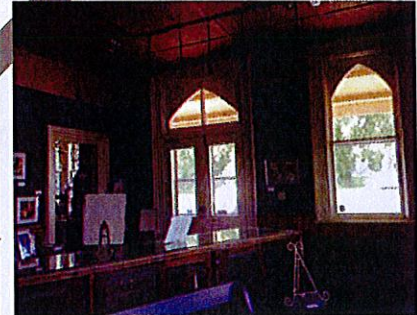
18. Bridge St. Gallery.

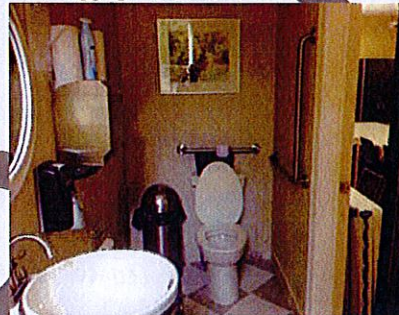
20. WR. Non-B.F. conforming.
